# **1 MAY 2003 BİNGÖL EARTHQUAKE**

## **ENGINEERING REPORT**

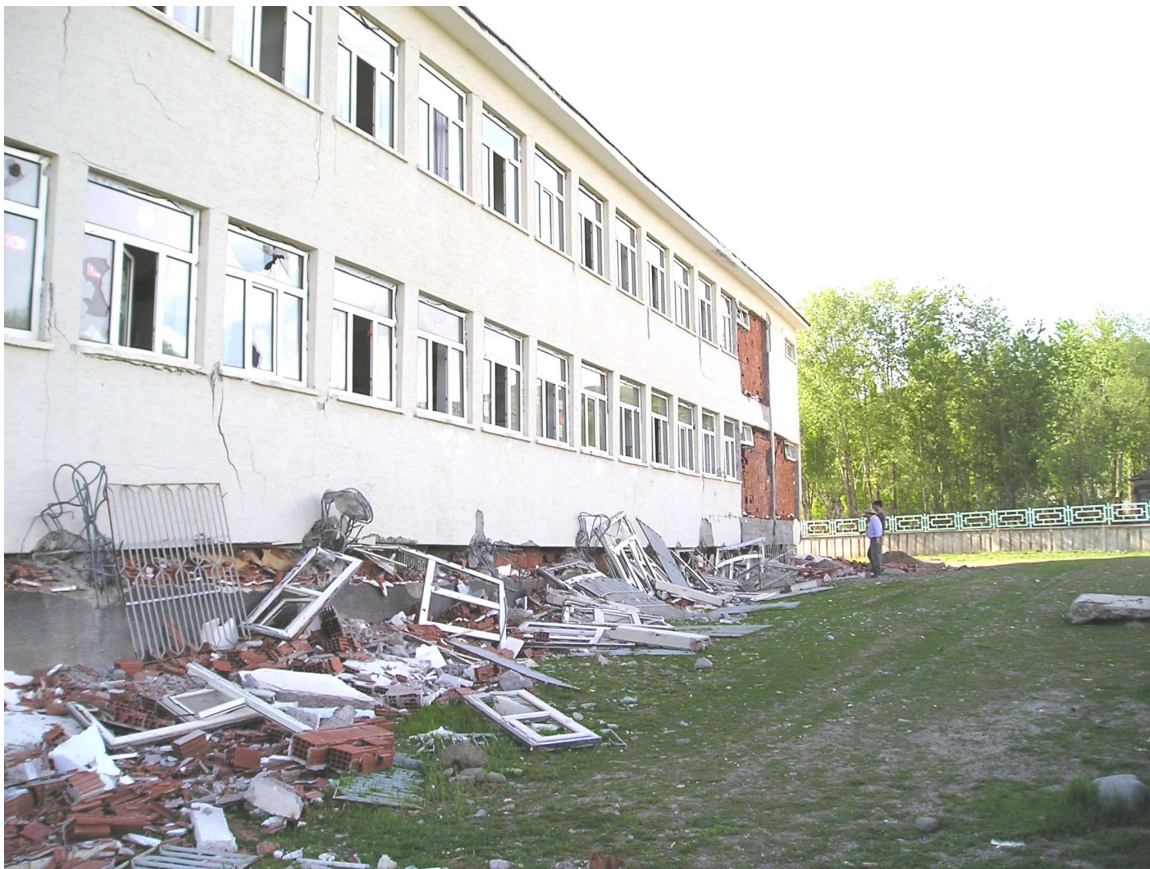
The only noticeable ground deformation was found in the school (Figure 4.3). There was a crack in the ground, approximately 3 to 4 m from the perimeter of the building, which indicated settlement. The school had a basement, and thus the foundation was likely placed on the gravel deposit; the crack was the result of the settlement of the backfill behind the basement wall.

**Figure 4.3** School with collapsed first floor in NE Bingöl. Note that first floor is missing. Windows were in the first floor. Cracks in soil near foundation were at far end of building.

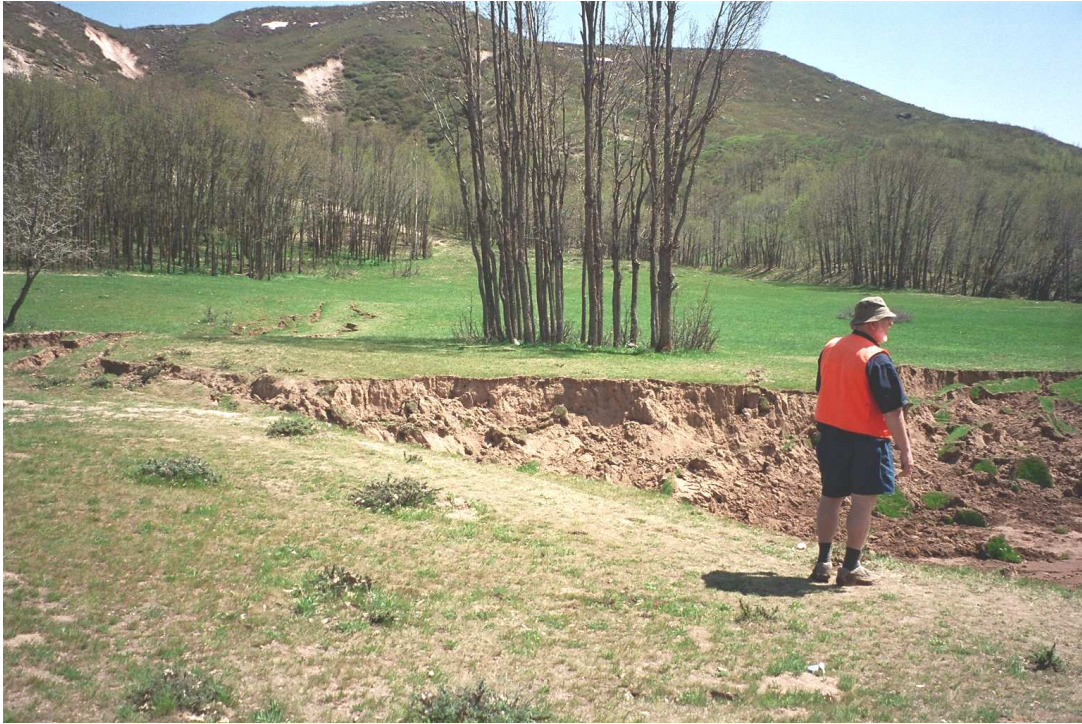
**Figure 4.9** Head of flowslide. In distance, to right of copse of trees in center, is narrow graben that connects to head and extends eastward across much of the pasture in the distance. The narrow graben is the so-called “fault ground rupture” that was supposed to be evidence of surface faulting during the Bingöl earthquake.

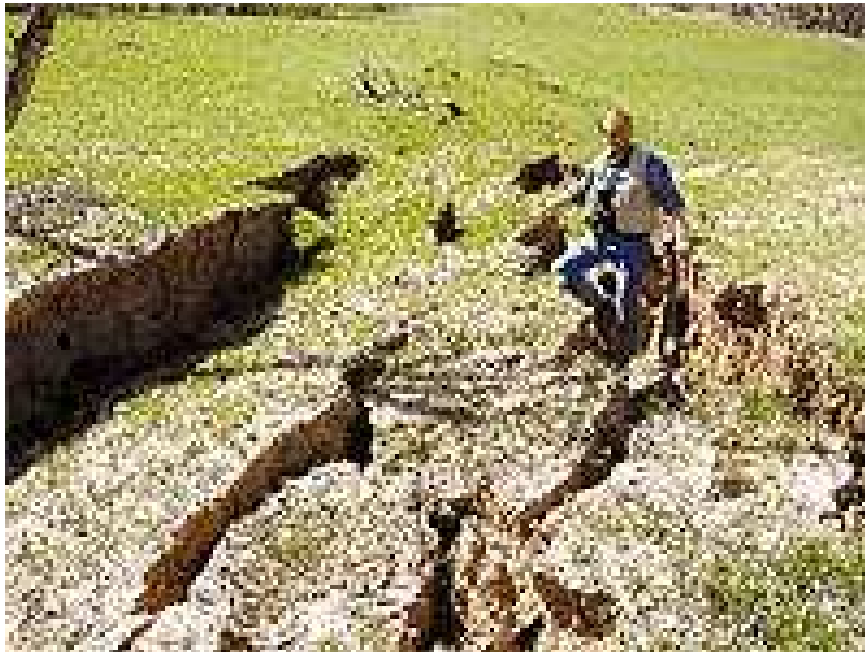
**Figure 4.10** Closer view of graben<sup>10</sup>. The diagonal tension cracks in mid-distance suggest right-lateral shearing as well as opening.

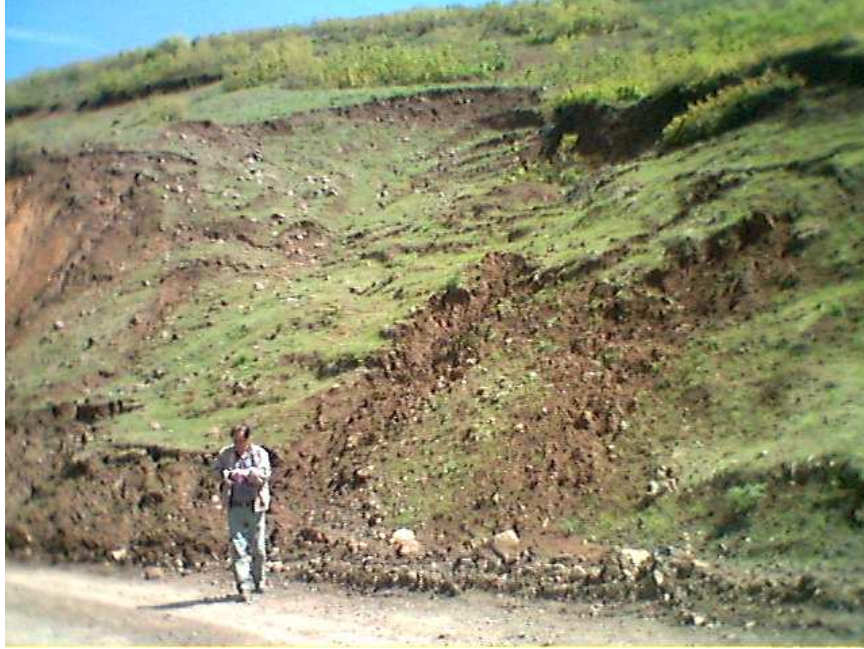
**Figure 4.17** Landslide at the south exit of Yazgülü village (Point 4 in Figure 4.13) ( $N 39^{\circ} 00.5'$ ,  $E 40^{\circ} 17.85'$ )

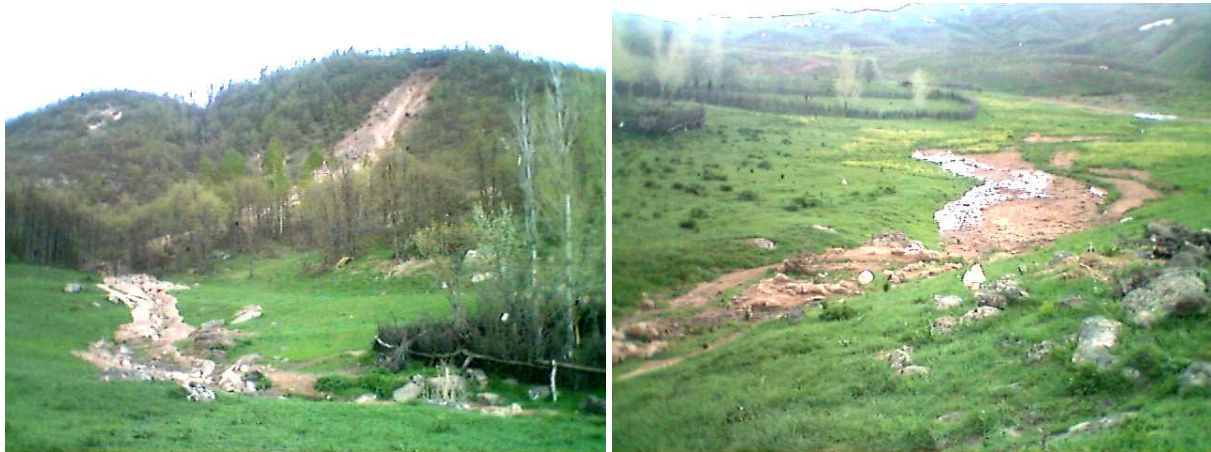
Seismically-induced mudflow was observed at Kurtuluş village where mud covered a horizontal extent of hundreds of meters. Villagers reported that mudflow started immediately after the earthquake and continued till the morning of the night of the earthquake (Figure 4.20).

**Figure 4.20** Mudflow at Kurtuluş village (Point 15 in Figure 4.13) (N 39° 06.66', E 40° 39.48')

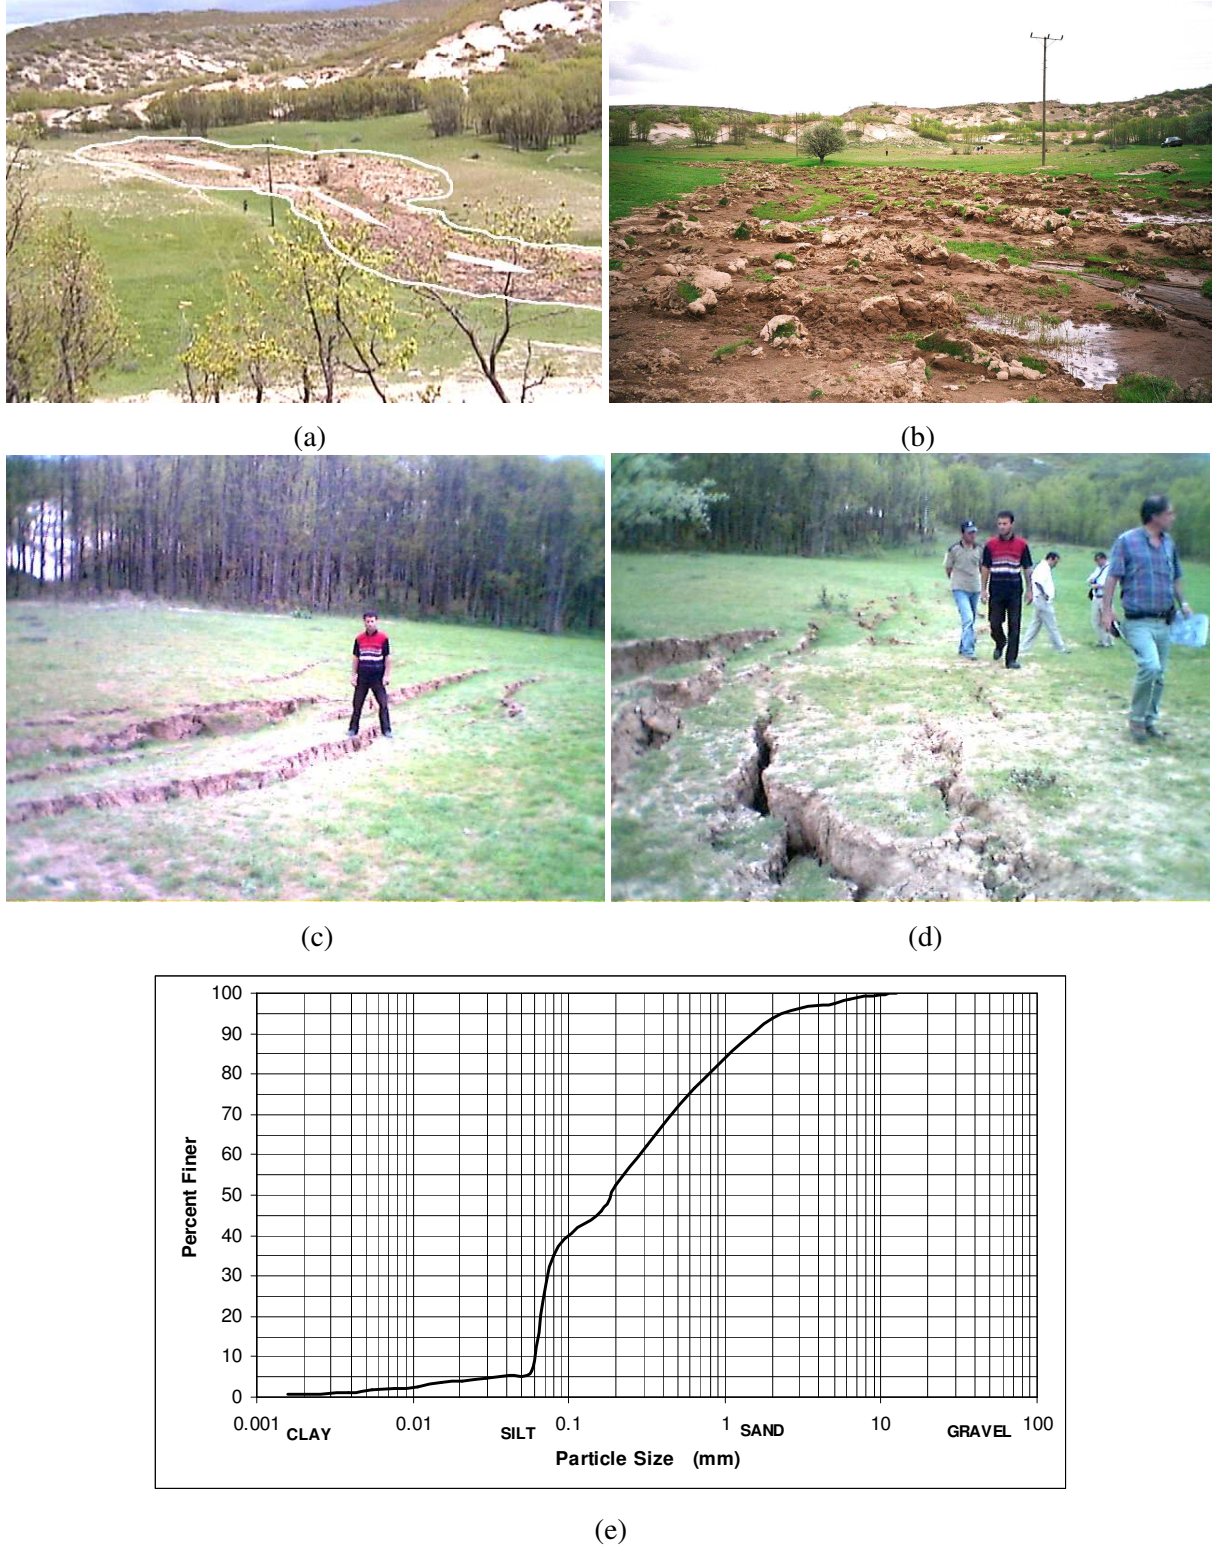
**Figure 4.27** Lateral spreading and mudflow at Hanoçayırı (Point 16 in Figure 4.13) (N 390 03.1', E 400 30.46')

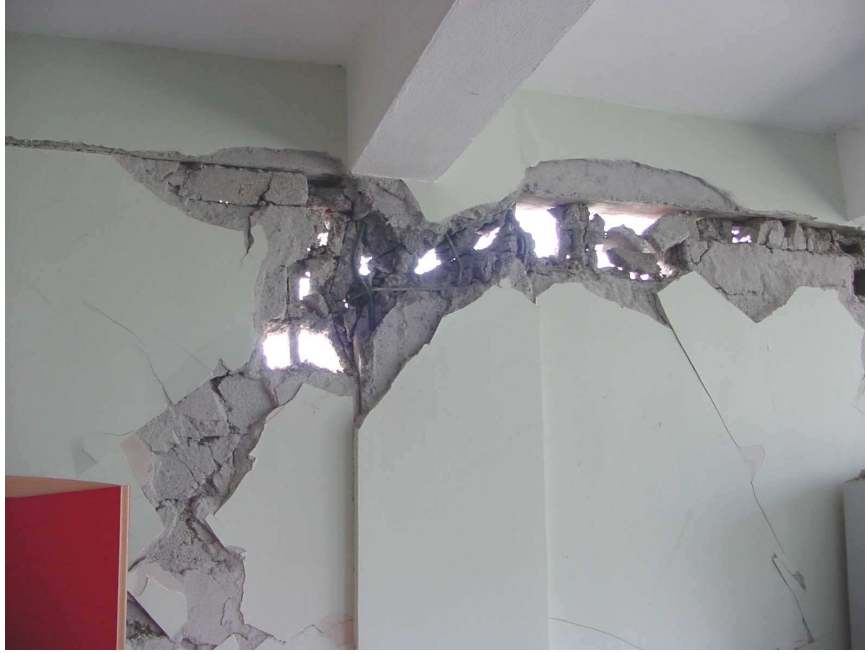
**Figure 5.12** A clear column-end failure and masonry wall damage

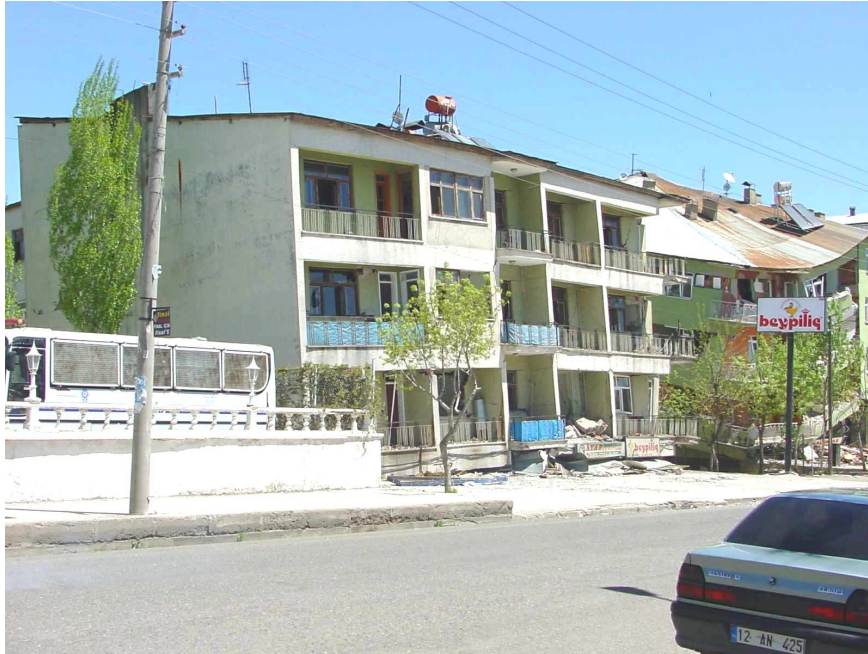
**Figure 5.14** First story collapse of a four-story building

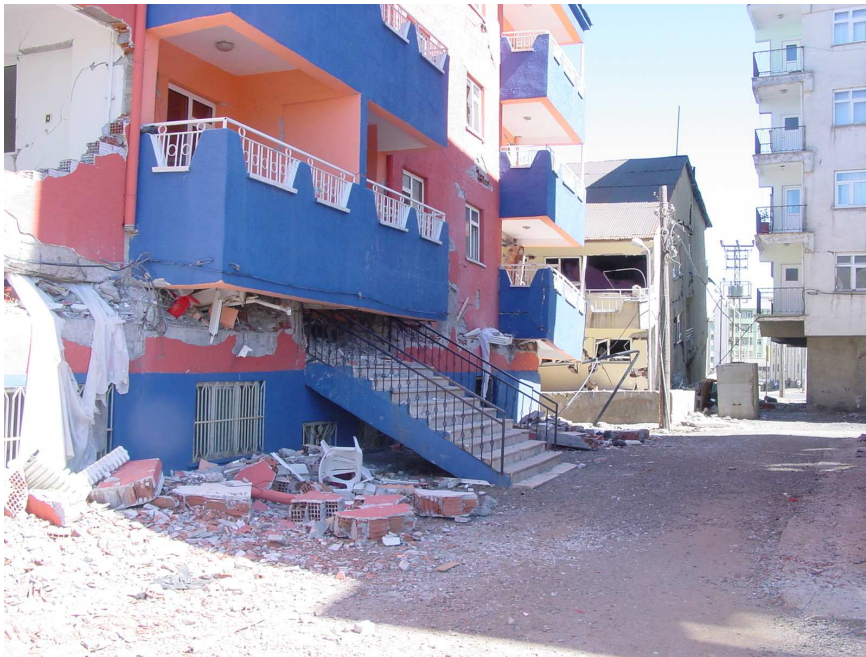
**Figure 5.17** Loss of soft story in reinforced concrete frame building

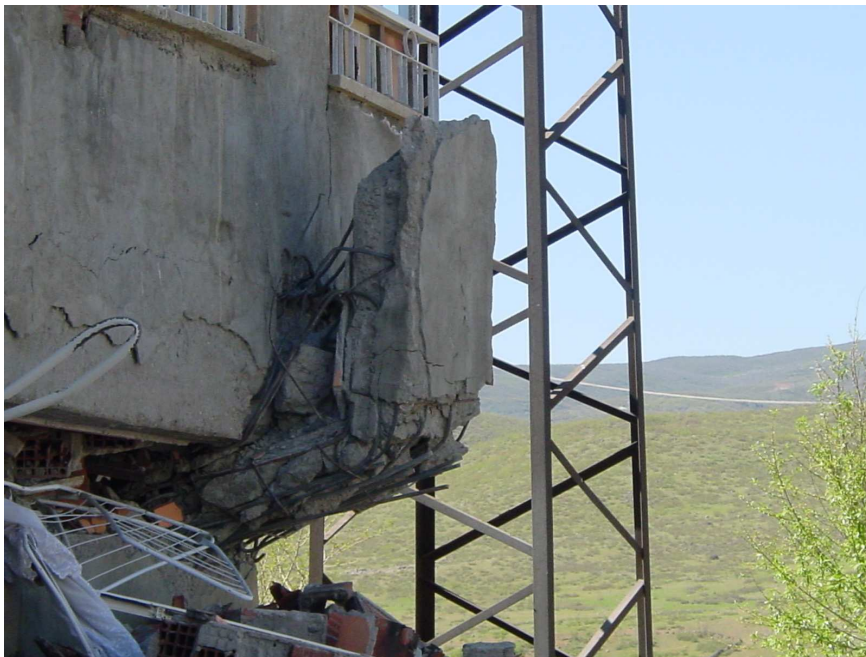
**Figure 5.19** Insufficiently confined column of a collapsed building

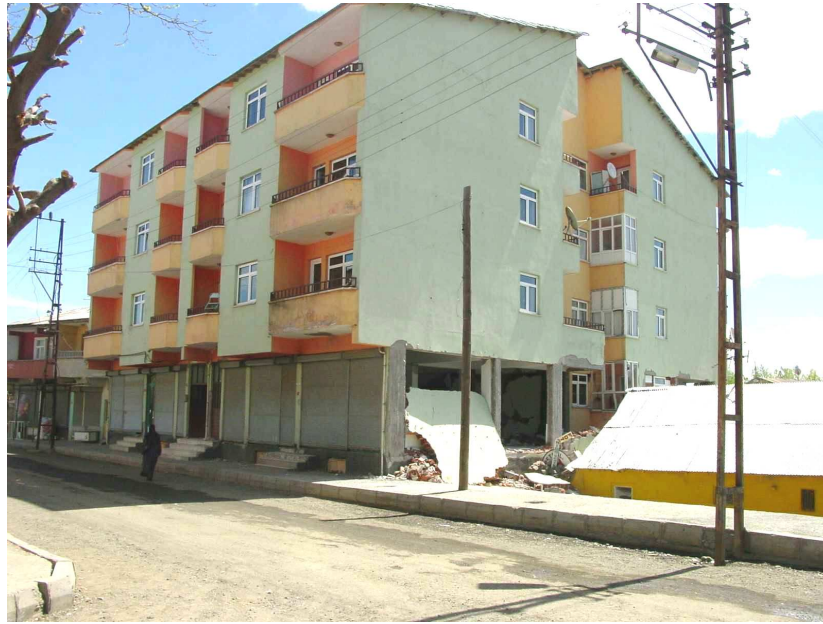
**Figure 5.20** A heavily damaged four-story building in Yenimahalle

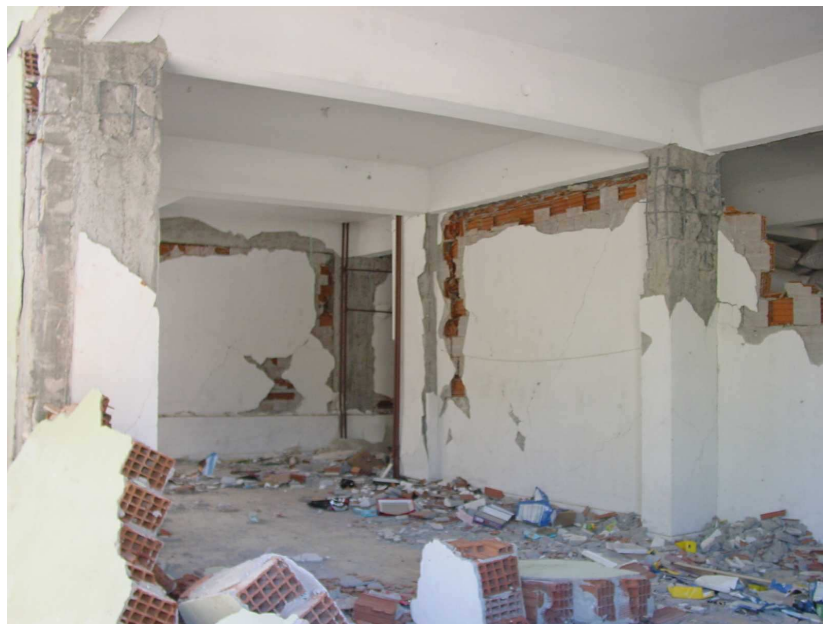
**Figure 5.21** Spalling and crushing of concrete due to high axial loads

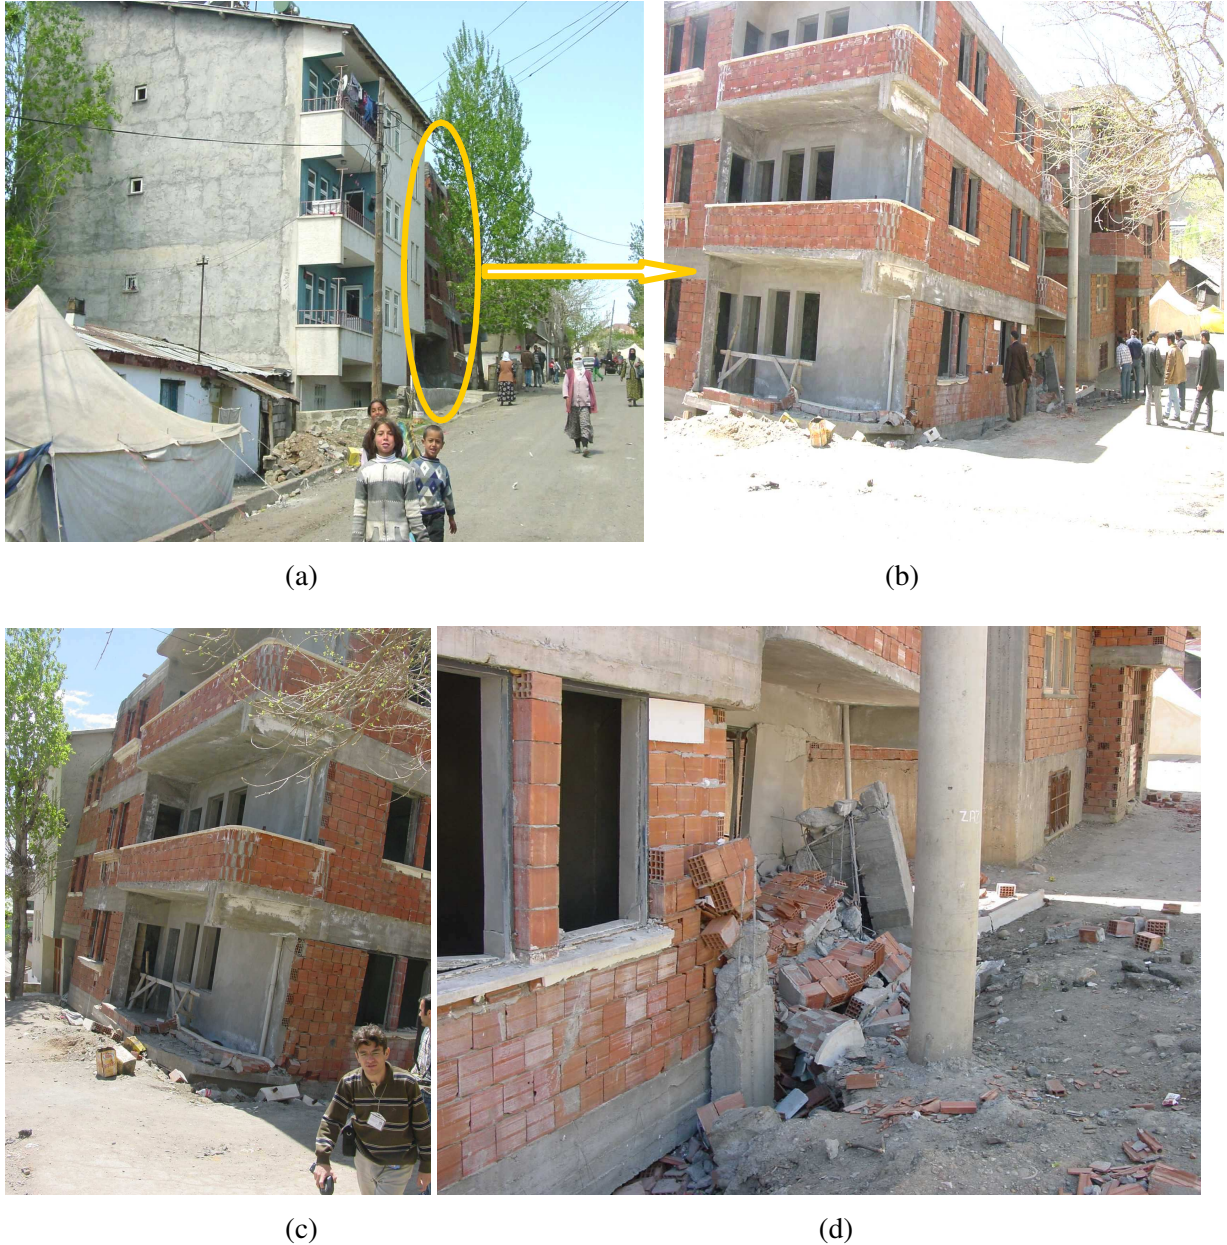
**Figure 5.22** a) Lightly damaged four story RC building constructed in 1996; b, c) Complete damage to four story RC building constructed in 2003; d) Column offsetting at collapsed floor due to improper connection.

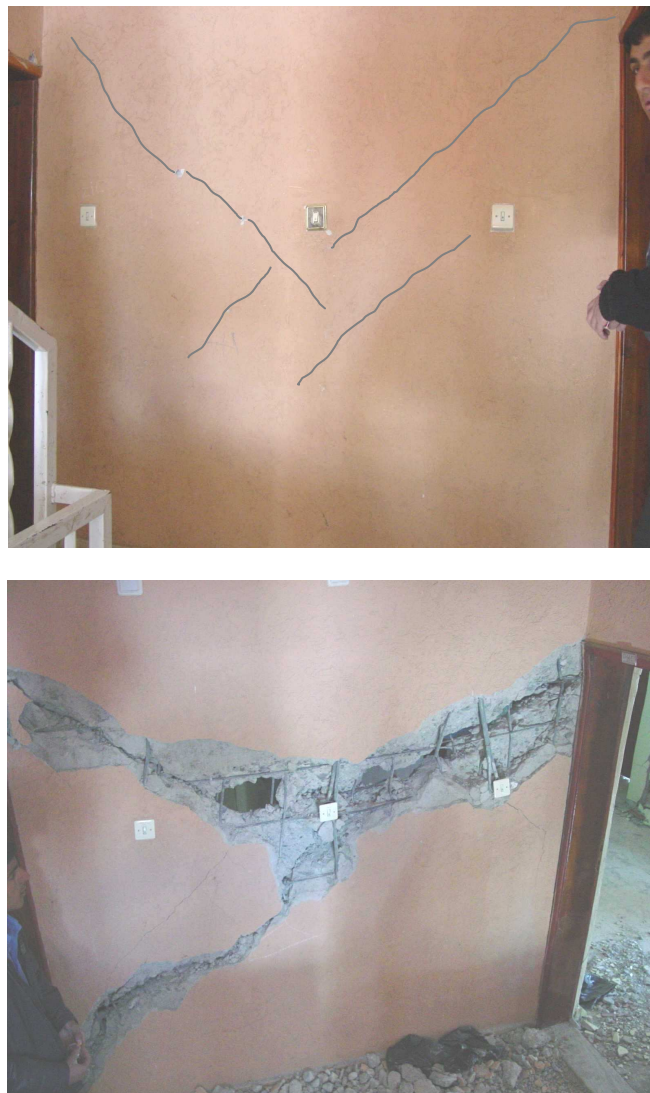
**Figure 5.24** Shear failure of ground floor (top) and first floor (bottom) shear walls

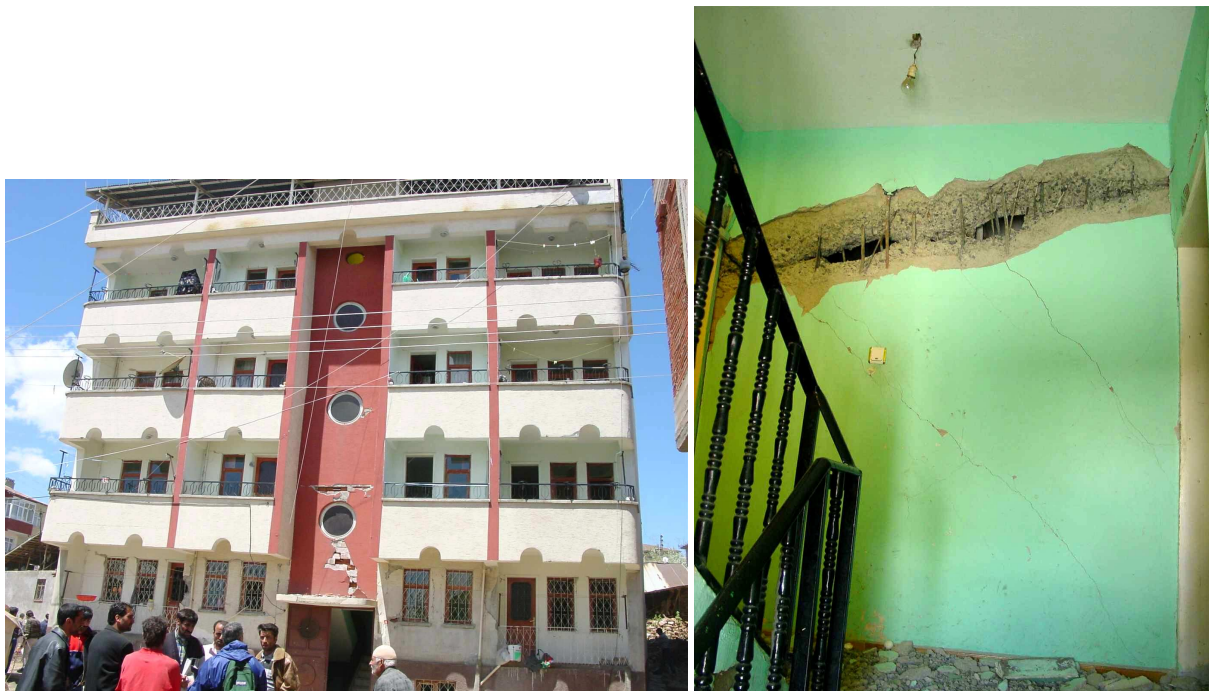
**Figure 5.26** Heavily damaged 4 -story building (plus penthouse) and the damage experienced by its shear wall

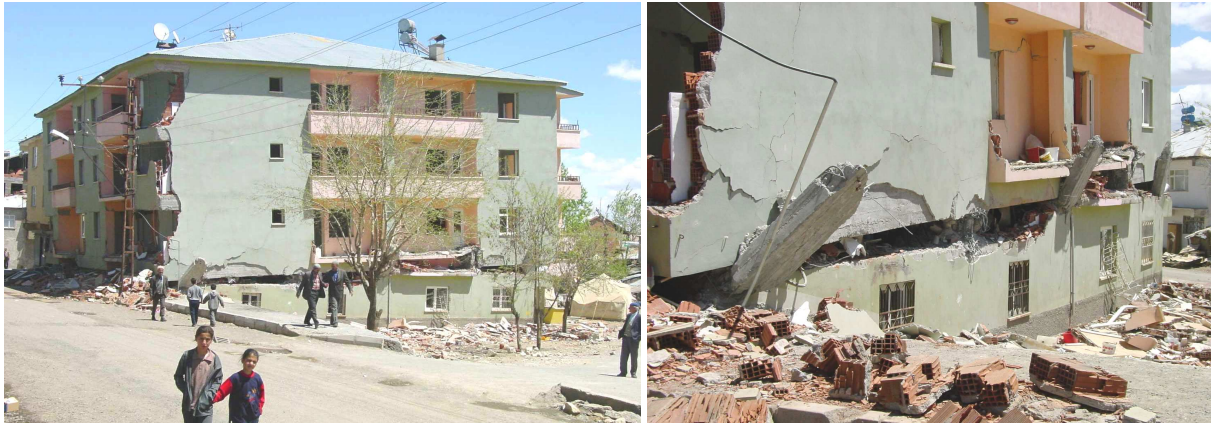
**Figure 5.27** Collapsed 5 story building in Yenimahalle.

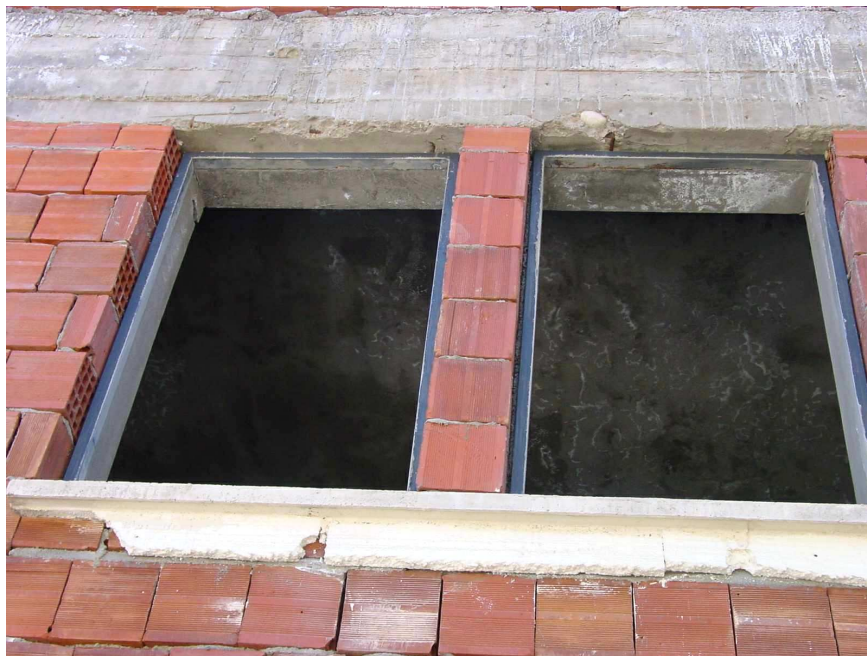
**Figure 5.28** Window framing detail. Steel frame is welded to the rebar of the beam.

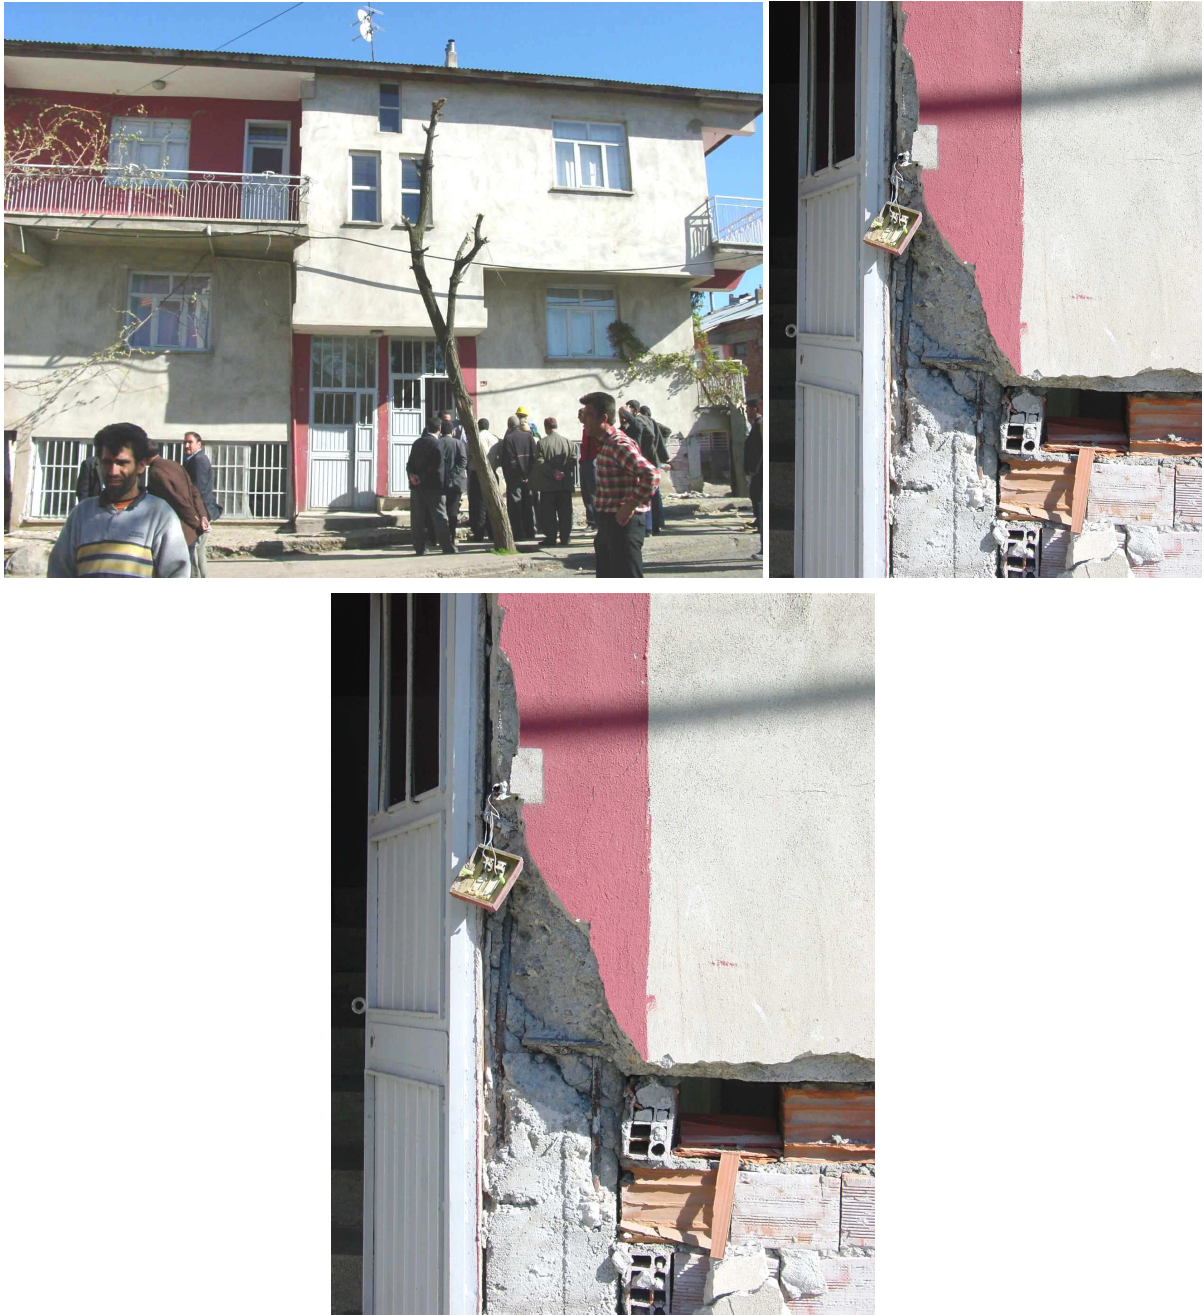
**Figure 5.29** Short column damage of a two-story reinforced concrete frame building in Yeşilyurt.

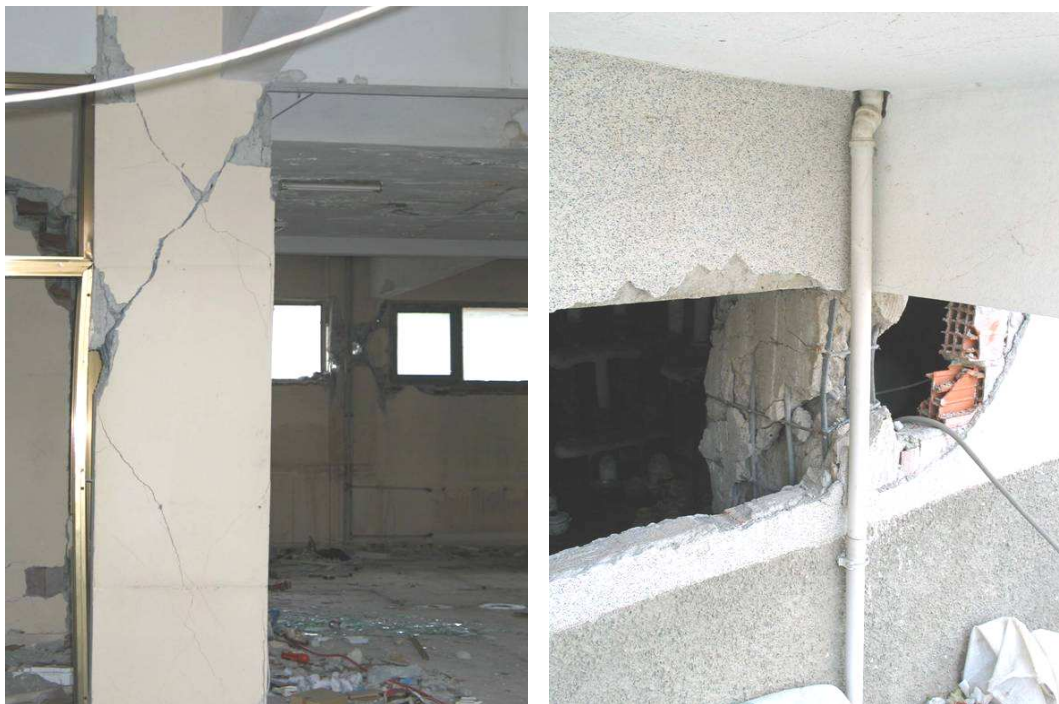
**Figure 5.37** Shear failures in unrestrained and captive columns.

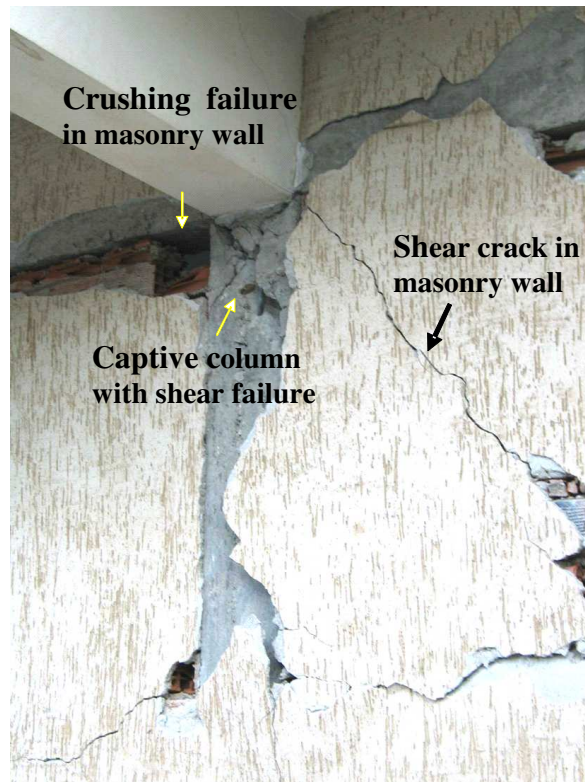
**Figure 5.38** Damage to masonry walls.

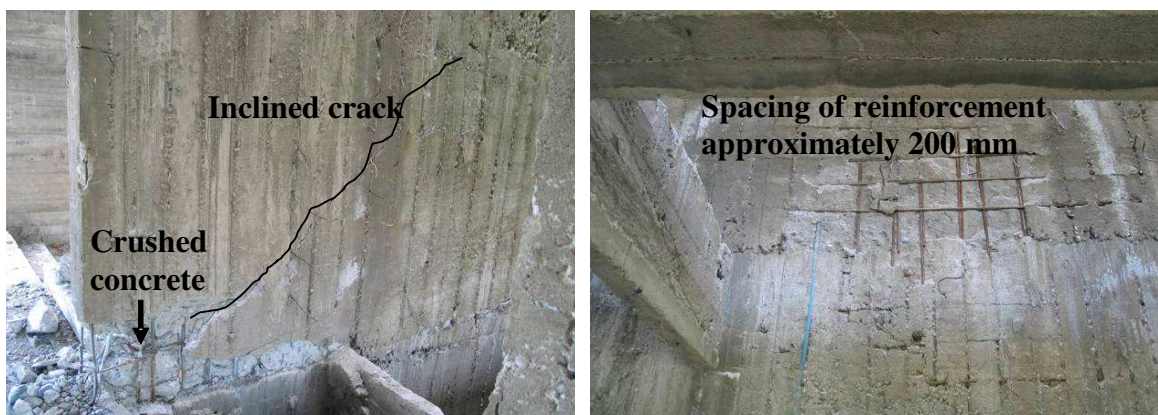
**Figure 5.48** Types of damage and detailing characteristics observed in structural walls.

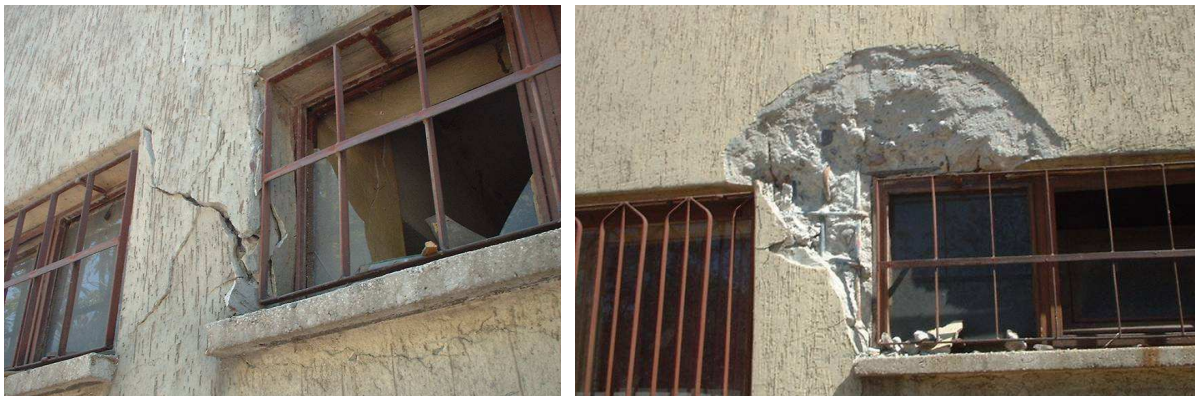
**Figure 5.71** Shear failure of captive columns created by the small windows of the furnace room in building C-14-03.

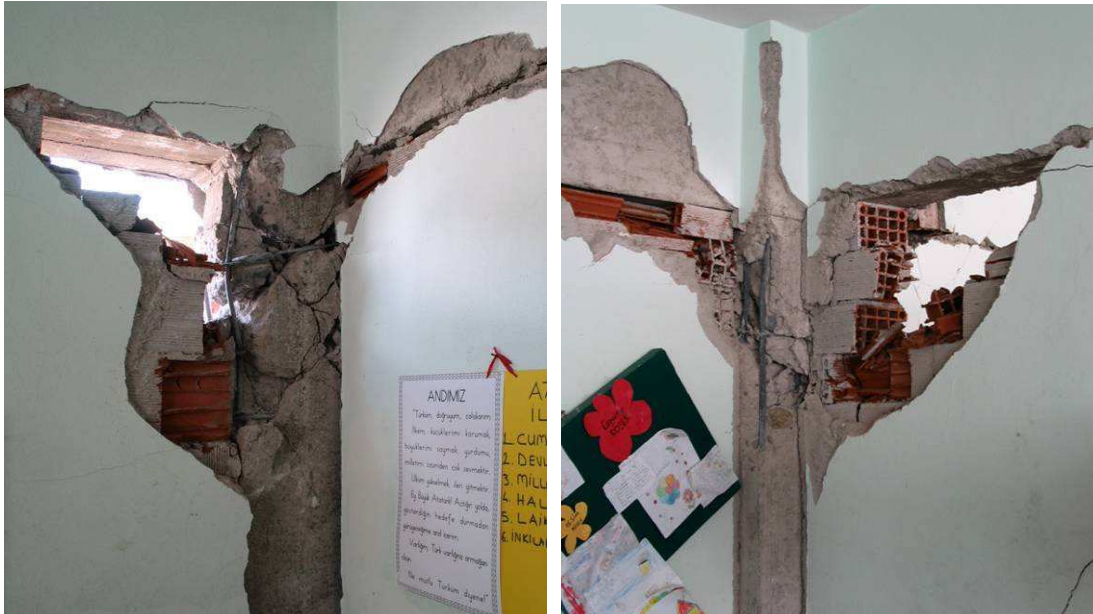
**Figure 5.72** Shear failure of captive columns as a result of crushing of upper corner of masonry walls in building C-14-01.

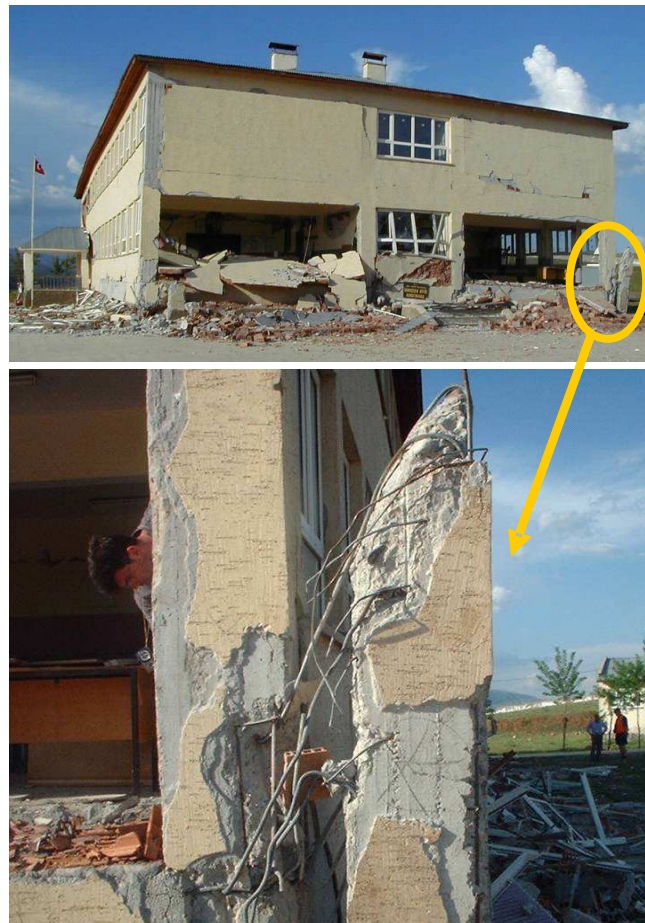
**Figure 5.73** Typical confinement detail of a column in building C-13-09. The shear failure in the columns initiated the collapse of the first floor. The spacing of the transverse reinforcement is 10 cm at the top 30-cm portion of the columns. The ends of the stirrups were not anchored properly.

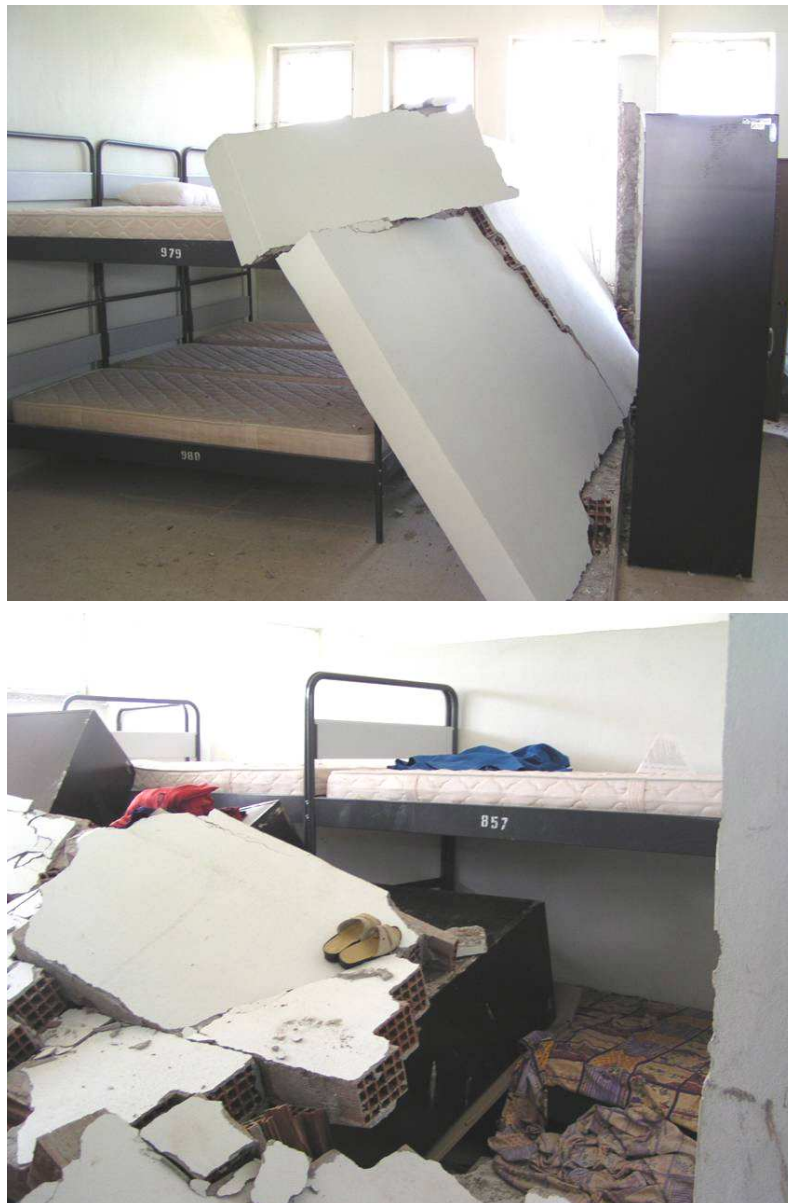
**Figure 5.79** Collapse of the free standing masonry walls onto the beds in the dormitory buildings.
