# **1 MAY 2003 BİNGÖL EARTHQUAKE**

## **ENGINEERING REPORT**

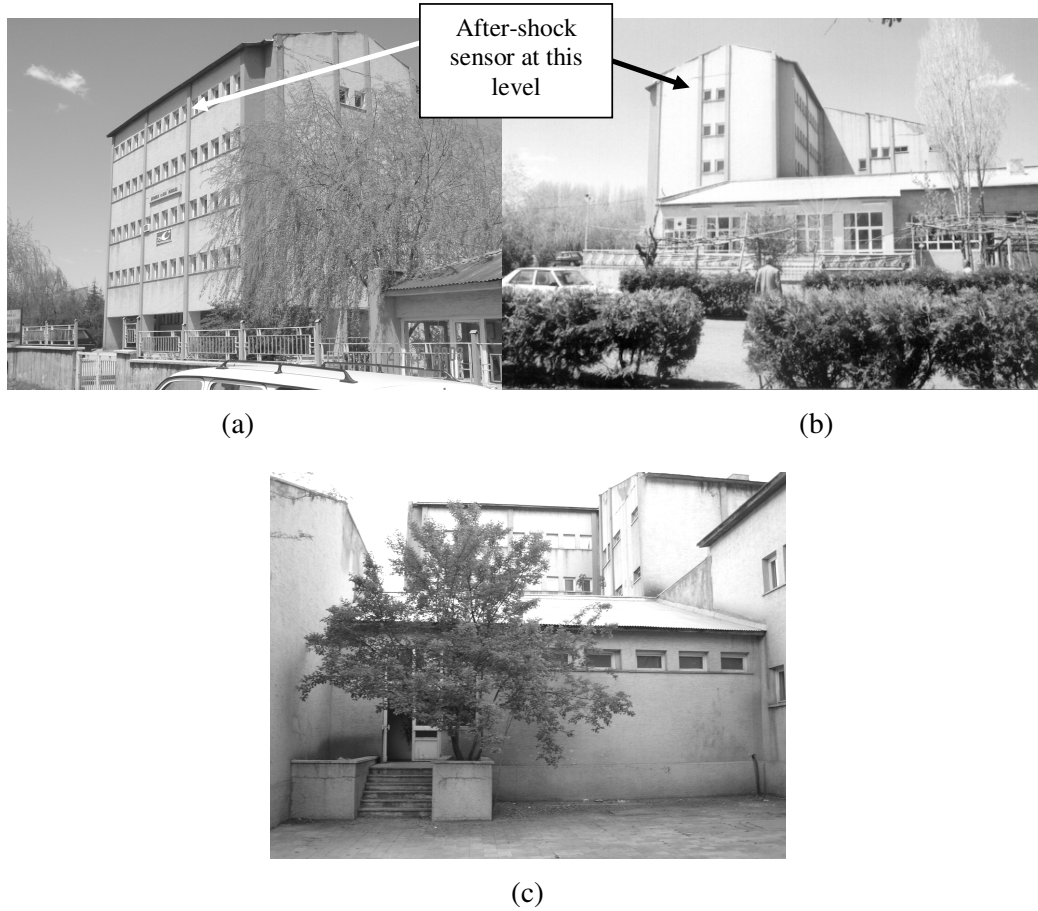
The pictures in Figure 2.3 show the general view of the Bingöl recording station. This is a reinforced concrete office complex of the Bingöl Public Works and Settlement (Figure 2.3a and Figure 2.3b). The strong ground motion instrument is placed inside the one story auxiliary structure that is adjacent to the mid-rise office buildings (Figure 2.3c). Expansion joints separate each adjacent block in the complex. The buildings have been designed and constructed according to template designs developed by the parent Ministry. Identical provincial Public Works and Settlement building complexes exist in many cities of the country. The station is located in the north of the city, on an estimated 50 m high alluvial terrace between two streams. The terrace material is dense formations comprising predominantly uniform granular alluvial deposits. Further north from the building, there are slopes toward the bottom of the valley formed by the second stream. The authors do not have an upper 30 m shear wave velocity variation of the area of interest but the geological formation described above suggests that the soil profile in this area would be classified as USGS site class C or D (i.e.,  $360 \leq v_s < 750$  m/s and  $180 \leq v_s < 360$  m/s, respectively).

**Figure 2.3** Bingöl Public Works and Settlement branch office complex. Figure 2.3a shows the 5-story reinforced concrete main office building. Figure 2.3b describes the way the 5-story structure is connected to the adjacent 4-story office building in the rear. The accelerometer sensor is deployed inside the 1-story auxiliary building (Figure 2.3c) situated approximately 15 m from the mid-rise office buildings shown at the rear. The two mid-rise buildings experienced severe pounding during the main event. The effects of this pounding are not discernible in the main shock accelerogram. (Courtesy of Prof. Mete Sozen, Purdue University)

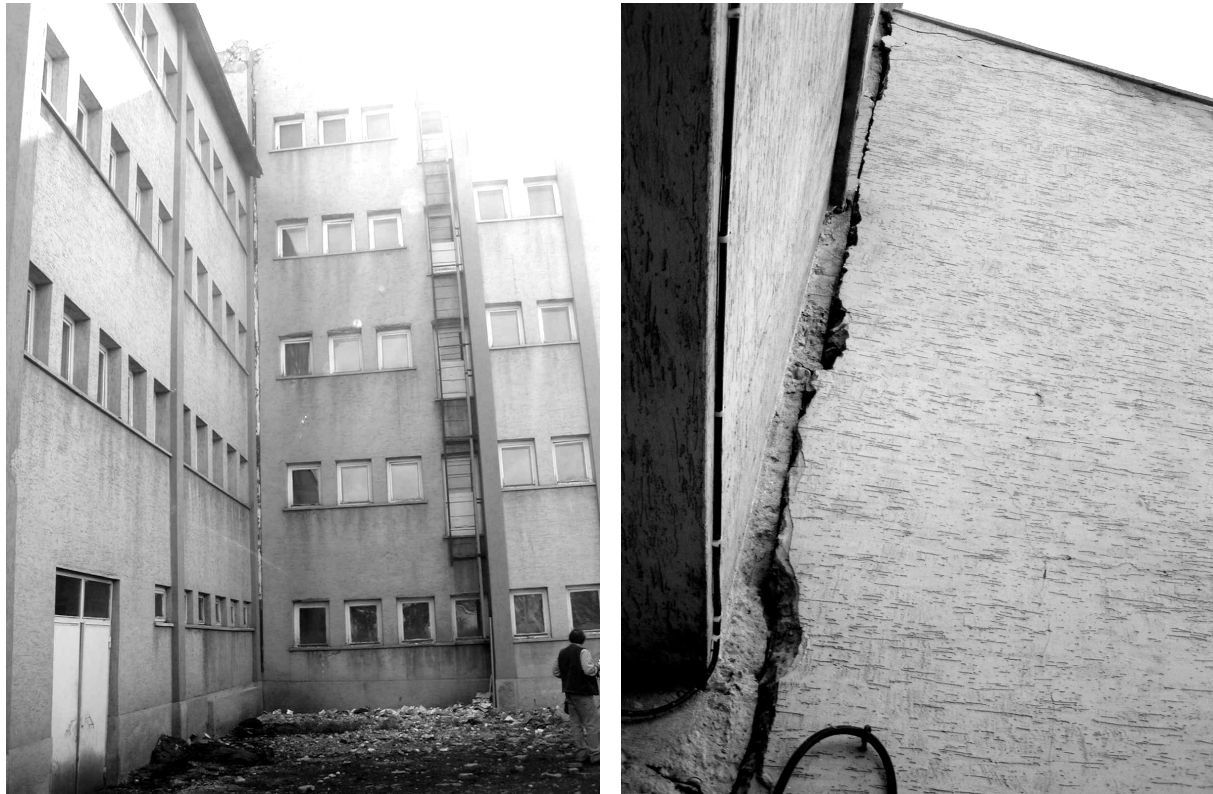
Figure 2.11 shows evidence for the pounding between the two mid-rise office buildings observed immediately after the main shock. The pounding occurred mainly in the NS direction and the distance between the strong ground motion instrument and the office buildings is approximately 15 m. The authors conducted Fourier analysis on 59 sets of aftershock time series recorded by the same instrument. Aftershock motions have PGA values of less than 0.01 g. The purpose was to see any dominant site behavior at the recording station. These analyses focused on the N10E component because it is the direction of pounding observed in the adjacent blocks. Figure 2.12 is the normalized Fourier spectra for the main shock and geometric mean aftershock data arranged for comparison purposes. The authors considered the maximum amplitude of the geometric mean for the normalization of aftershock data. The Fourier components of the N10E curves are amplified in the near proximity of 0.15 s (i.e. 6.67 Hz). The mean aftershock Fourier components reach the maximum at 7.38 Hz (0.14 s), and the main shock Fourier components have a significant amplification at 6.39 Hz (0.16 s). The slight shift in the frequency between the main shock and aftershock data might be attributed to possible nonlinearity of the soil during the main shock. The geometric mean of the E10S aftershock data also reaches its maximum value at about 6.7 Hz. The comparison of the main shock

**Figure 2.11** Evidence of pounding between the mid-rise office buildings of the Bingöl Public Works and Settlement branch complex. The photograph on the left is taken from the enclosed garden surrounded by the office buildings and the 1-story auxiliary structure where the strong ground motion instrument was located. The distance between the office buildings and the auxiliary structure is approximately 15m. The image on the right shows that the effect of pounding grows with height. The pounding is significant in the NS direction.

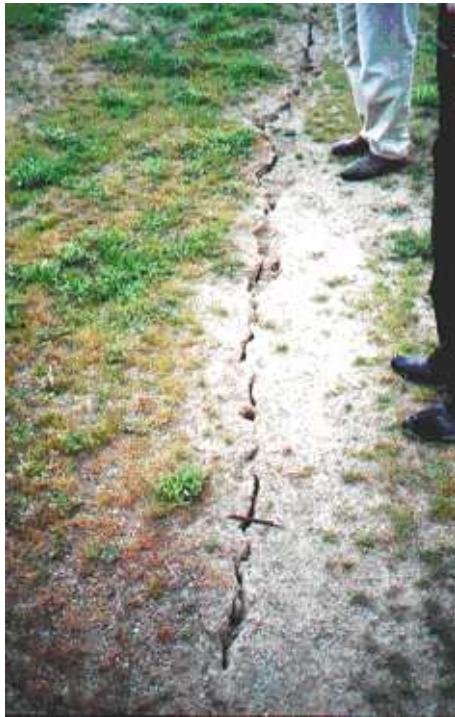
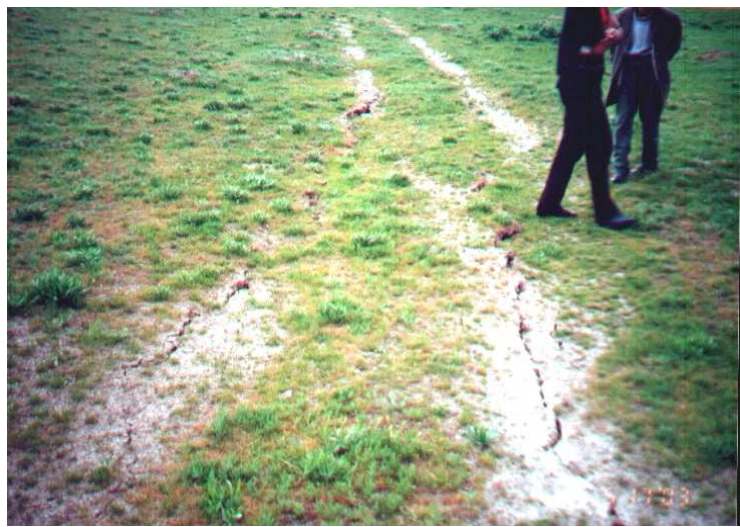
**Figure 3.6** Views from N30E trending short cracks at Hanoçayırı

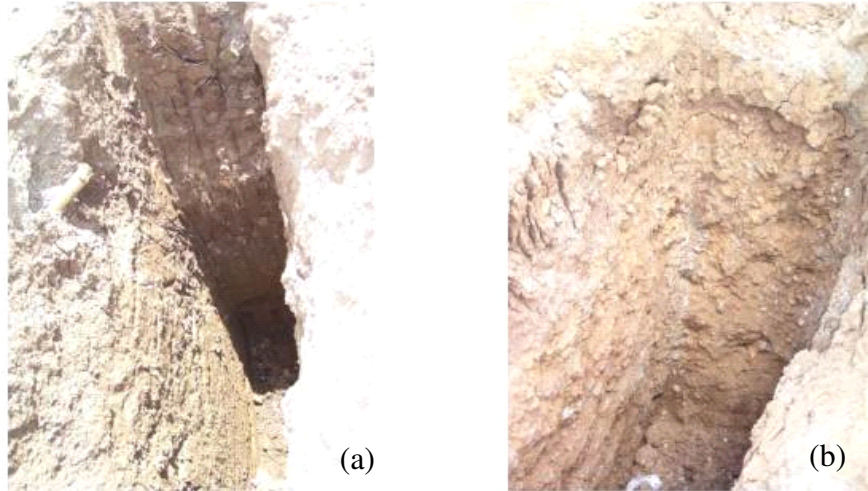
**Figure 4.4** Trenches excavated near the collapsed dormitory building.

A number of schools were surveyed at different locations far from the urban area. Some of the schools suffered collapse. Of particular interest was the site where the Çeltiksuyu Boarding School dormitory failed, killing more than eighty students. There were other two buildings in the same location: a school that collapsed, and the teacher's building that suffered light damage. The three buildings were placed on top of an alluvial deposit. Figure 4.4 shows pictures of two trenches excavated near the buildings. The first trench (Figure 4.4a) shows a stiff fine grained soil on the surface (note the marks of the teeth of the excavator on the front wall and the vertical walls of the trench), and a gravel at the bottom of the trench; there is also a fill on the top meter or so (note the yellow plastic pipe), but this is local to the site where the trench was excavated. The second trench (Figure 4.4b) was excavated on gravel, dense to very dense. Note that in none of the trenches are there signs of water. This is expected because of the nature of the soils in the area: alluvial deposits, predominantly granular, with high permeability. The location of the buildings was on an elevated terrace, and thus it is likely that the water table in this area was very low, closer to the level of the river.

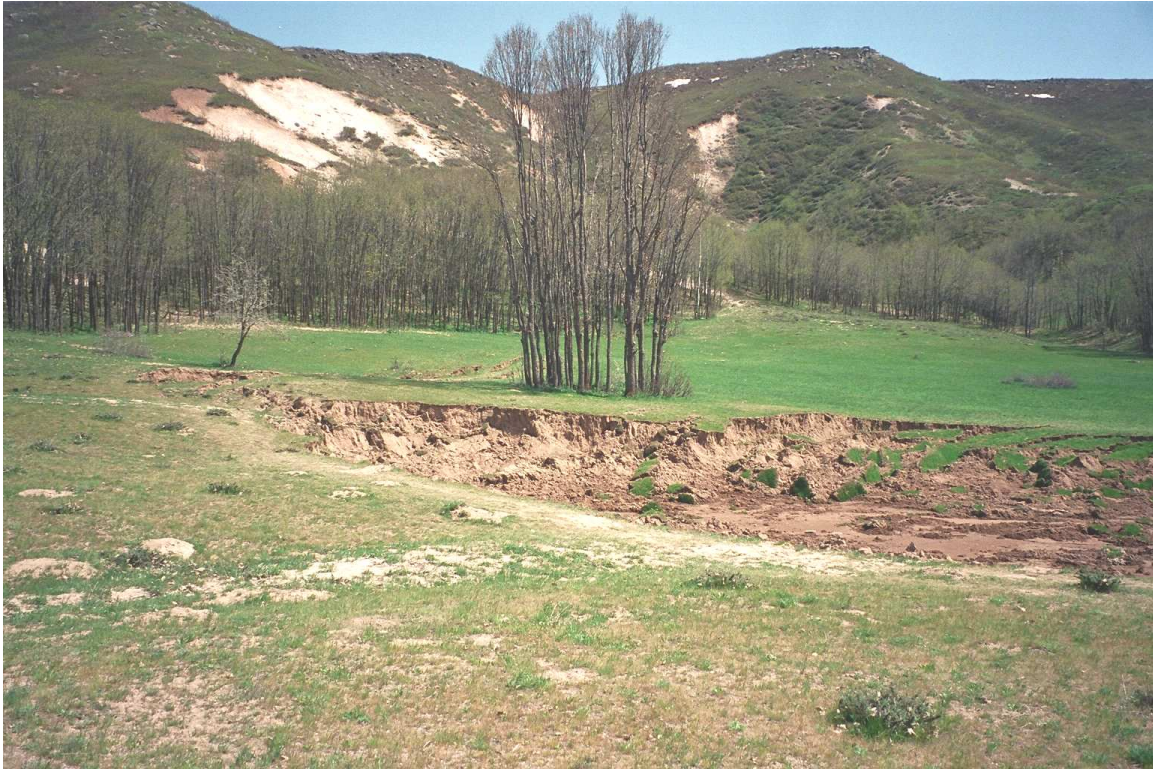
**Figure 4.5** Head of flowslide channel at Hanoçayırı.

Members of the NSF-TÜBİTAK team visited the site and briefly examined the ground ruptures and the landslide mass. The landslide is an excellent example of a flowslide, which is almost certainly a result of liquefaction on long-range flowage. The flowslide started as a landslide mass along a shallow valley in an open meadow (Figure 4.5). Parts of the flowing mass moved some hundreds of meters from the source (Figure 4.7; Figure 4.8) landslide so the liquefied debris was highly mobile.

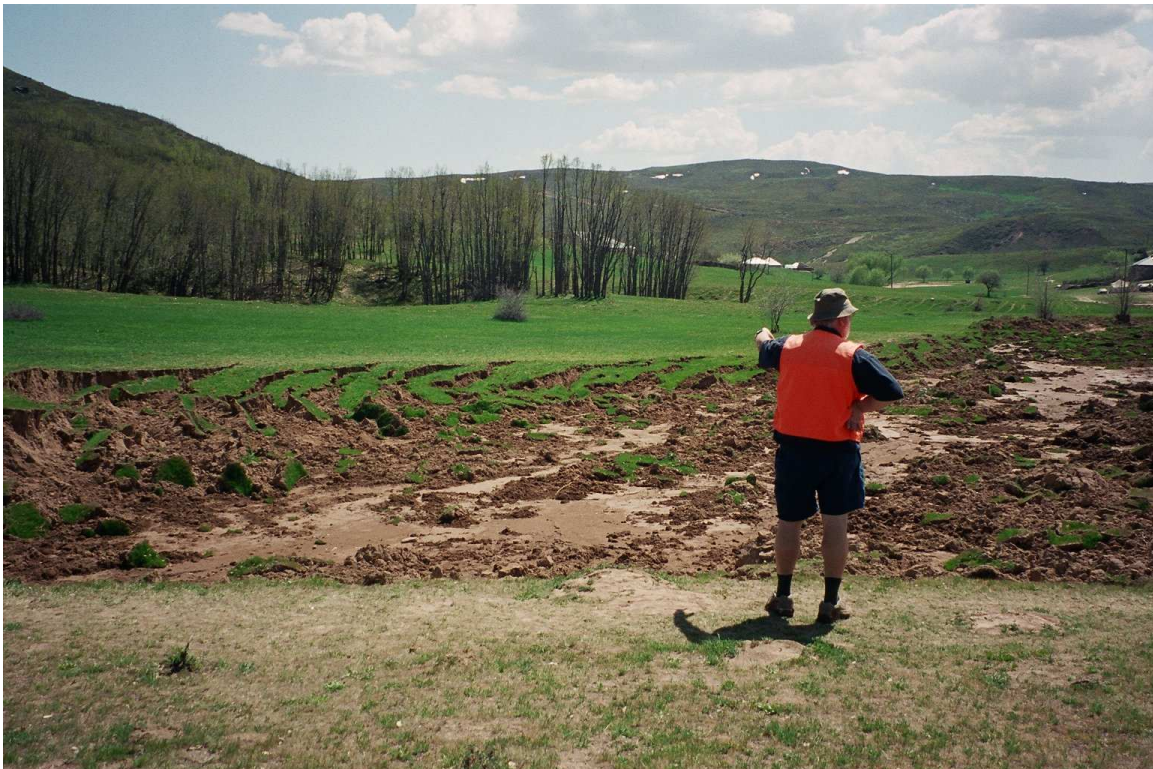
**Figure 4.6** Main flowslide channel just below the head. On far side are slices of grass sod that began to detach and become mobilized when sliding stopped.

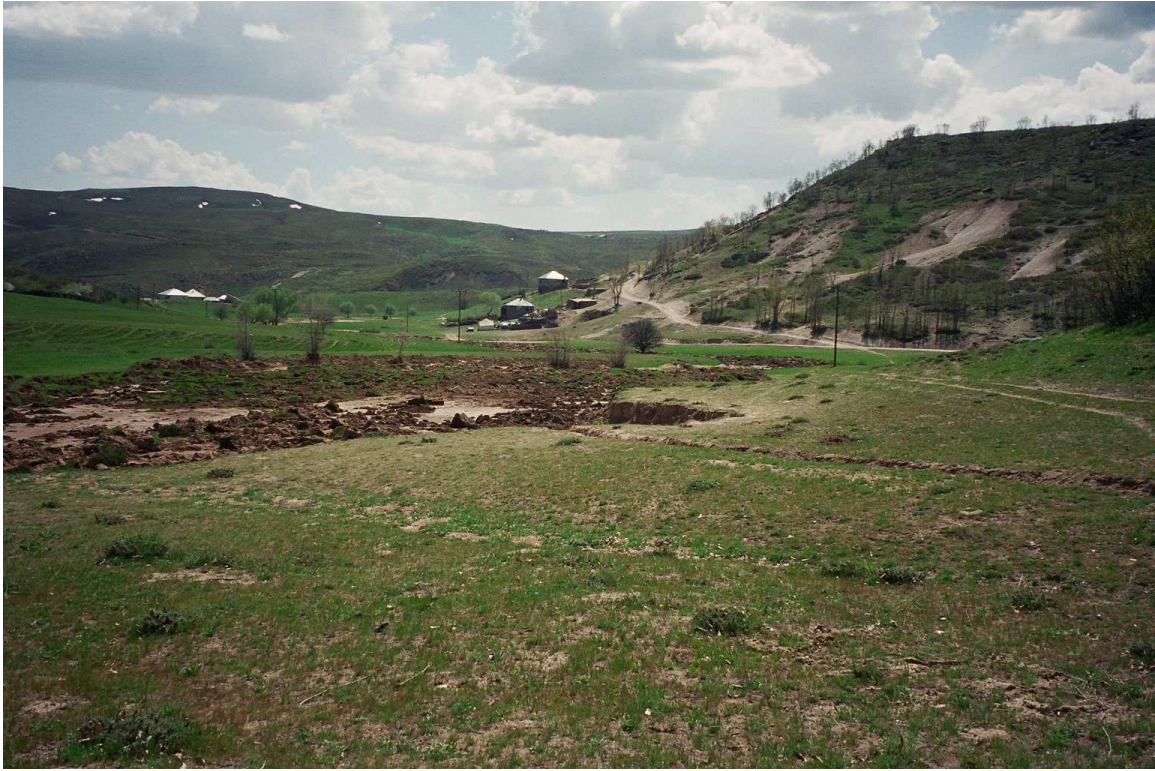
**Figure 4.7** More of the flow channel. View south. The flow moved debris to vicinity of buildings visible in distance on the left in photo.

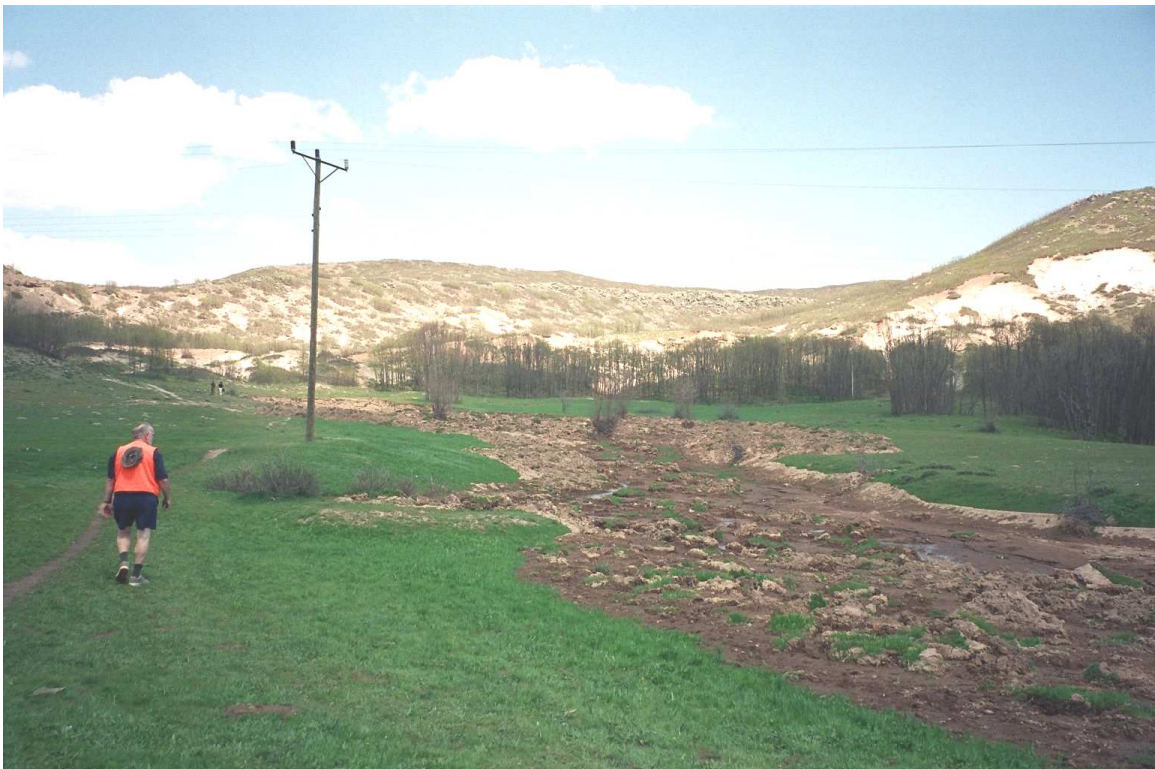
**Figure 4.8** Farther down the flow channel. View north. A sheet slide mass on left.

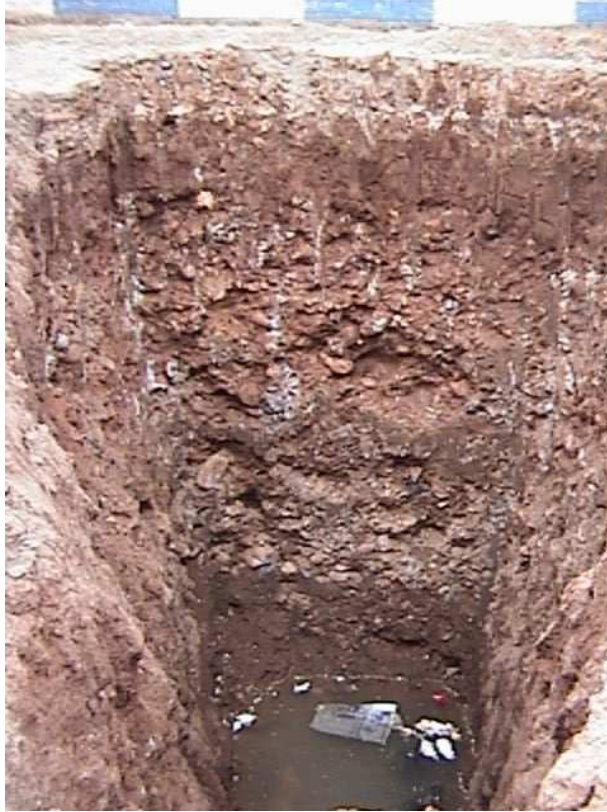
The observations on both the trenches opened near some collapsed or heavily damaged government buildings after the earthquake (Figure 4.11) and the open cuts by highways (Figure 4.12), supported the geological evidences revealing the fact that Bingöl city center is located on deep alluvial fan deposits composed of coarse gravel to boulder with sand and some to traces of silt and clay. Also the deep water table level in conjunction with the none to limited strain softening character of Bingöl alluvial fan deposits limited the foundation deformations. However, a clear concentration of the structural damage on the cliff side of the flat hill where the city center is located suggests a possible amplification of ground shaking at the cliff side pronouncing the contribution of topographical effects on the observed damage.

**Figure 4.11** Observation Trench opened at Hulusi Bey (Point 7 in Figure 4.13) primary school (N  $38^{\circ} 53.784'$ , E  $40^{\circ} 30.396'$ ),

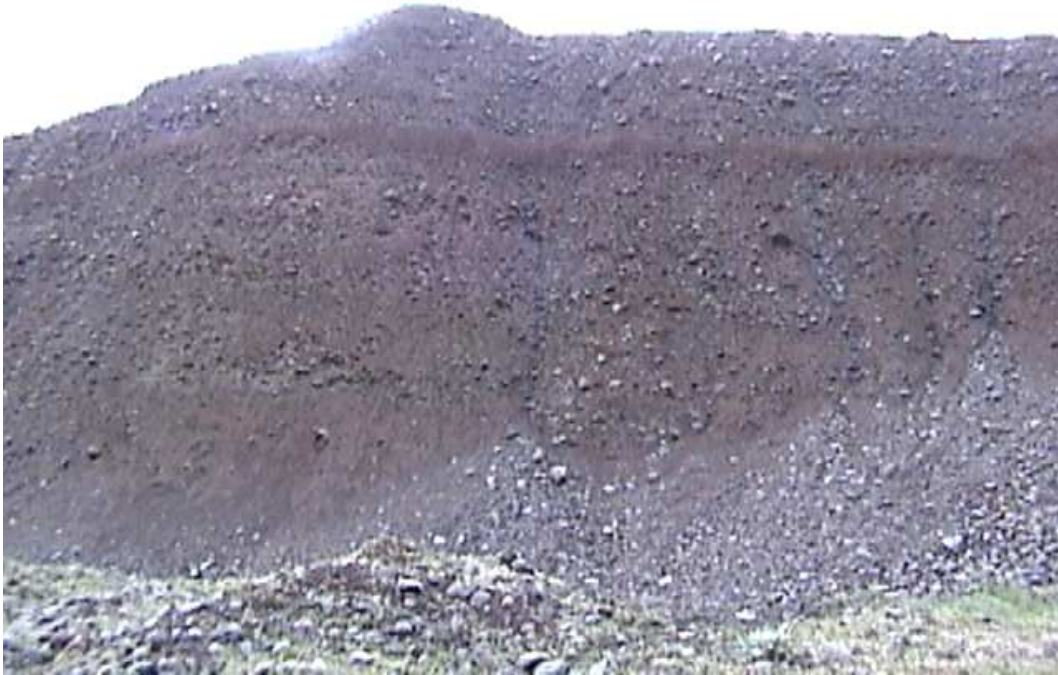
**Figure 4.12** Views of open cuts (alluvial fan deposits) near the district of Hacıçayır (Koçan Creek) (Point 12 in Figure 4.13) (N  $38^{\circ} 54.03'$ , E  $40^{\circ} 36.93'$ )

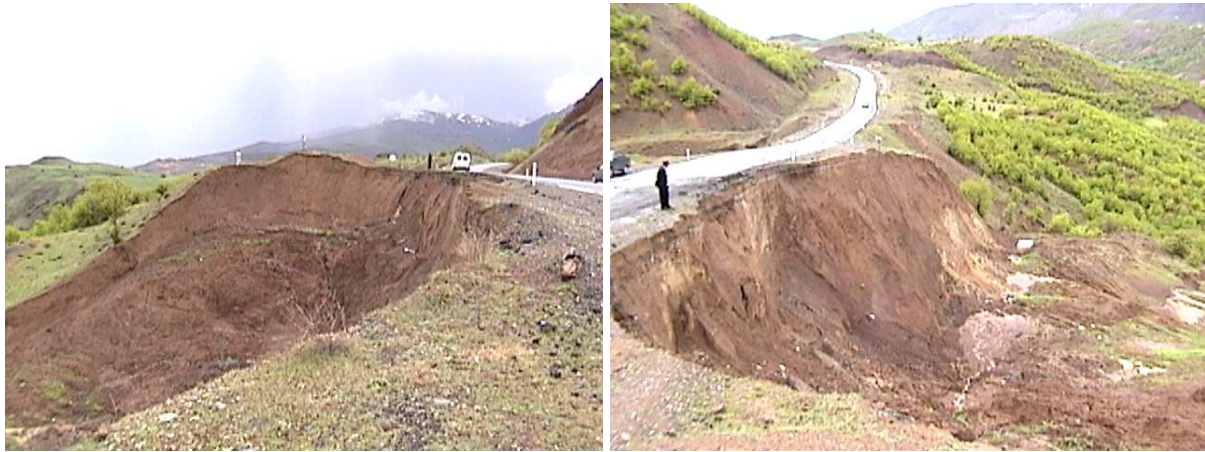
One of the most significant seismically-induced landslides was documented near the Soğukçeşme section of the country roadway extending from Bingöl to Karlıova, and occurred in a highly weathered volcanic rock transformed into cohesive soil (Figure 4.14 (a) and (b)). It was originally a rotational failure followed by a flow running about 70-80 m towards west, and occurred on the SE bank of the Göynük River. It is a 25 m high slope with an inclination of about 30°. A few local slides of small volume were also observed on the NW bank of this river near the same locality (Figures 4.15 and 4.16).

**Figure 4.14** Different views of Soğukçeşme landslide, (Point 14 in Figure 4.13) ( $N 39^{\circ} 03.380'$ ,  $E 40^{\circ} 46.908'$ ) (Slope = 30 degrees to the west,  $H = 25$  m,  $L = 70$  m)

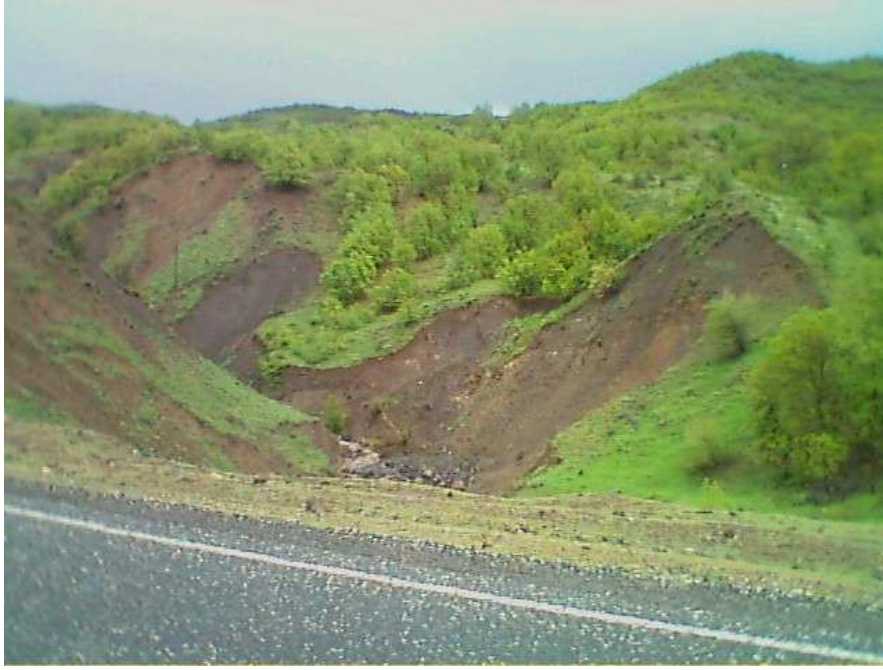
**Figure 4.15** A small scale landslide in the Soğukçeşme region (Point 14 in Figure 4.13), (N 39° 03.380', E 40° 46.908')

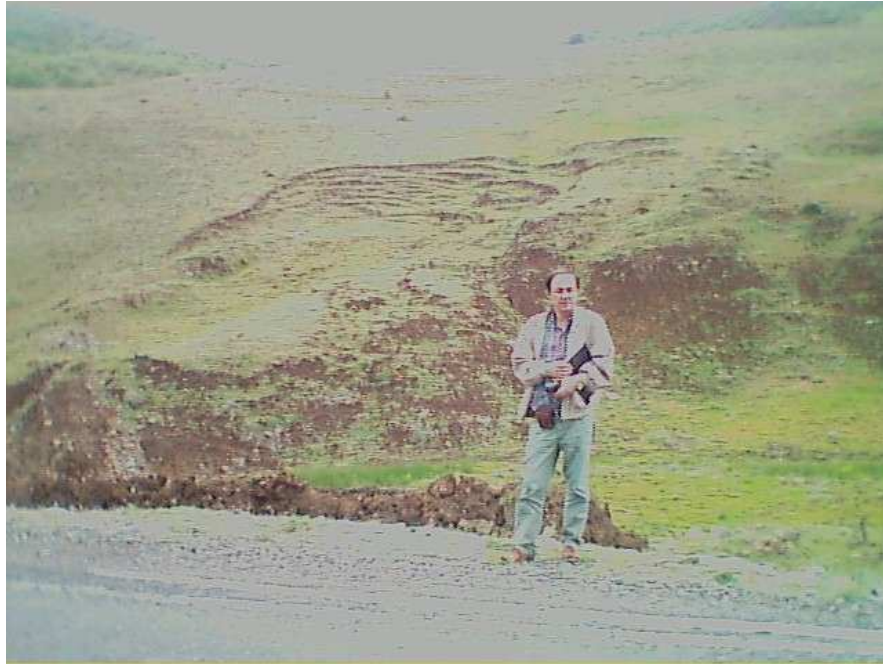
**Figure 4.16** A landslide by the Göynük River (Point 13 in Figure 4.13) (N 38° 57.808', E 40° 39.586')

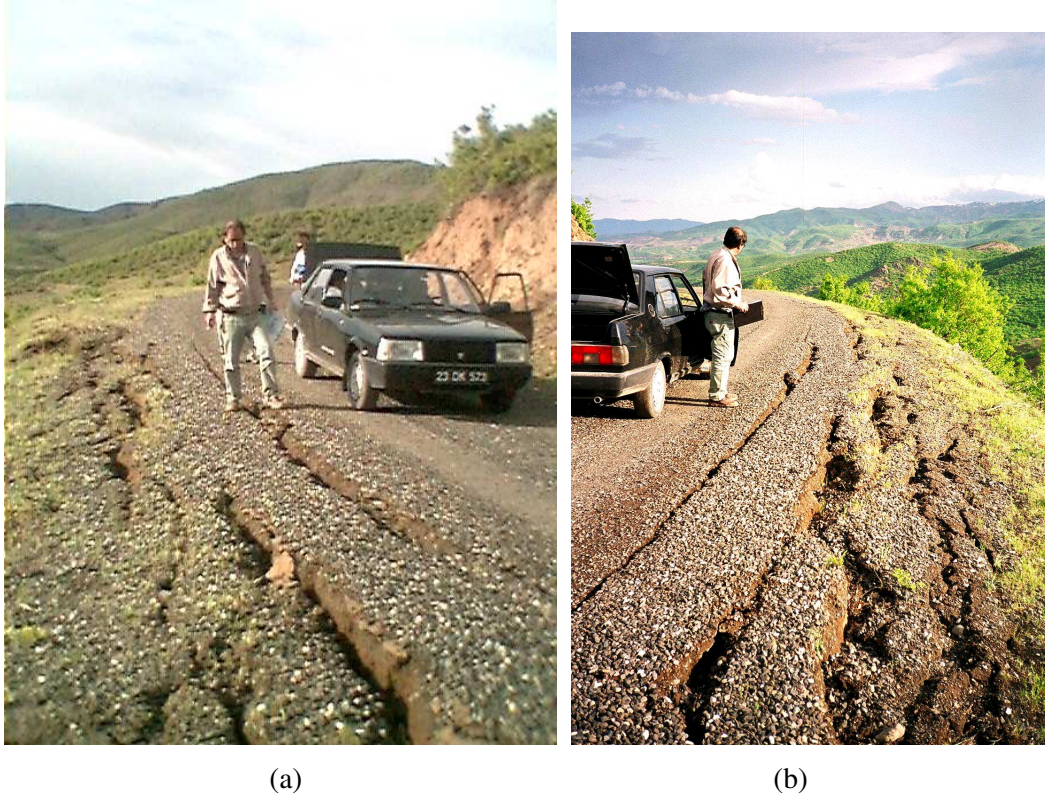
The head of the Çiçekdere landslide has jeopardized the stability of the Çiçekdere Village road. Cracks as wide as 38 cm and vertical offsets as high as 10 cm were mapped (Figure 4.18).

**Figure 4.18** View of the head of Çiçekdere landslide (Point 6 in Figure 4.13) ( $N 38^{\circ} 57.53'$ ,  $E 40^{\circ} 26.65'$ )

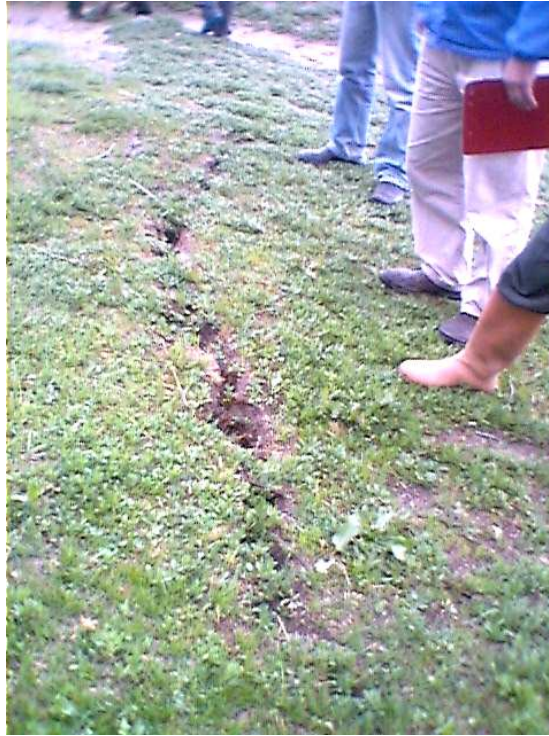
Ground deformations mapped at Kurtuluş Village as wide as 5 cm with a vertical offset of 2 to 5 cm extending to the North 40 degrees West direction suggest a potential slide at Kurtuluş Village. Another possible explanation for these ground deformations could be the surface expression of faulting; however lack of surface evidence for strike slipping has weakened this alternative (Figure 4.19).

**Figure 4.19** Ground deformations at Kurtuluş (Point 15 in Figure 4.13) village (N 39° 06.66', E 40° 39.48')

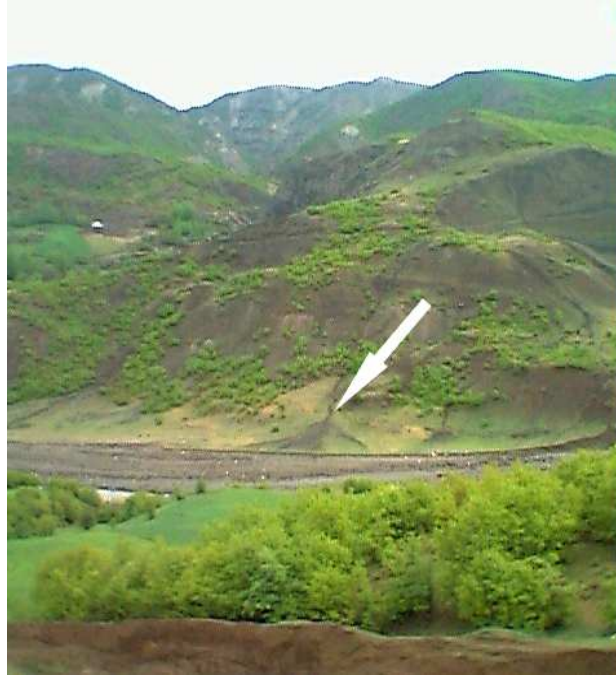
A similar but a smaller scale mudflow took place after the earthquake in the hills of Soğukçeşme. Figure 4.21 shows the extent of the flow through the steep hills of Soğukçeşme.

**Figure 4.21** Mudflow at Soğukçeşme (Point 14 in Figure 4.13) (N 390 03.380', E 400 46.908')

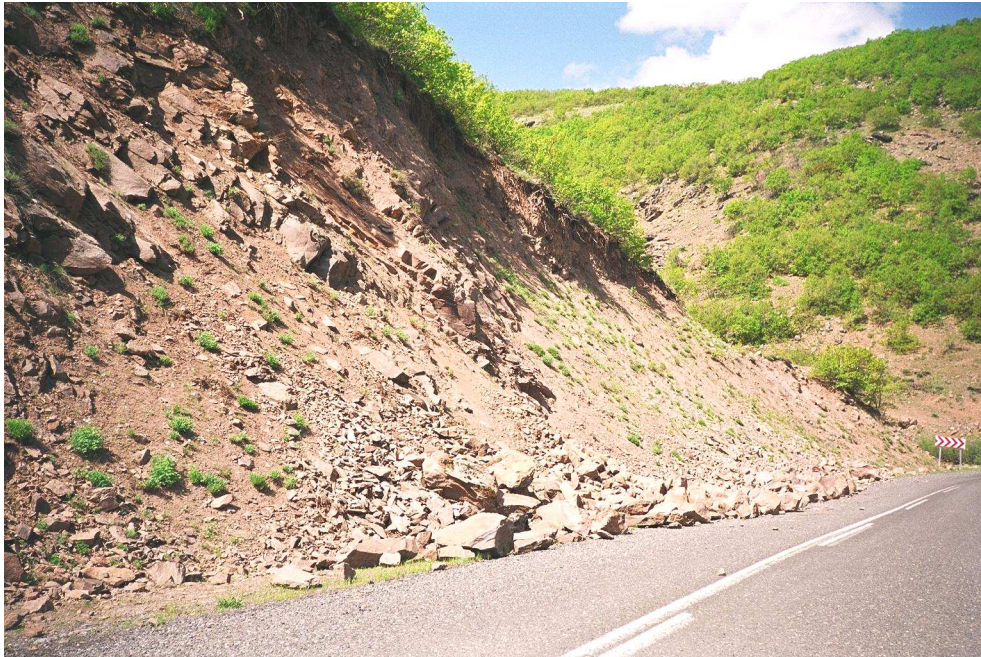
Various small volume rock falls were documented along the village and intercity roads. Figures 4.22, 4.13 and 4.14 show pictures from rock falls at Gökçekanat, Arıcılar and Kurtuluş village roads.

**Figure 4.22** Rock falls near Gökçekanat (Point 5 in Figure 4.13) (N 380 58.6', E 400 17.05'). Joint has a dip angle of 50 degrees to the North; strike is from east to west

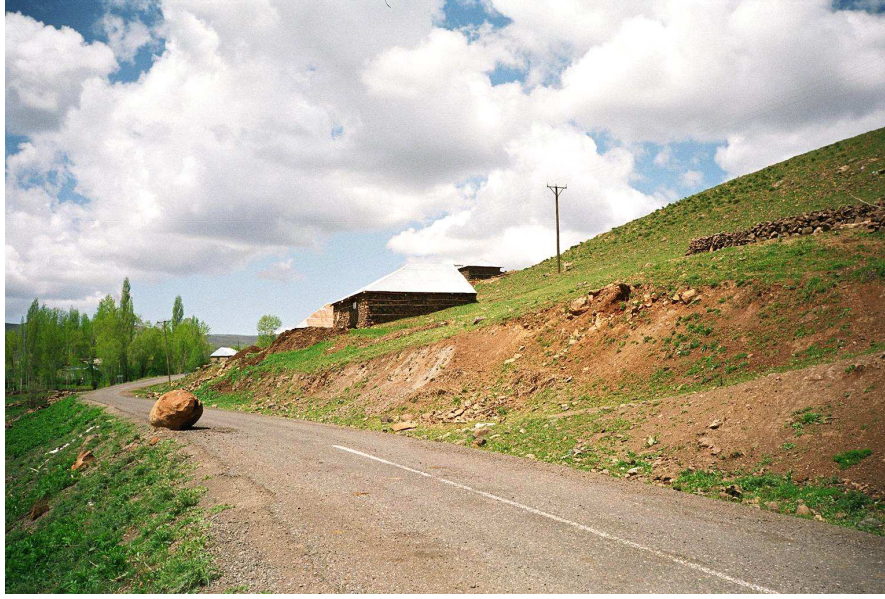
**Figure 4.23** Arıcılar village (Point 2 in Figure 4.13), northeast exit (N 390 03.83', E 400 18.96'),

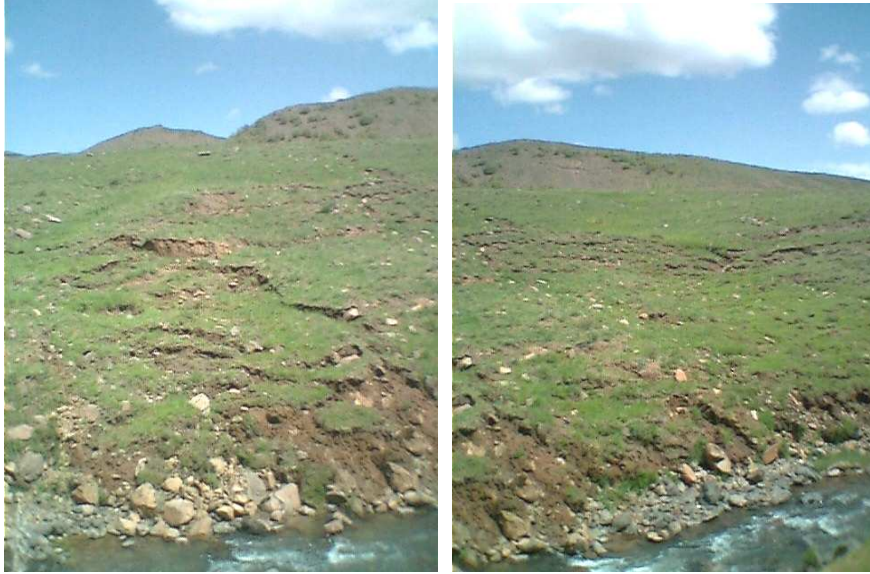
One of the typical examples of liquefaction-induced lateral spreading occurred near Yaygınçay village on the northern bank of Uğuroba Stream (Figure 4.25). Sand boiling was observed along the southern bank of the stream (Figure 4.26), which confirmed triggering of soil liquefaction. Three distinct zones of lateral spreading were identified. The maximum lateral spread displacement at this place was mapped to be 30 cm, whereas the inclination of the stream bank was measured as 15°.

**Figure 4.25** Different views of liquefaction-induced lateral spreading by Uğuroba stream (N 390 03.3', E 400 17.88')

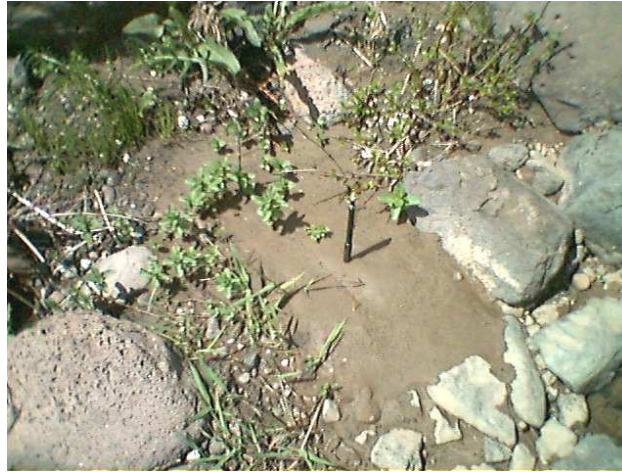
**Figure 4.26** Sand boiling mapped near Uğuroba stream (N 390 03.3', E 400 17.88')

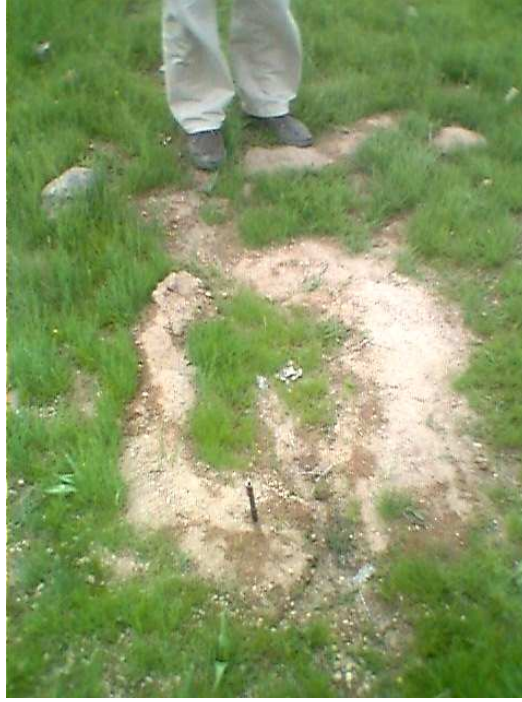
The other significant lateral spreading along a sloping ground was mapped at a locality called Hanoçayırı near Sudüğünü village (see Figures 4.13 and 4.27 (a)-(d)). This place is located in the close vicinity of the earthquake epicenter. The presence of a shallow-seated silt and sand sized nonplastic surficial layer (grain size distribution is shown in Figure 4.27 (e)) originated from the tuffs and combined with shallow water table depths makes this material highly vulnerable to liquefaction. Even under relatively very mild slopes ranging between  $3^\circ$  and  $7^\circ$ , as a result of soil liquefaction, mudflow and lateral spreading were observed. The presence of traceable sand accumulations with a very small extent on the eastern flank of this ground failure and other observations suggest that a 0.2 to 3 m thick sandy silt layer moved over an unknown thickness of liquefied ground. Due to the loose nature of the liquefied ground and heavy rains before the earthquake, the material flowed down in the S55W direction and the trend of flowing material then directed towards the SE. The width and length of this flow were about 35 m and 400 m, respectively. Also sand boiling was observed by the lateral spreading area (Figure 4.28).

**Figure 4.28** Sand boil at Hanoçayırı (Point 16 in Figure 4.13) (N 390 03.1', E 400 30.46')

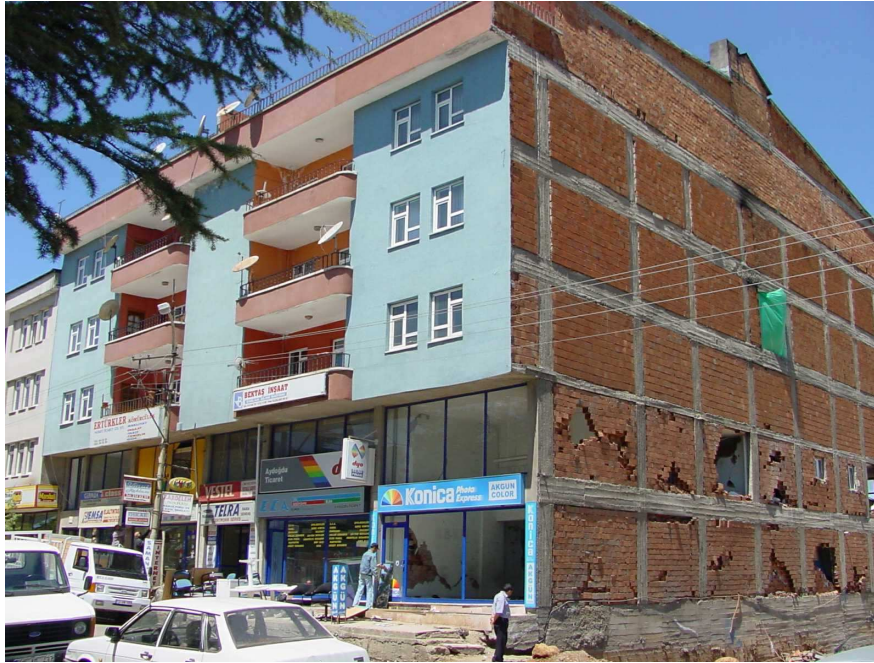
Figure 5.7 shows a conventional four-story reinforced concrete building located in the İnönü sub-district, a commercial area. The building experienced moderate damage indicating that load-resisting elements performed well with respect to life-safety. The resistance to lateral loads was mainly provided by the columns and filler walls since the building does not have any shear walls. The increased strength demand in the first floor was supplied by the contribution of infill walls as evidenced by heavy infill wall damage concentration in that floor (Figure 5.7). The building has several undesired architectural features that are worth mentioning here. The presence of a mezzanine floor, commercial use of the ground floor, the penthouse and strong beam-weak column are some of those features that can be seen from Figure 5.7. The uncovered masonry infill on the side face of the building outlines the structural system. The infill walls are composed of conventional hollow clay tile, Figure 5.8, used in practice for partition walls. The ratio of holes in the tile directly affects the load carrying capacity of the wall. The nonstructural components, i.e. masonry infill, suffered severe damage (Figure 5.9) whereas reinforced concrete components had experienced moderate damage.

**Figure 5.7** Four-story residential (except ground floor) building in İnönü sub-district

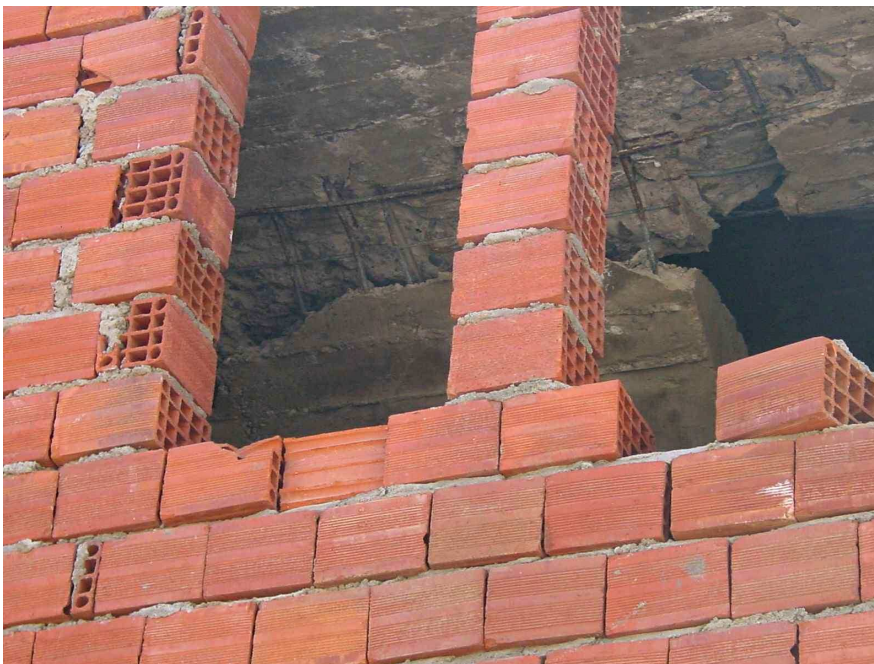
**Figure 5.8** Typical hollow clay tile used in infill walls

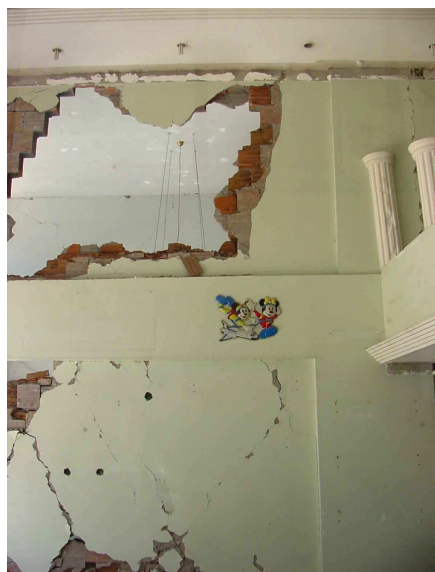
**Figure 5.9** Severe infill wall damage

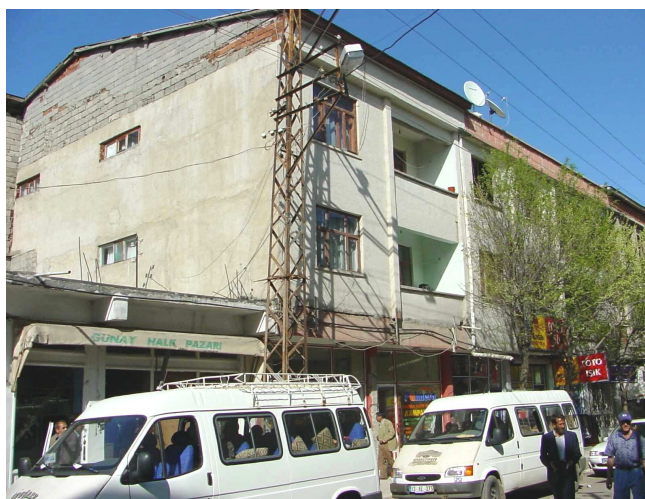
A three-story residential building located in the same sub-district suffered severe damage due to its poor material quality and detailing as shown in Figures 5.10 to 5.13. The building has a basement and a soft ground story where the heaviest damage was observed. A spectacular example of the diagonal tension crack at the upper end of the column due to a combination of inferior material quality and inadequate transverse reinforcement is shown in Figure 5.11. The condition of several other columns and masonry walls illustrated in Figures 5.12 and 5.13 reemphasizes the poor quality of construction combined with a high deformation demand in the ground floor. The level of damage in the beams was generally insignificant compared to the columns (Figure 5.13). Despite extremely poor performance of the columns, the masonry walls, which were made of unreinforced solid brick blocks, are believed to have prevented the collapse of the building.

**Figure 5.10** Two-story residential building

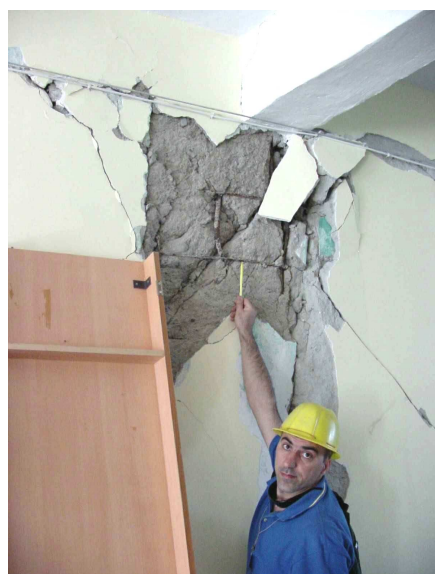
**Figure 5.11** Diagonal tension crack at the upper end of the ground floor column

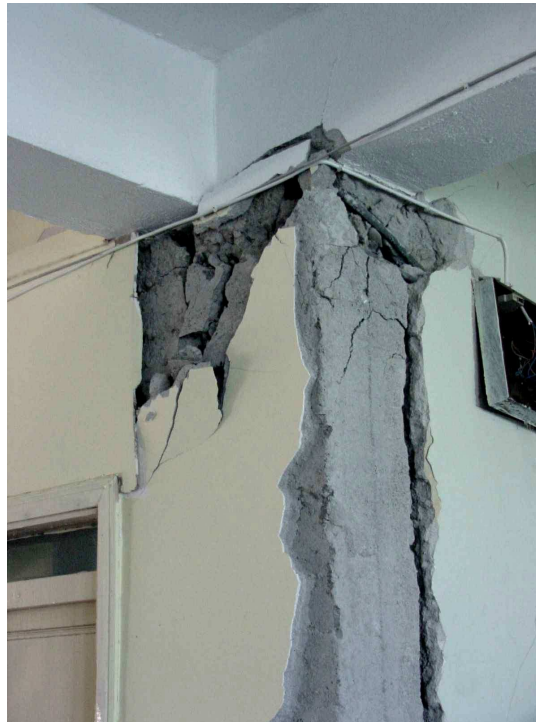
**Figure 5.13** Column damage and condition of beams

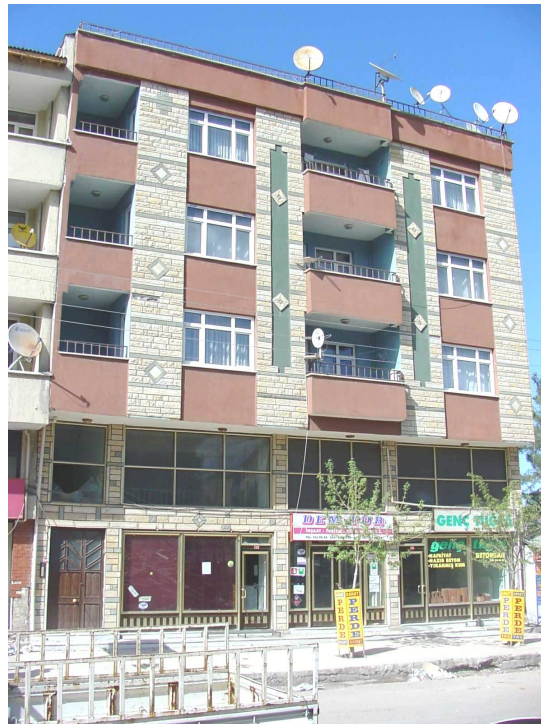
The influence of sufficient lateral load resistance was evident from the excellent performance of reinforced concrete shear wall buildings. Two identical buildings separated by dilatation joints and possessing a sufficient area of structural walls have survived the earthquake almost unscathed. It is also worth noting that the apparent quality of material and workmanship was quite good. The building on the left was completed and being occupied but the one on the right had only its structural system finished. The pounding between adjacent buildings did not result in significant damage most likely due to short duration of the shaking (Figures 5.15 and 5.16).

**Figure 5.15** Lightly damaged five-story reinforced concrete frame building

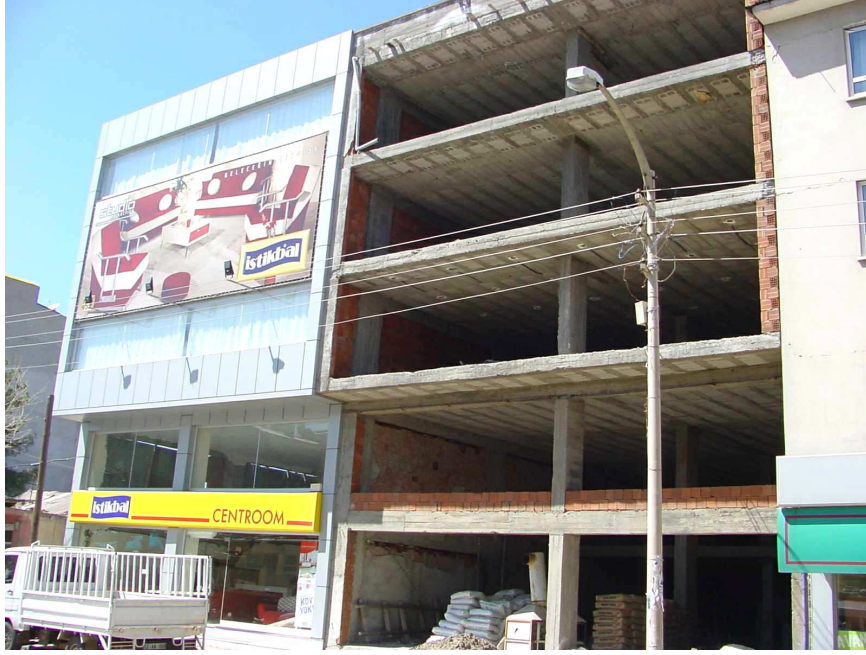
**Figure 5.16** Satisfactory performance of two-identical shear wall buildings, BNG-10-4-9 in Table 5.1.

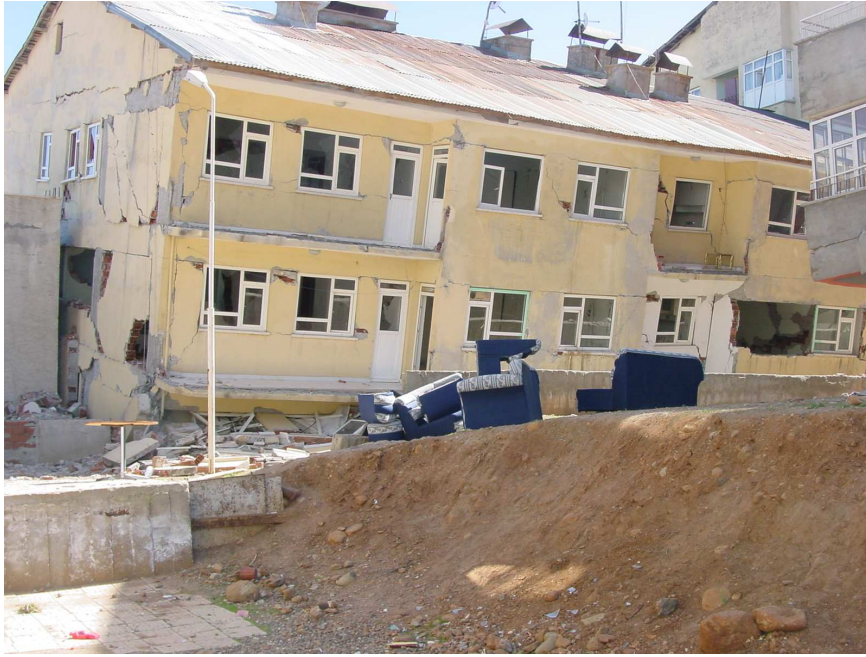
Another sub-district, Saray, located in the provincial area north of the major highway connecting Bingöl to the cities of Elazığ and Muş was visited and the buildings were evaluated. Most of the buildings along a line parallel to the highway experienced heavy/complete damage. The majority of these buildings had a reinforced concrete frame structural system and a soft ground floor where the heaviest damage was concentrated. These buildings generally had insufficient structural resistance and poor construction quality and detailing which played important part in their collapse as depicted in Figures 5.17 to 5.19.

**Figure 5.18** Collapse of ground floor

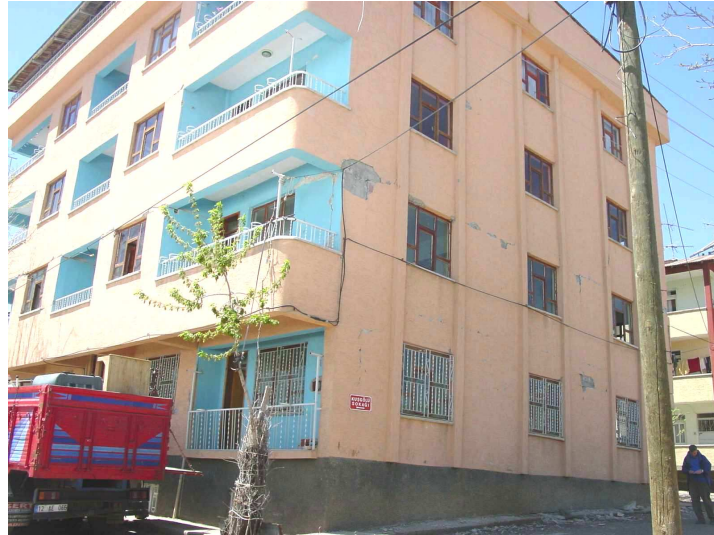
Among the concrete buildings that were surveyed throughout the city only a few had limited and in some cases primitive shear walls contributing to their lateral load resistance. The presence of these shear walls very likely prevented the collapse of the buildings (Figure 5.23 – 5.25) despite their inferior material quality. The walls picked up a significant part of the seismic force experiencing substantial damage. One unusual observation was that the wall was observed to have more significant damage in the first floor than the ground floor level (Figure 5.24). Although the building had many favorable features such as regular rectangular floors, no soft stories and continuous vertical frames, substandard construction and material quality were the major factors that led to heavy damage.

**Figure 5.23** Heavily damaged reinforced concrete frame with shear wall type construction
