# **1 MAY 2003 BİNGÖL EARTHQUAKE**

## **ENGINEERING REPORT**

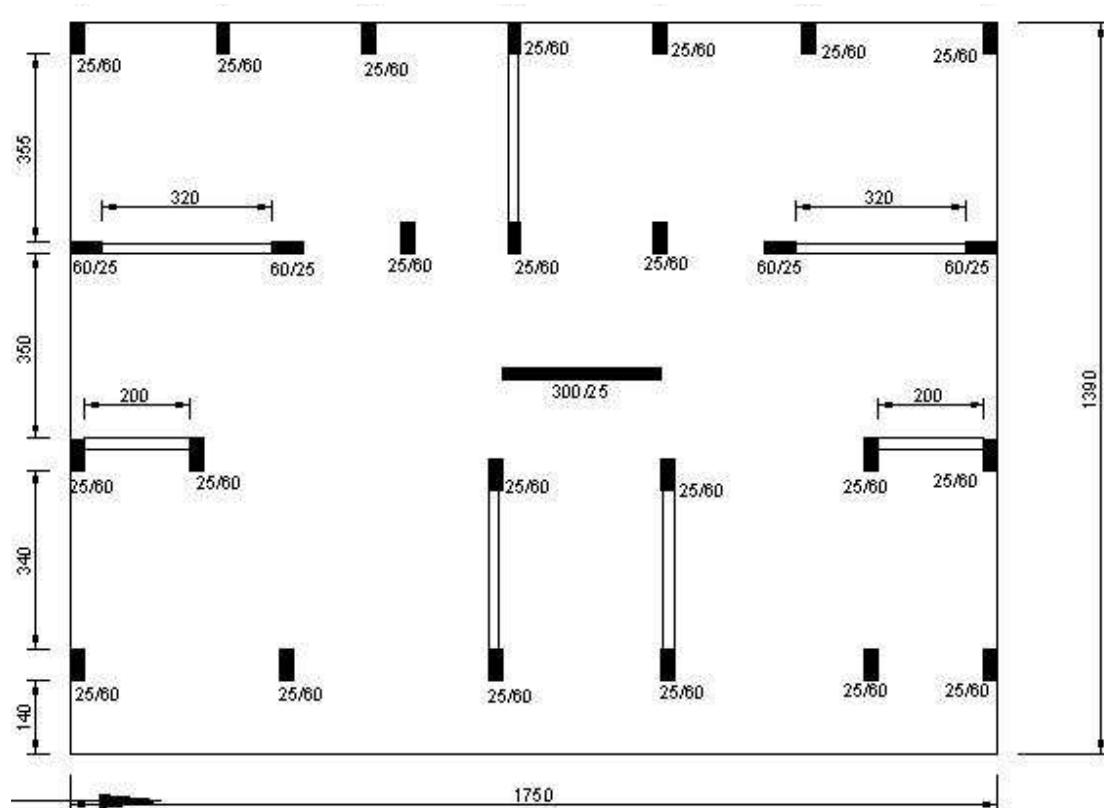
Among the concrete buildings that were surveyed throughout the city only a few had limited and in some cases primitive shear walls contributing to their lateral load resistance. The presence of these shear walls very likely prevented the collapse of the buildings (Figure 5.23 – 5.25) despite their inferior material quality. The walls picked up a significant part of the seismic force experiencing substantial damage. One unusual observation was that the wall was observed to have more significant damage in the first floor than the ground floor level (Figure 5.24). Although the building had many favorable features such as regular rectangular floors, no soft stories and continuous vertical frames, substandard construction and material quality were the major factors that led to heavy damage.

**Figure 5.25** Structural floor plan of the building

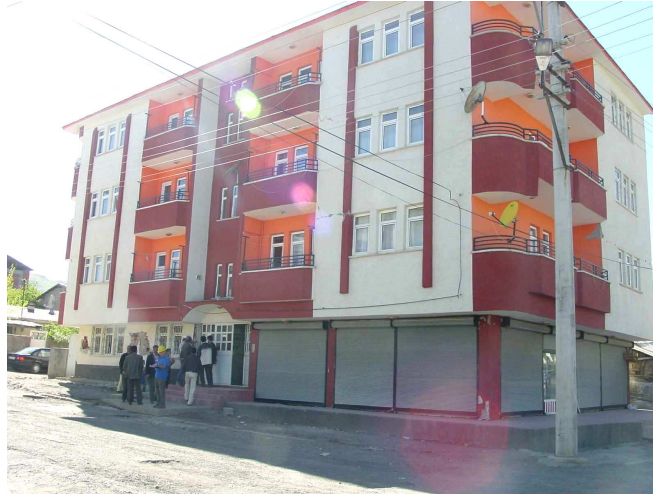
**Figure 5.30** Four story residential building. The look from outside is quite different and misleading for a heavily damaged building.

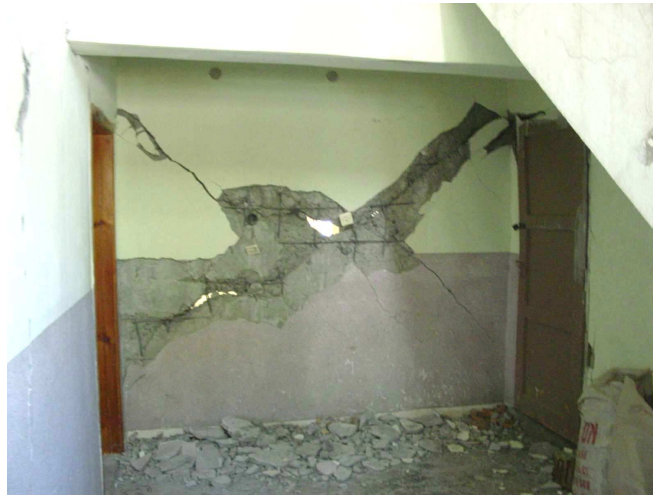
**Figure 5.31** Failure of the shear wall due to inferior material quality and detailing.

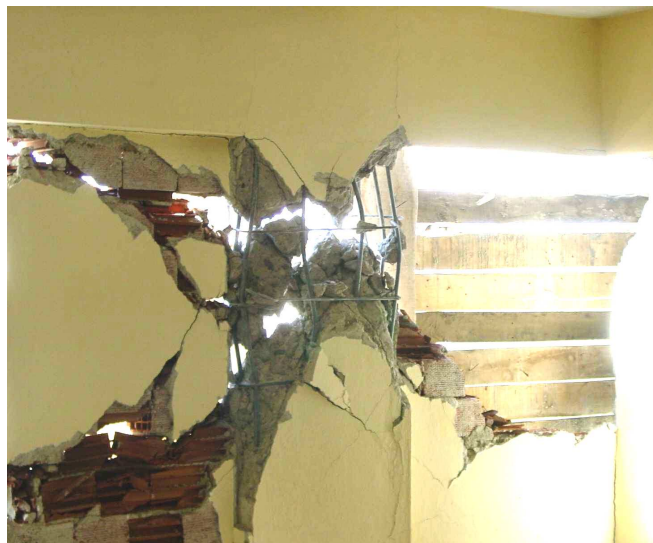
**Figure 5.32** Brittle failure of the column of building shown in Figure 5.30. Buckling of bars due to insufficient lateral confinement and crushing of core concrete.

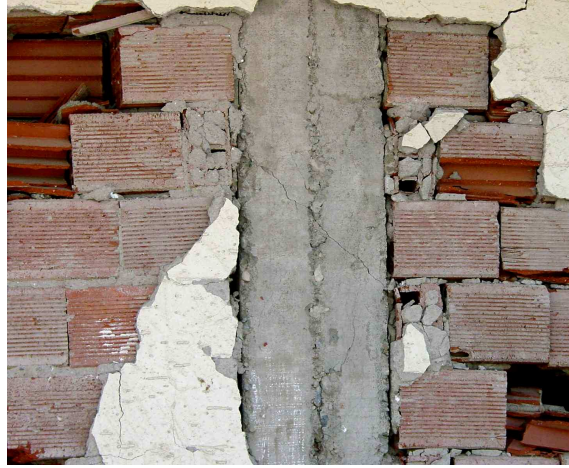
**Figure 5.33** An inclined shear crack of a moderately damaged column.

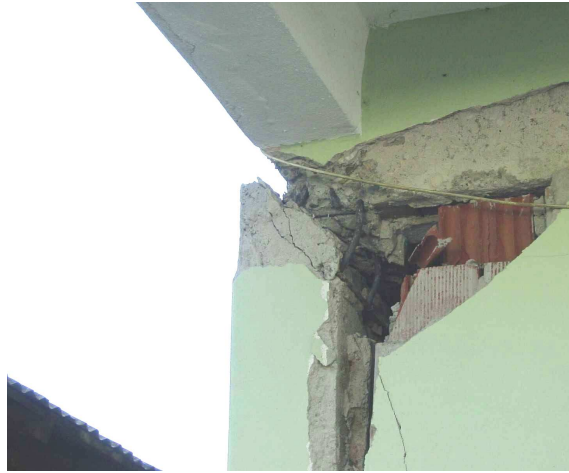
In the Yeşilyurt sub-district the damage patterns were pretty similar to the examples shown above. A striking example of connection damage of a four-story building is illustrated in Figure 5.34.

**Figure 5.34** A corner column on the ground floor of a four-story building. Separation of the column due to improper detailing.

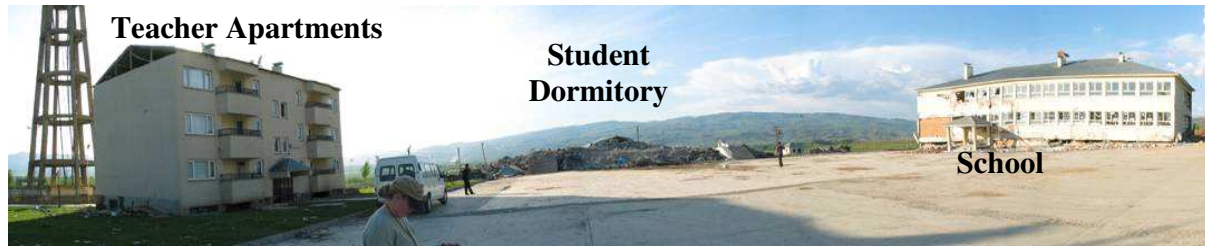
A good example of the different types of response experienced by different structural systems is illustrated in Figure 5.39. Before the earthquake, there were three buildings at the site of Çeltiksuyu Boarding School, located approximately 10 km to the south east of Bingöl. The buildings were the teachers' apartments (C-13-11), the student dormitory and the school building (C-13-10). The figure shows the state of the three structures after the earthquake. Both the school building (right of the picture) and the student dormitory (center of the picture), with moment-resisting frames, collapsed with a death toll of 84 (mostly children). The apartment building for the teachers, with a dual structural wall – moment frame resisting system, survived without damage. Figure 5.40 is a photograph taken inside the kitchen of an apartment located in the second story of the apartment building. Objects violently thrown out of shelves are an indication of the high accelerations that must have taken place at the site. There is also an elevated water tank behind the apartments building that survived without any visible damage.

**Figure 5.39** Damage to three different structures

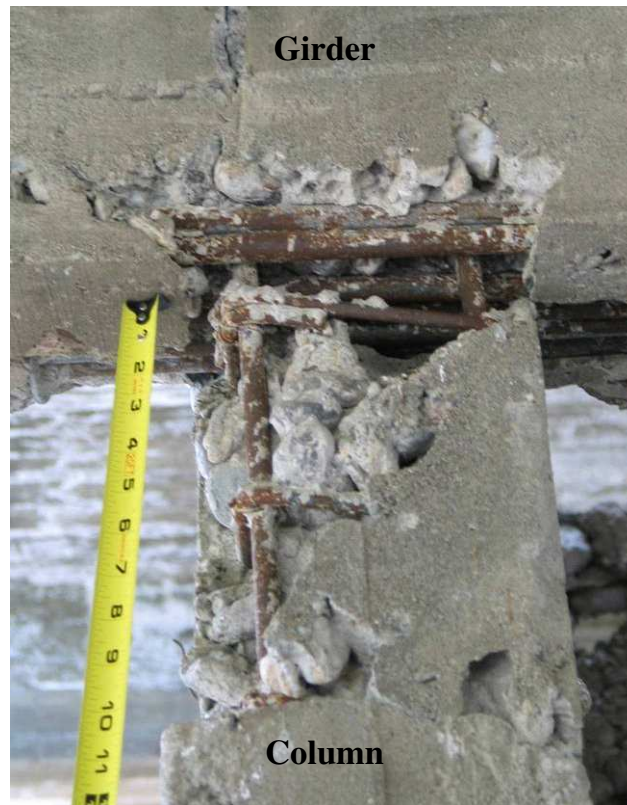
Tolerances in forms (Figure 5.43 and 5.44) and steel cages are of the order of several centimeters, and it is common to have very small or no cover for the reinforcement. The placement of the concrete is carried out without compaction or vibration. As a result, problems in structural members such as voids in the concrete and exposed reinforcement are commonly observed (Figure 5.42).

**Figure 5.42** Beam-column joint in building under construction

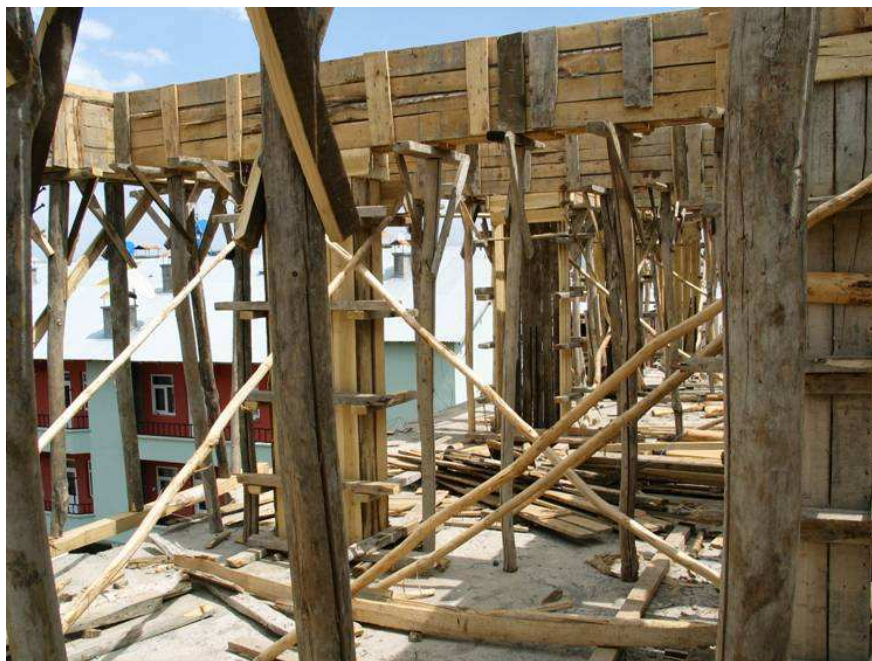
**Figure 5.43** Beam and column formwork in building under construction

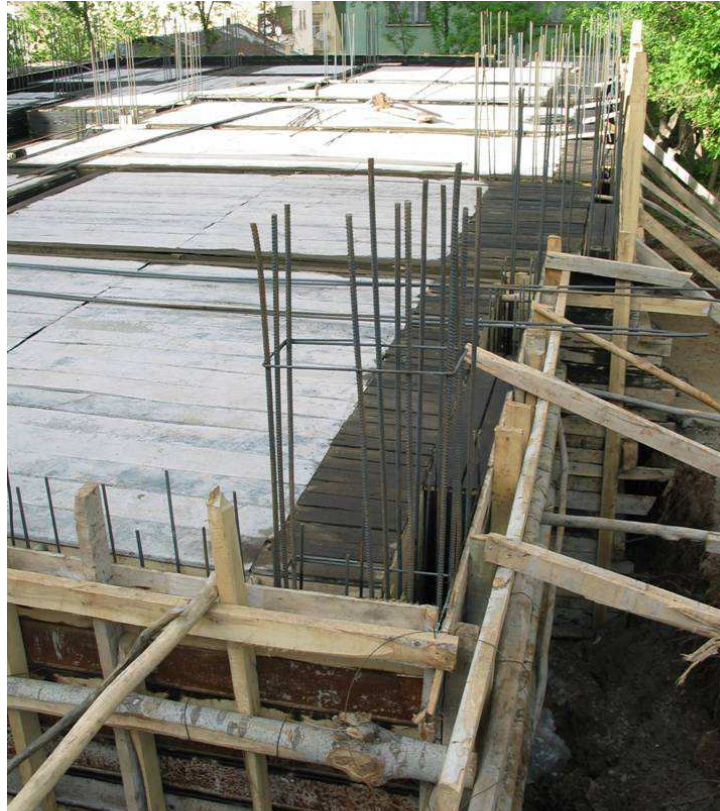
**Figure 5.44** Slab formwork in building under construction

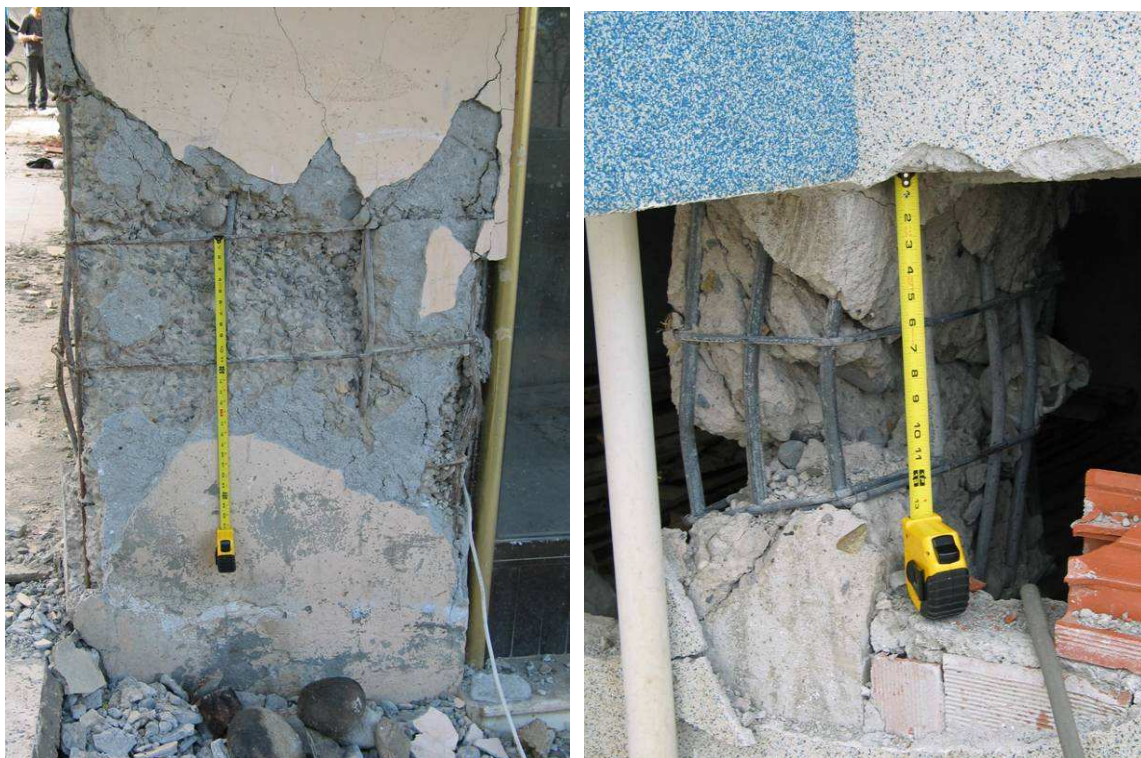
Even if the amount of shear reinforcement had been sufficient to achieve some level of ductility, the toughness of the columns would have been questionable for several reasons. The amount of confining reinforcement provided was very light. In the case of two columns sampled in the field, the amount of confining reinforcement was approximately 30 percent of the amount required by the ACI 318-02 building code. The combination of inadequate confinement and weak concrete would have resulted in rapid deterioration of the core, and a significant loss in the maximum shear carried by the columns.

**Figure 5.45** Typical column details in plastic hinge regions

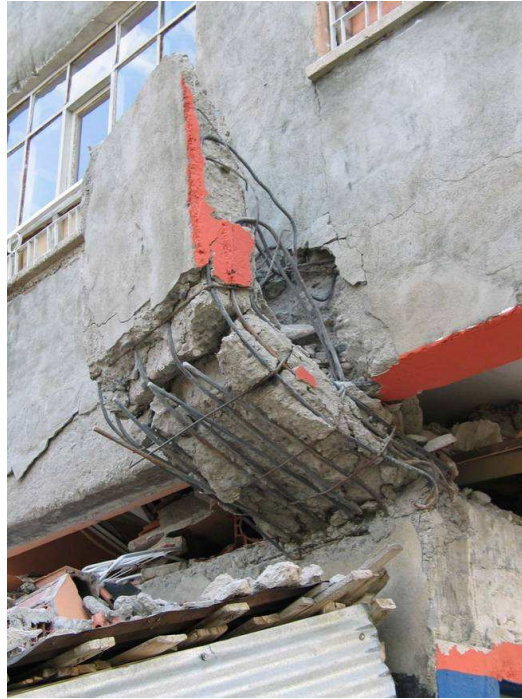
Other issues that could have affected the performance of frames at larger drift demands include the location of splices in plastic hinge regions (Figure 5.46), the use of 90 degree bends to anchor bars in stirrups (Figure 5.47), and the lack of ties providing out of plane support for intermediate bars (Figure 5.45).

**Figure 5.46** Typical location of column splice

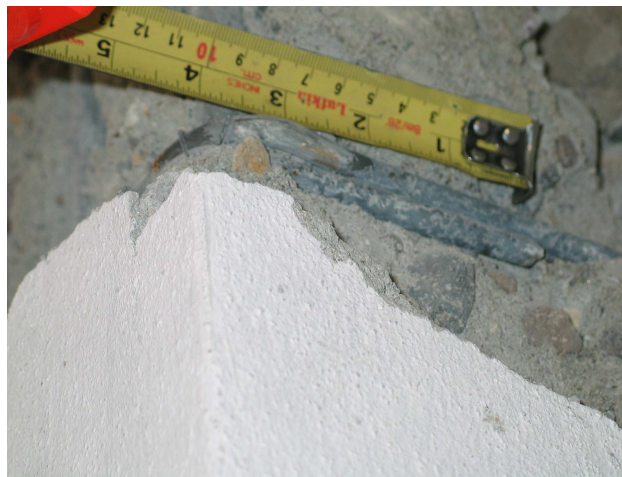
**Figure 5.47** Typical detail for anchorage of stirrups

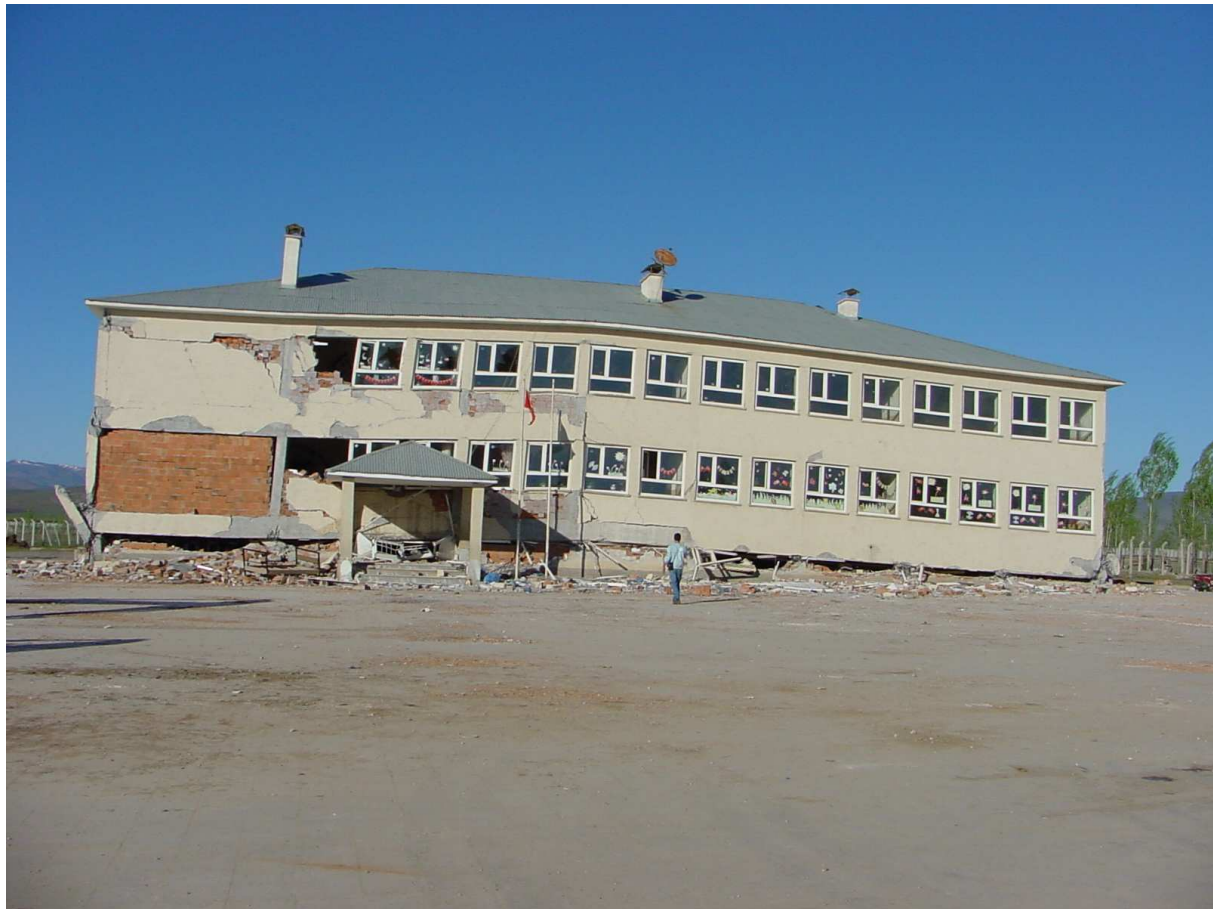
In this earthquake, the most tragic collapse occurred at Çeltiksuyu Yatılı İlköğretim Okulu [ Çeltiksuyu Primary Boarding School ] which was a primary school (Figure 5.52) with a dormitory (Figure 5.53). Since the earthquake occurred at 3:27 a.m. local time, the majority of the students were asleep inside the collapsed dormitory in which 84 (out of 195) students and 1 teacher lost their lives. In Figure 5.54, on the same block there appears a 3-story building, which was used by the teachers for

**Figure 5.52** Çeltiksuyu Yatılı İlköğretim Okulu, school building

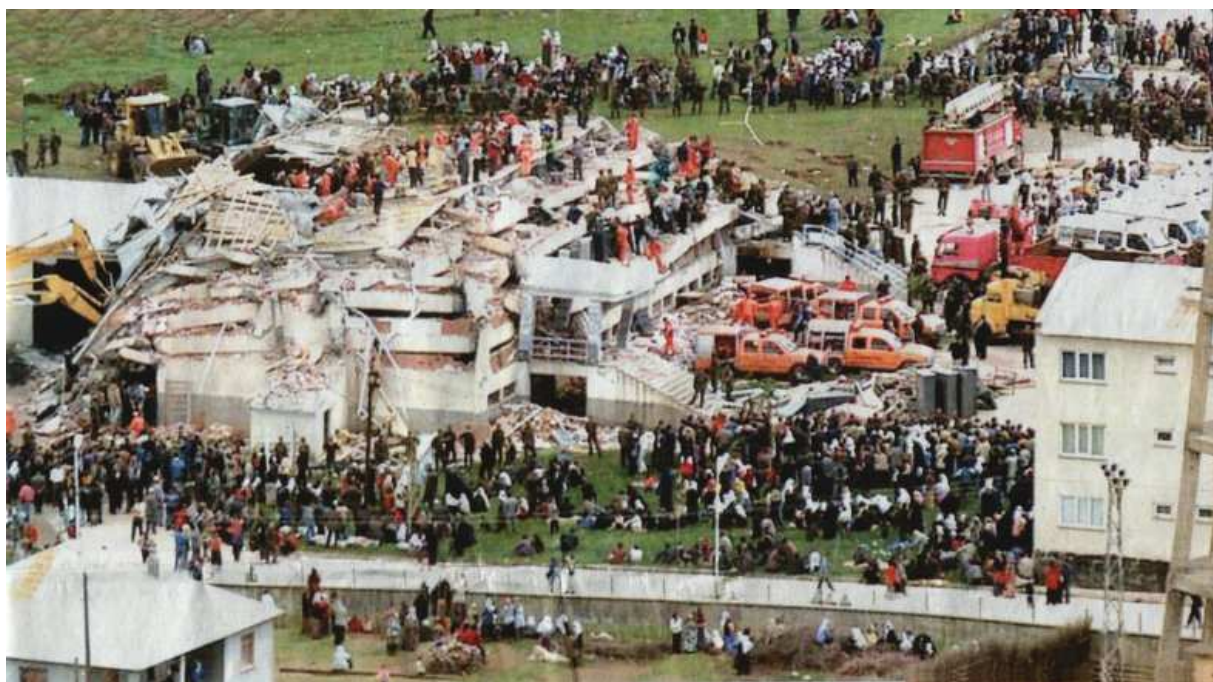
**Figure 5.53** Çeltiksuyu Yatılı İlköğretim Okulu, dormitory building (Akşam newspaper)

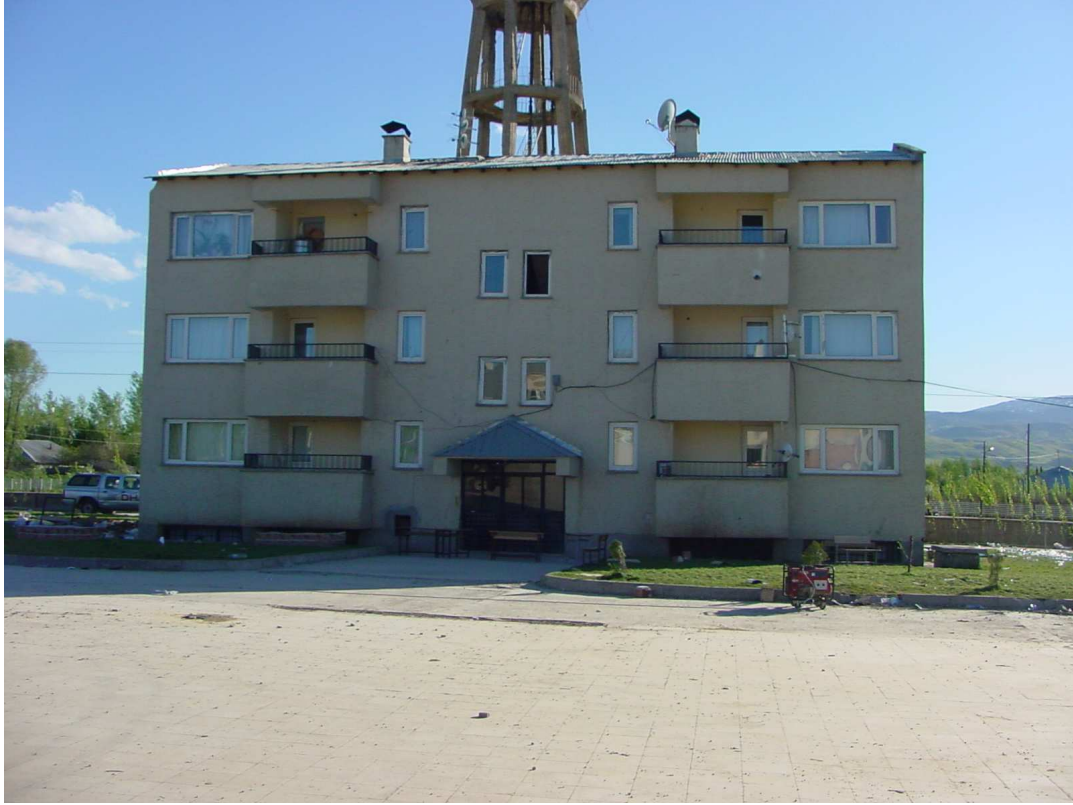
accommodation. As is seen, there was no damage observed in that building (Figure 5.54). Therefore the explanations of the damage implying the effect of soil conditions seem unreasonable.

**Figure 5.54** Çeltiksuyu Yatılı İlköğretim Okulu, teachers accommodation building

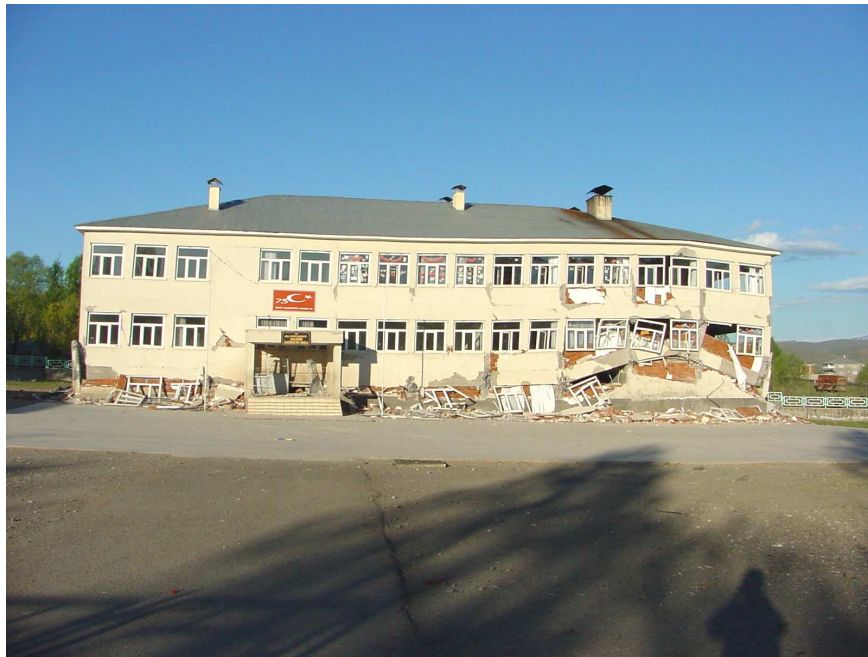
Another school building which had the same number of stories, type of structural system, apparent quality, plan of the building, and same orientation with the Çeltiksuyu İlköğretim Yatılı Okulu was the Kaleönü İlköğretim Okulu. As is seen in Figure 5.55, both school buildings had the same damage although the soil conditions were different. Similar to the case of the Çeltiksuyu İlköğretim Yatılı Okulu office building, there was no damage at all in the Kaleönü İlköğretim Okulu office building (Figure 5.56).

**Figure 5.55** Kaleönü İlköğretim Okulu, school building

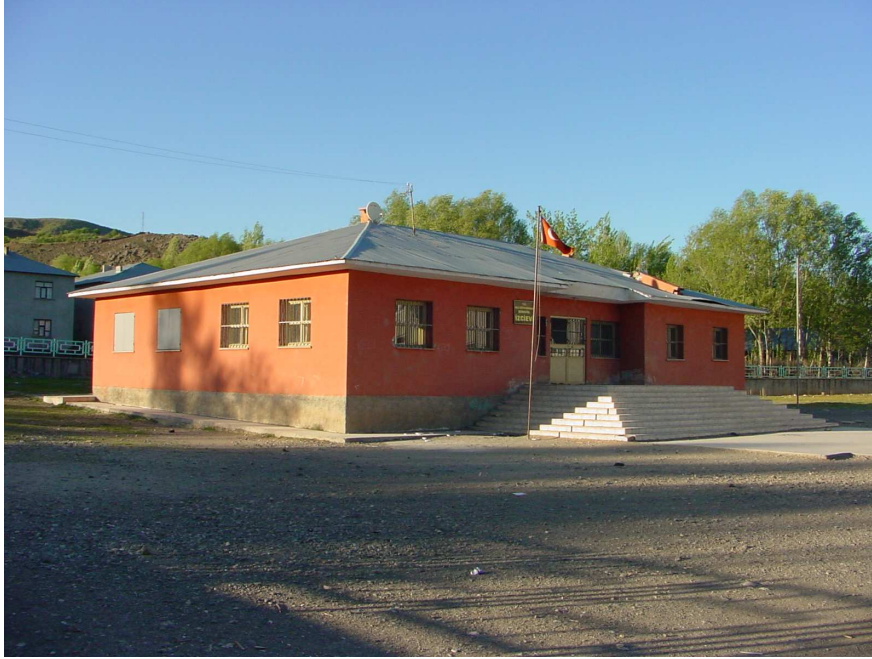
**Figure 5.56** Kaleönü İlköğretim Okulu, office building

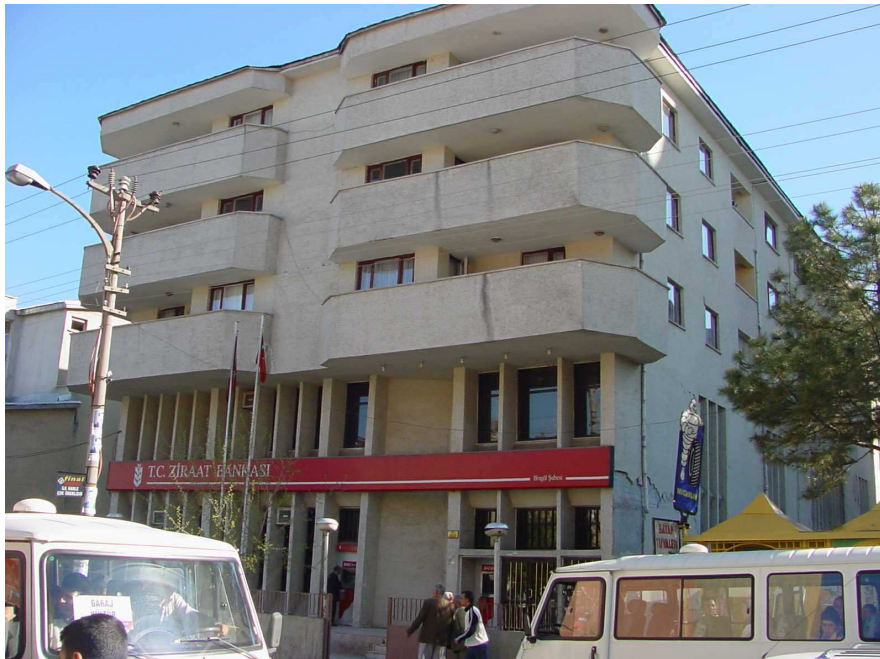
Figures 5.57 and 5.58 show a conventional four-story reinforced concrete frame and shear wall building used as a government bank. Although the building has a soft story (Figure 5.58) it experienced light damage indicating that the load-resisting elements performed very well. The apparent material quality was good, and the resistance to lateral loads was mainly provided by the shear walls. The infill walls are composed of conventional hollow clay tile used in practice for partition walls. Diagonal cracks appear on the nonstructural components, i.e. masonry infill walls (Figure 5.58).

**Figure 5.57** Ziraat Bankası (State Agricultural Bank)

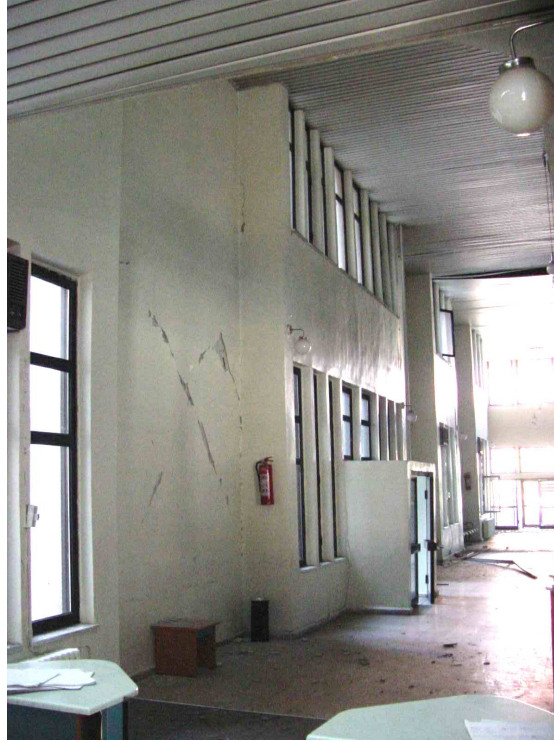
**Figure 5.58** Diagonal cracks on partition walls (Ziraat Bankası, State Agricultural Bank)

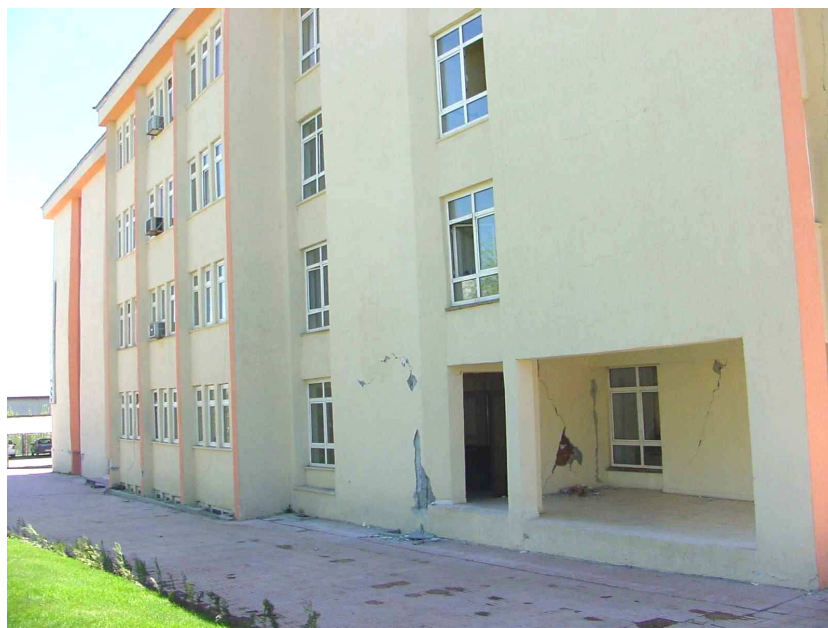
Another conventional four-story reinforced concrete frame and shear wall government building with poor apparent material quality is TEDAŞ (Figures 5.59 and 5.60). This building is the branch office of the Turkish Electricity Distribution Company. The building experienced moderate damage indicating that load-resisting elements performed well with respect to life-safety. The resistance to lateral loads was mainly provided by the shear walls and there was no damage in these shear walls. On the other hand, columns suffered moderate to heavy damage. The building has several inadequacies against lateral loads like strong beams-weak columns, short columns (Figure 5.60), and insufficient transverse steel (Figure 5.61). In Figure 5.62 a corner of the structure is shown. As is seen the end zone of the column was inadequately confined and damage has occurred due to the short column effect created by window openings in the hollow clay brick infill walls.

**Figure 5.59** TEDAŞ Bingöl branch

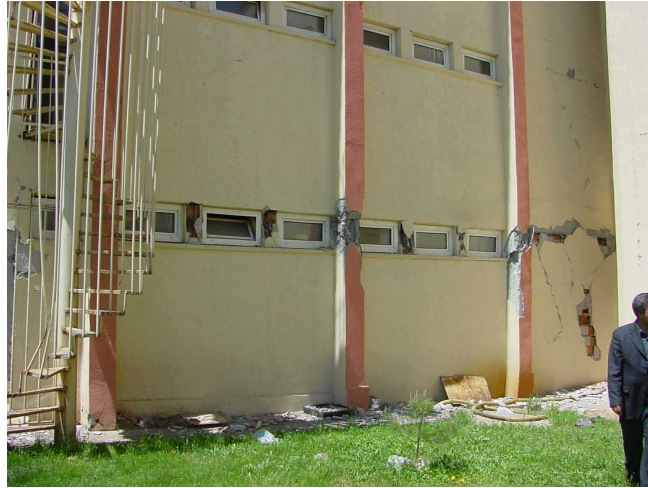
**Figure 5.60** TEDAŞ Bingöl branch, short column effect

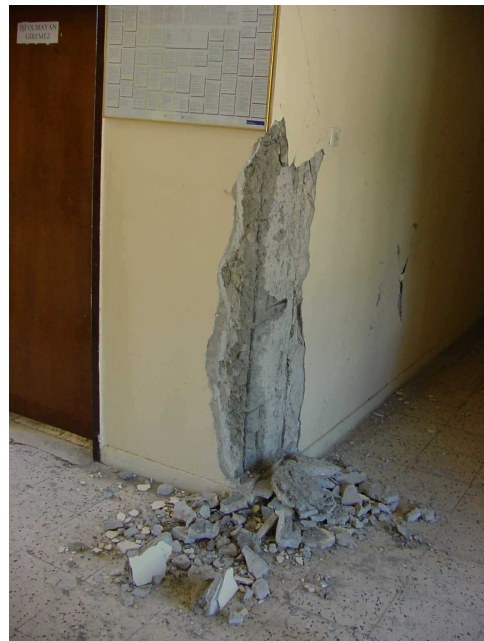
**Figure 5.61** TEDAŞ Bingöl branch, inadequate confinement at column ends

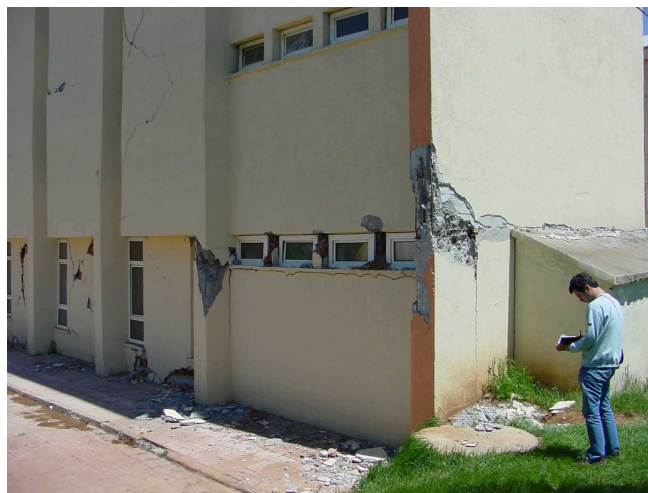
**Figure 5.62** TEDAŞ Bingöl branch, damage in column end zone due to short column effect

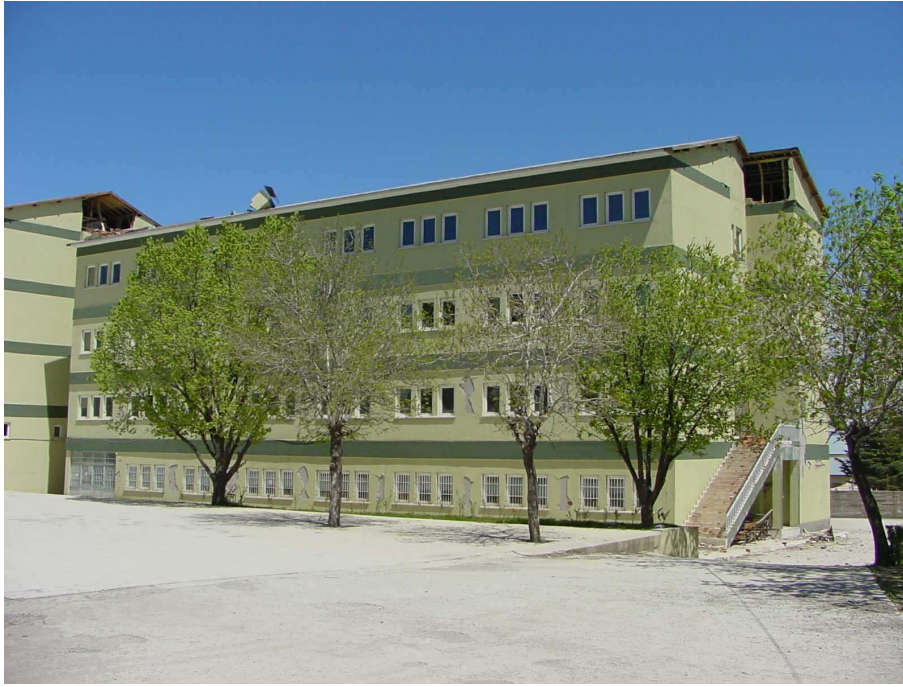
In Figure 5.63, a high school building, Bingöl Lisesi is shown. This building is also a four-story reinforced concrete frame with shear wall structure. However its apparent material quality and the lateral reinforcement were poor. As a result the structural system suffered heavy damage. A spectacular example of the diagonal shear crack and crushing of the concrete core in the shear wall due to a combination of inferior material quality and inadequate transverse reinforcement is shown in Figures 5.64 and 5.65. As may be observed, the resulting gap in the shear wall easily enabled the entry of a human hand. Although the shear walls were heavily damaged their presence prevented the total collapse of the building. Also, there are diagonal shear cracks in the nonstructural members which suffered light damage (Figure 5.66).

**Figure 5.63** Figure 5.63. Bingöl Lisesi, high school building

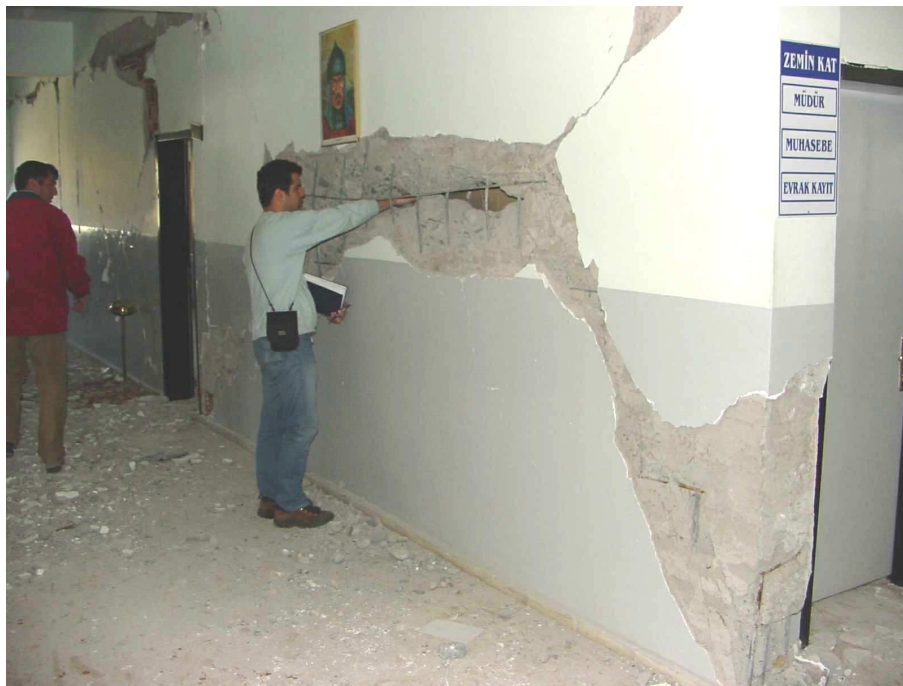
**Figure 5.64** Bingöl Lisesi, school building, core concrete crushing and resulting gap in the shear wall

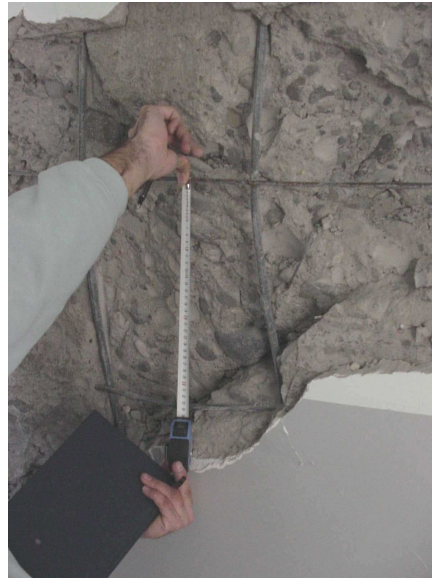
**Figure 5.65** Bingöl Lisesi, school building, inadequate lateral reinforcement in the shear wall (spacing is greater than 30 cm.)

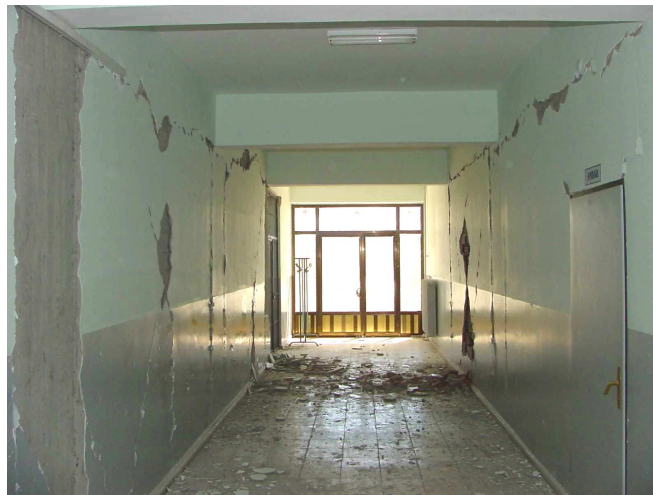
**Figure 5.66** Bingöl Lisesi, school building, diagonal cracks in the infill masonry walls

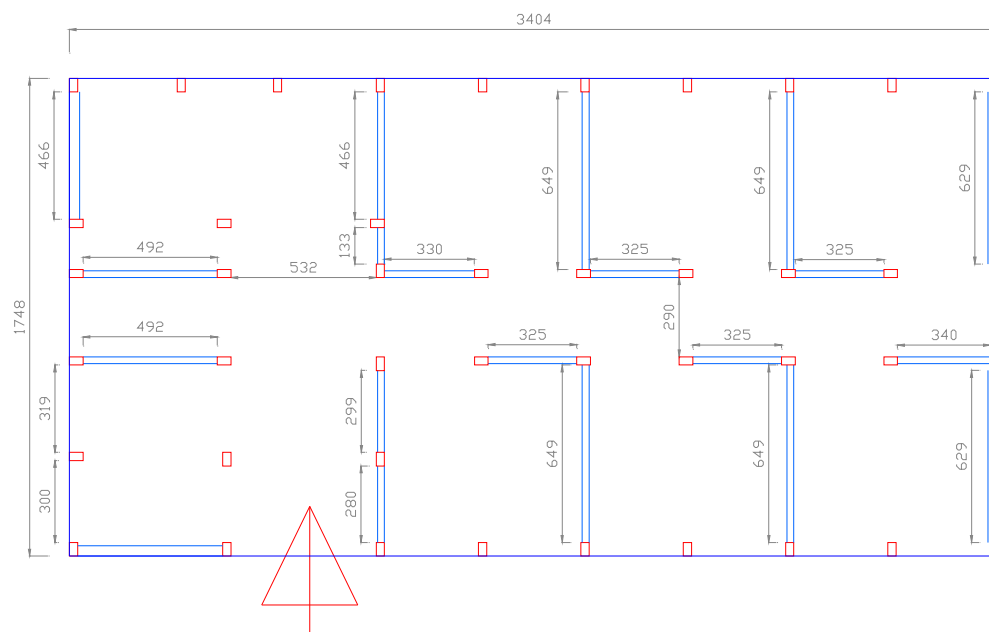
Of the 17 buildings in this category, 16 had the same column layout (Figure 5.68 and 5.69). As the floor plan indicates, the lateral load resisting system in these buildings can be categorized as regular in plan. The majority of the columns were aligned in regular bays, and most of the beams framed into columns. The dimensions of the columns in the buildings were typically 0.3m x 0.5m. The orientation

**Figure 5.68** Typical school plan without shear walls. All the walls shown in the drawing refer to those occupying a full span. Walls with openings are excluded. All the columns have dimensions of 0.3m x 0.5m. The arrow indicates the entrance to the building. Dimensions are in cm.

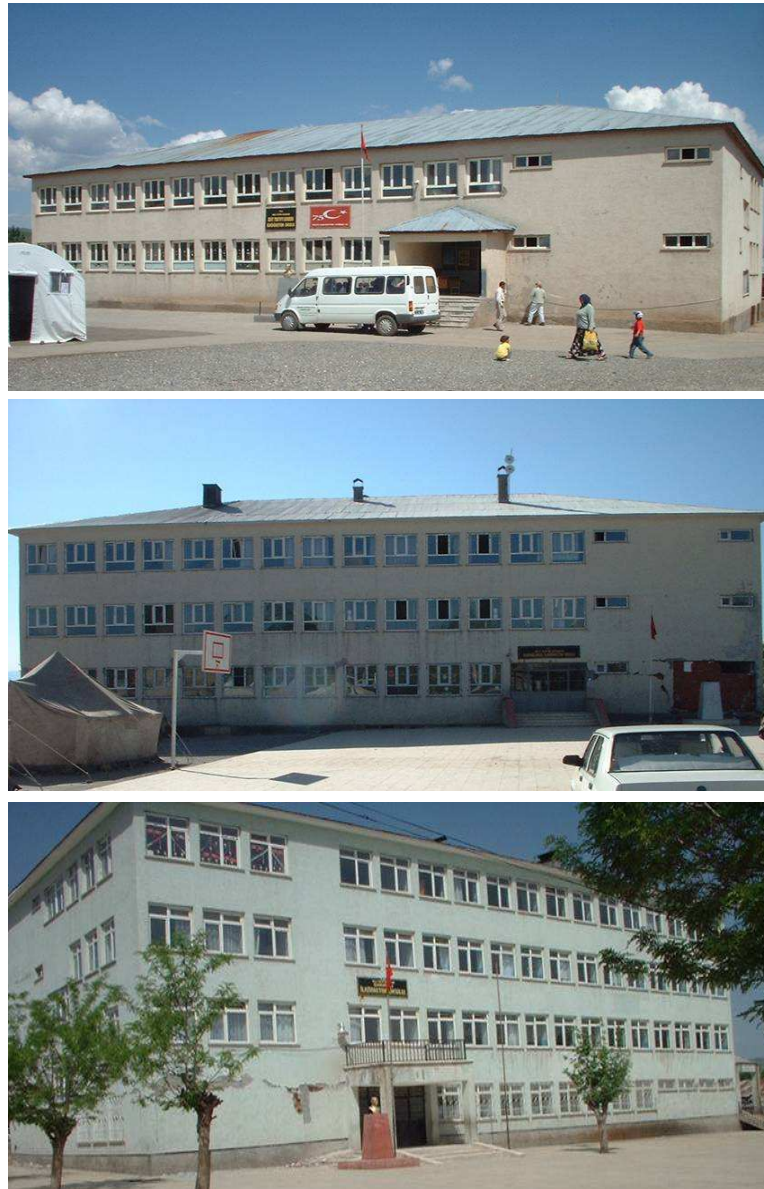
**Figure 5.69** School buildings with typical floor plan. Column dimensions are the same regardless of the number of floors.

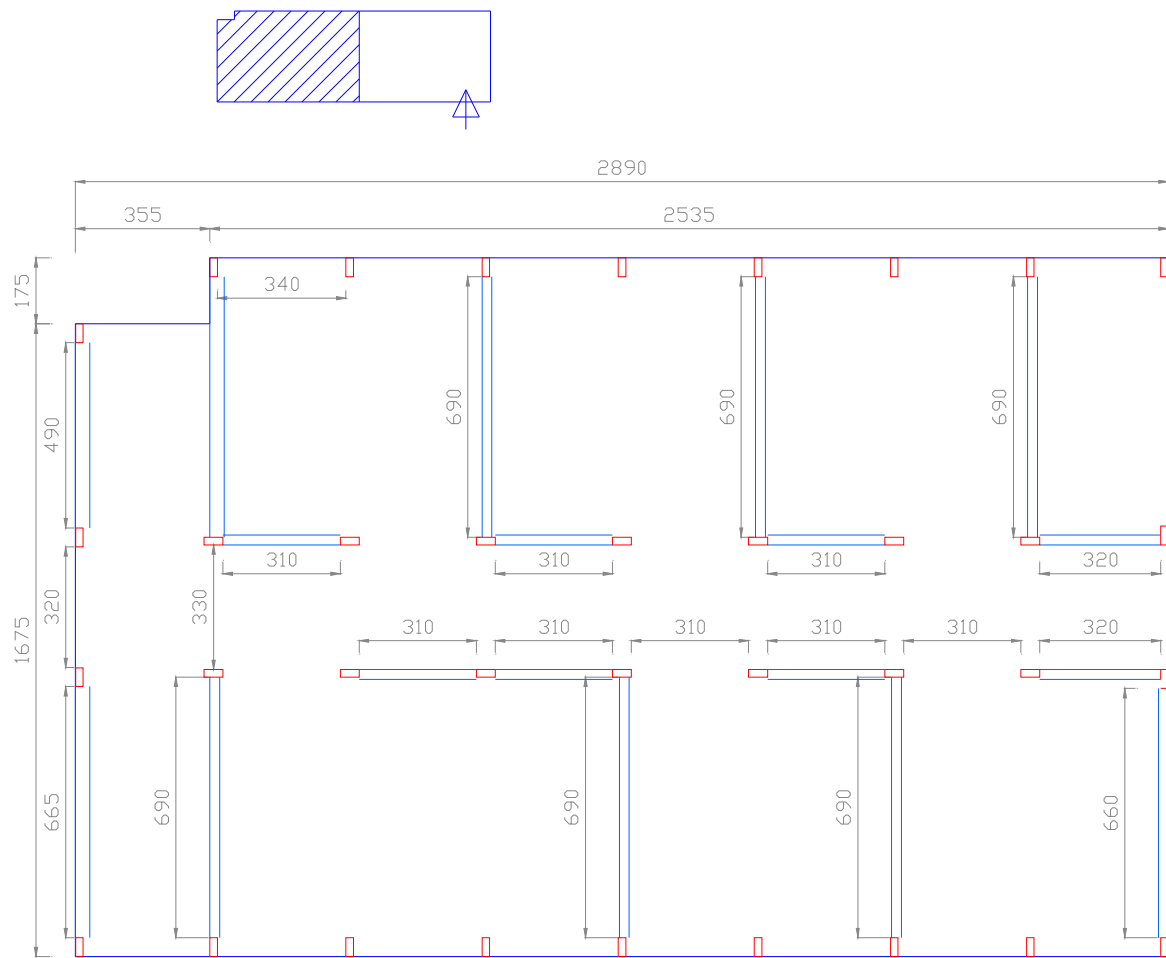
The only school building with a different column layout was C-13-02. The school complex was a combination of two separate buildings. The separation afforded by the expansion joint between the two buildings was not sufficient to avoid pounding between the two structures. The floor plan of the northern building is shown in Figure 5.70. All the columns shown in the figure have dimensions of 0.2m x 0.5m.

**Figure 5.70** The floor plan for C-12-02. The structural system is a moment-resisting frame. The columns are 0.2m x 0.5m. The school building comprises two independent structures separated by an insufficient expansion joint. Only the shaded part in the upper figure was surveyed. The arrow indicates the entrance to the building. The dimensions are in cm.

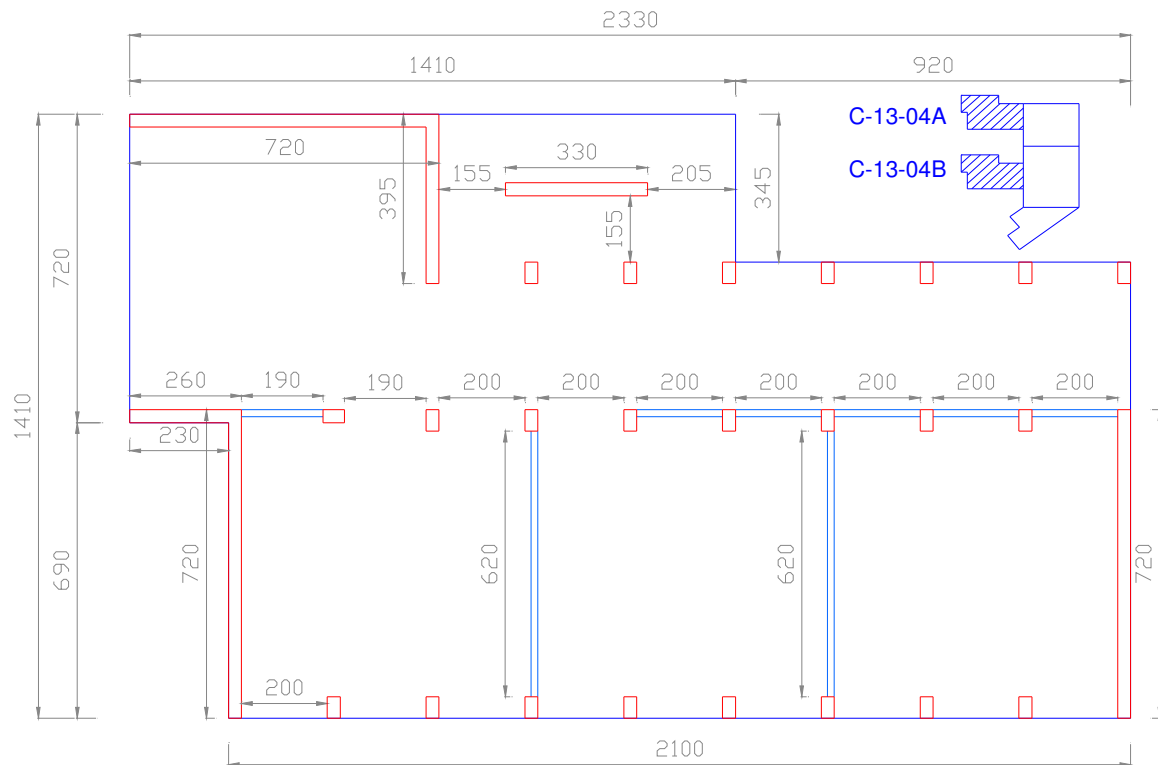
These buildings were part of the same school complex comprising five different structures separated by expansion joints. Buildings C-13-04A and C-13-04B had a similar lateral load resisting system, shown in Figure 5.74. The only difference between the buildings was the location of masonry walls. The total shear wall area of the structure in the longitudinal and transverse directions was 1.4 and 2.0 percent of the floor area, respectively.

There were no indications of structural damage in the buildings, and the masonry walls were only lightly damaged.

**Figure 5.74** Structural floor plan for building C-13-04A. All the columns have dimensions of 0.3m x 0.5m. The thickness of the reinforced concrete and masonry walls were 0.3m and 0.16m, respectively. Dimensions are in cm.

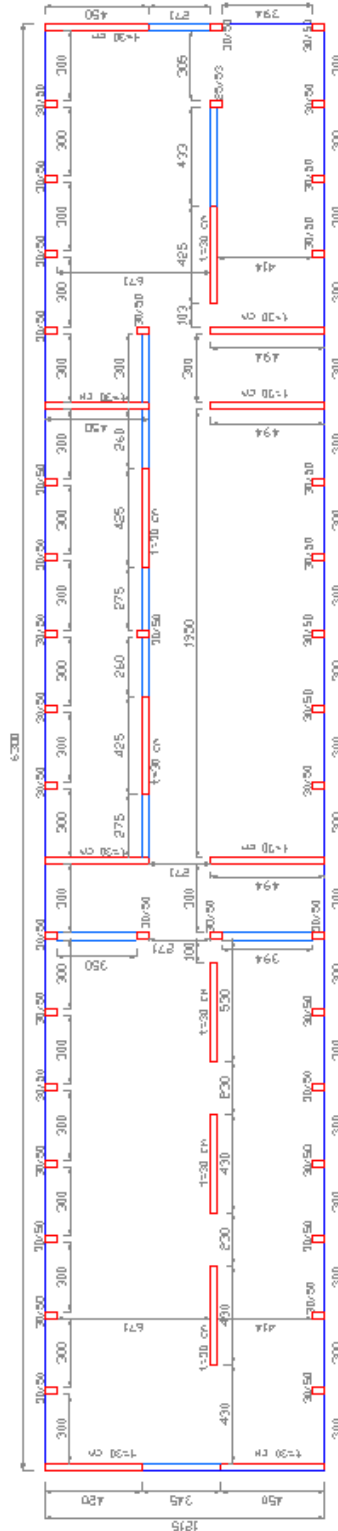
**Figure 5.78** Structural floor plan for dormitory buildings. The masonry wall thickness was 0.3m. Dimensions are in cm.

Of the four dormitory buildings that were surveyed, the structural systems of two of them, D-17-01 and D-17-02, were rated as severely damaged because of the inclined cracks on the captive columns. There were also inclined hairline cracks on the shear walls. Some of the beams had flexural and shear cracks, and damage was commonly observed in beams that framed into other beams as opposed to columns.

Because buildings D16-02 and D-17-04 had inclined hairline cracks on shear walls and shear and flexure cracks on beams the damage to them was rated as moderate.

The most striking damage in these buildings was the collapse of the free standing masonry walls separating the sleeping units in the upper levels. These walls were not included in the damage rating because they were unattached to the structural system. However, they presented a serious hazard to the students living in these dormitories because in some cases the walls collapsed on the beds (Figure 5.79). Fortunately the collapse of the walls did not result in any fatalities because almost all the beds so affected were happened to be unoccupied.

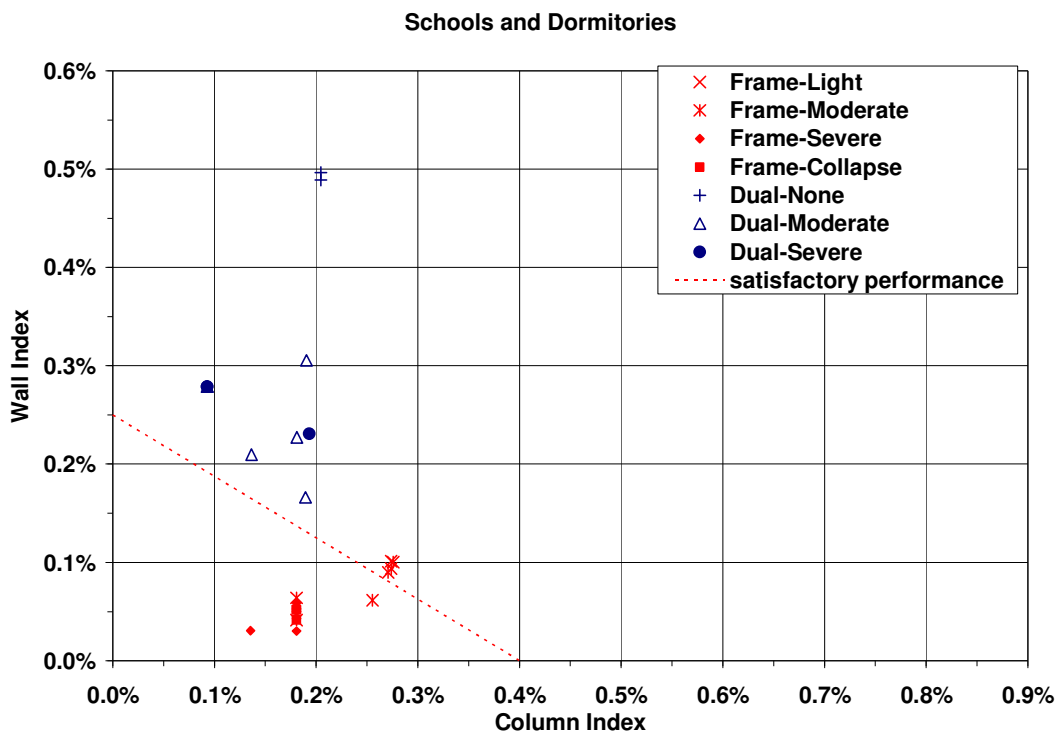
The wall and column indexes calculated for the school and dormitory buildings in Bingöl are given in Table 5.9. The correlation between the damage category of the buildings and the wall and column indexes are presented in Figure 5.80. As the figure shows, the damage level tended to decrease as the wall and column indexes increased.

Based on the damage assessment of these buildings, a boundary for the minimum column and wall indices for satisfactory performance is shown in Figure 5.80.

**Figure 5.80** Correlation between the structural performance and the wall and column indexes defined by Hassan and Sozen (1997).
