# **1 MAY 2003 BİNGÖL EARTHQUAKE**

## **ENGINEERING REPORT**

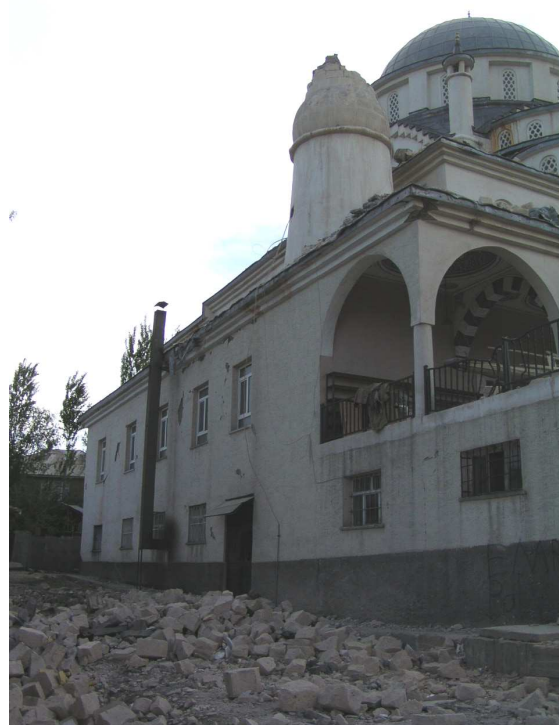
In the district of Yenimahalle, the Yenimahalle Mosque lost both of its minarets. As can be seen from the debris in Figure 5.84, unreinforced masonry blocks were used in the construction of the minarets. Besides fallen debris from the collapsed minarets, the main building sustained some damage. It is worth noting that across the Yenimahalle Mosque a 5-story reinforced concrete building had a total collapse of its 2<sup>nd</sup> story (Figure 5.85). The second mosque that was to be demolished in town was the Yeni/Hacılar Mosque near the Mehmet Akif Ersoy Primary School and the İmam Hatip High School (Figure 5.86). Even though the presumably lightly reinforced concrete minaret sustained only minor spalling, the reinforced concrete and masonry combination main structure sustained enough damage to be slated for demolition. A similarly built minaret was found in the mosque complex next to Sarayıçi Primary School (Figure 5.87). While the main building sustained minimal damage, the minaret lost its tip and part of the rail guard. Two other minarets of similar construction were seen in the vicinity of the ground motion recording station. Neither of these minarets (Figures 5.88 and 5.89) had signs of damage. As with all other buildings, the quality of workmanship and attention to detail materially affect the seismic performance of special structures including places of worship like mosques.

**Figure 5.84** Yenimahalle mosque.

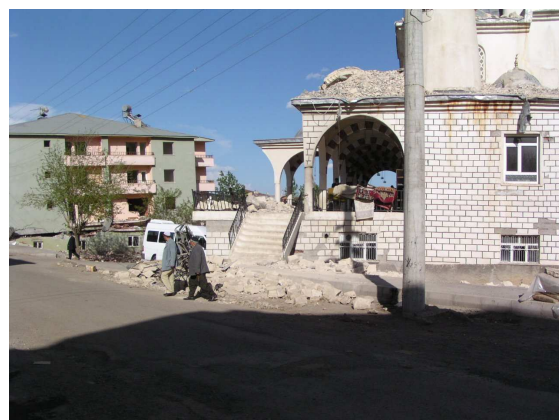
**Figure 5.85** View of Yenimahalle mosque with the private residential building that lost its 2nd story.

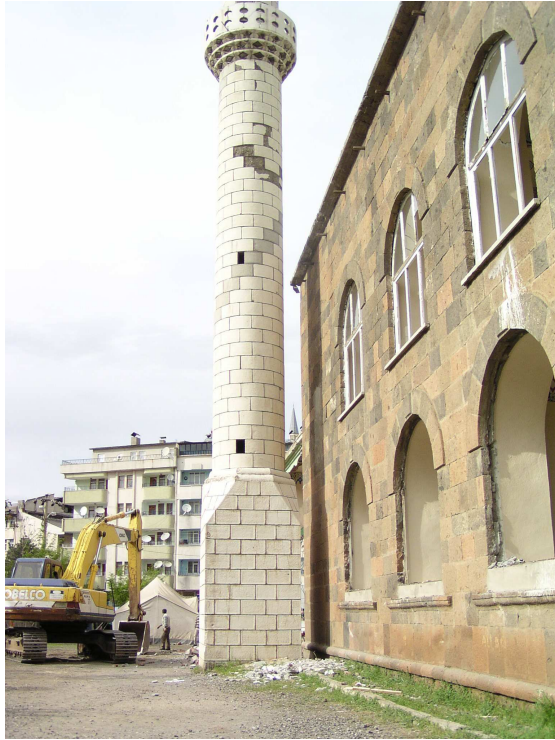
**Figure 5.86** Yeni/Hacılar mosque with spalling in its minaret. The structure is being demolished.

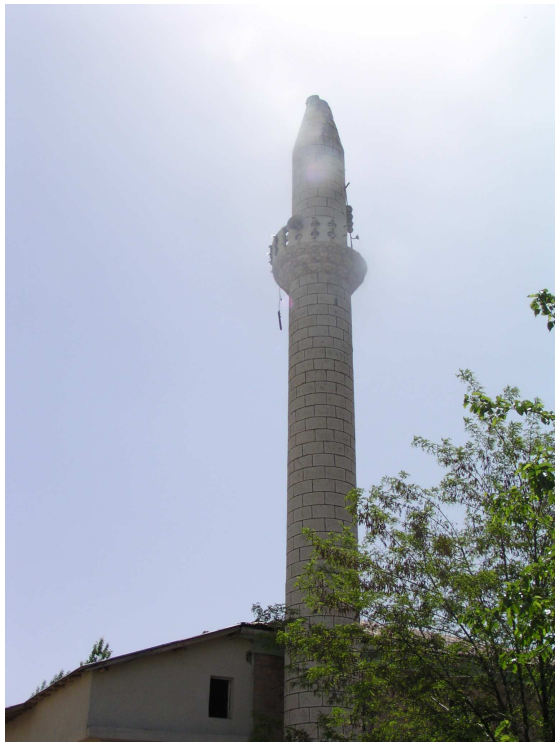
**Figure 5.87** Mosque next to Sarayıçi primary school. Minaret lost its tip and part of its rail guard.

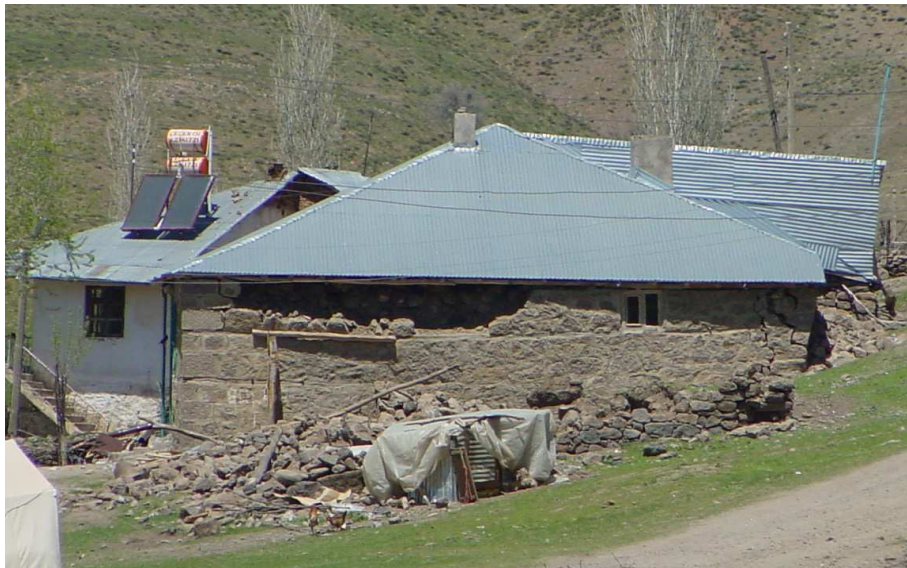
The categorization of nonengineered structures is not easy due to the large variation in construction techniques and workmanship. However, the majority of the houses in rural areas are constructed using large stones either in rectangular shapes or boulder like irregular forms. Those stones are commonly placed together using weak mortar along their contact surfaces with the other stones. On a smaller number of occasions, the walls are made out of solid fire bricks with wooden struts in the diagonal and vertical directions showing indications of engineering ingenuity (Figure 5.91). Such masonry construction usually performed better during the earthquake due to their lightweight construction and shear resistance shown by the diagonal struts. A portion of the nonengineered rural building stock composed of stone wall layers which are divided by the use of collar or ring beams in the form of band-like horizontal wooden layers (Figure 5.92). This type of construction has performed better than the stone-only type of construction with some instances of partial failure (Figure 5.93) because of the box-like action and integrity imparted by the ring beams.

**Figure 5.93** Partial collapse of hybrid masonry walls (bricks and horizontal wooden layers)

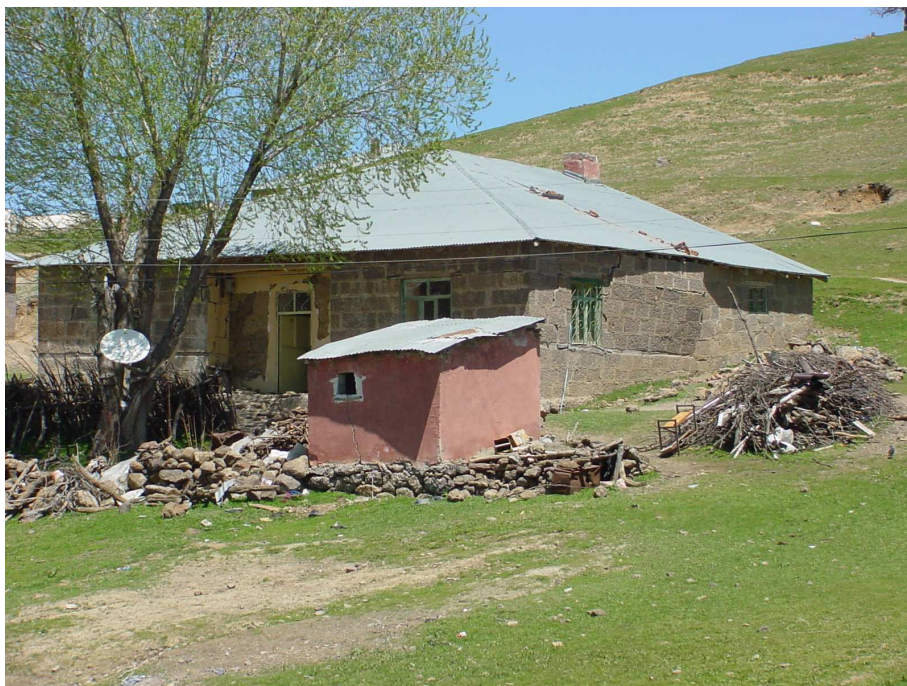
Most of the rural stone-masonry type building collapses are initiated by collapse of the wall midsection towards the top, due to lateral instability (Figures 5.94 and 5.95). Only a few instances of total house collapses are documented. The majority of the nonengineered structures, being mainly single storey dwellings, satisfied life-safety criteria.

**Figure 5.94** Stone-masonry type wall collapse initiation

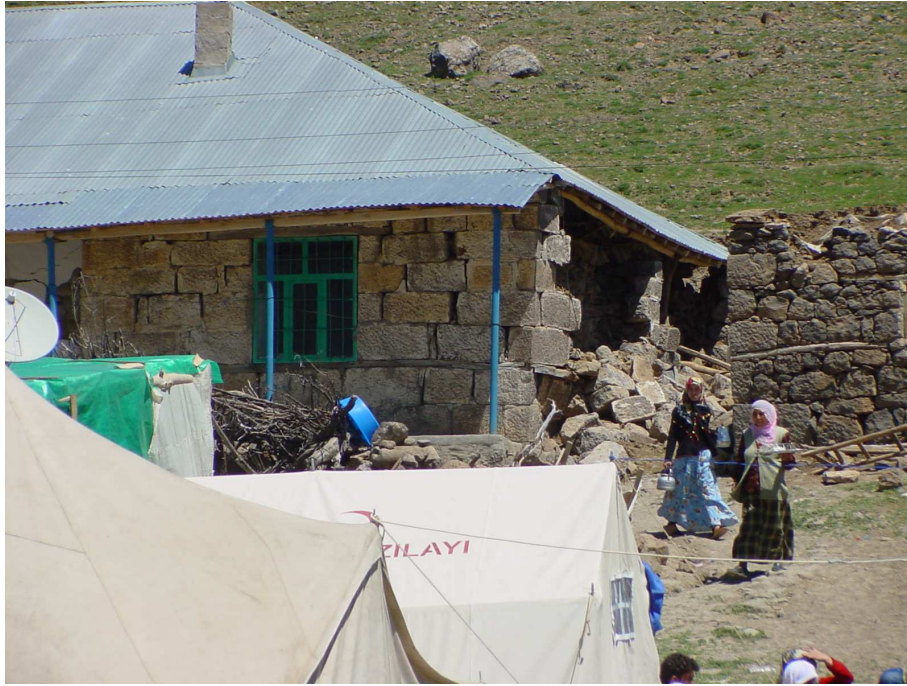
**Figure 5.95** Stone-masonry type wall collapse
