# Strengthening of Brick-Infilled RC Frames with CFRP

**Güney Özcebe, Uğur Ersoy, Tuğrul Tankut**  
*Professors of Civil Engineering*

**Department of Civil Engineering  
Middle East Technical University  
06531, Ankara Turkey**

**March 2003**

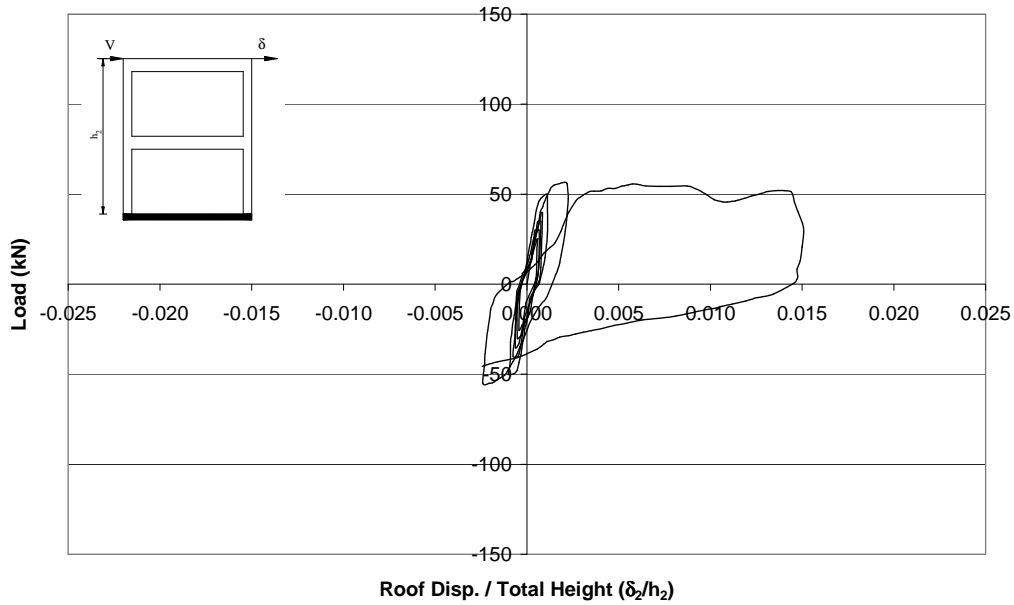
The lateral load–drift ratio curves for all stories are given in Figures 4.2 and 4.3.

**Figure 4.2** Lateral Load – Roof Drift Ratio Curves for SP-1

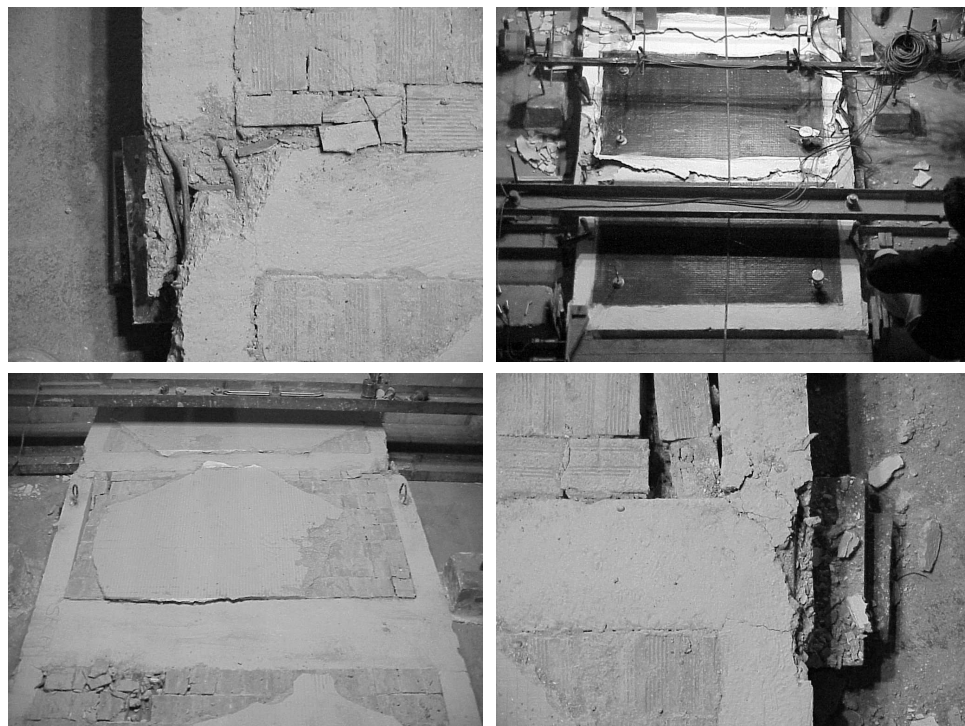
**Figure 4.8** SP-2 after the Test

The damage which occurred in the specimen during the test is shown in Figure 4.8

- In the sixth cycle, new cracks were observed at the top and middle of the first story columns.
- In the seventh cycle, maximum load reached was 65 kN. At this level, the cracks observed so far widened and extended. The frame was so damaged that the load capacity of the specimen could not exceed 65 kN in the following cycles.
- From this point on, the test was carried out on displacement controlled basis. In the eighth cycle, there was severe damage at the top of the first story columns.
- The specimen failed due to the crushing of the first story beam-column joints in the ninth cycle.

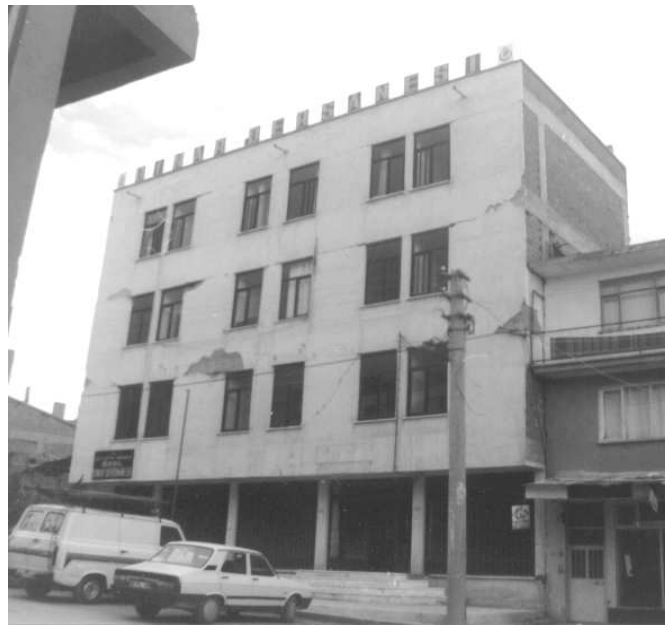
**Figure 6.6** Overview of DBI Building

The building is known as the DBI building in Dinar, which is a four story framed structure. The floor area at the base of the building is approximately 310 m<sup>2</sup>. The height of the first floor is 3.8 m and the height of the remaining three floors is 3.5 m. Moreover, the amount of brick infill walls at the first floor was much less as compared to the others resulting in a soft story problem. Observations made by the METU-EERC teams revealed that the structure had the typical deficiencies observed in Turkey like inadequate confinement, low lateral rigidity, beams stronger than columns and low concrete strength. The structure was originally rehabilitated by introducing reinforced concrete infill walls. The total area of reinforced concrete infill walls provided in each direction was 0.93% of the floor area at the base. The overview and the original strengthening scheme applied on the floor plan of the building are given in Figures 6.6 and 6.7.
